National Register of Historic Places
Inventory—Nomination Form

historic Luke Jillson House

and/or common Fisk House; Jillson-Thomas-Fiske House

street & number 2510 Mendon Road N.A. not for publication

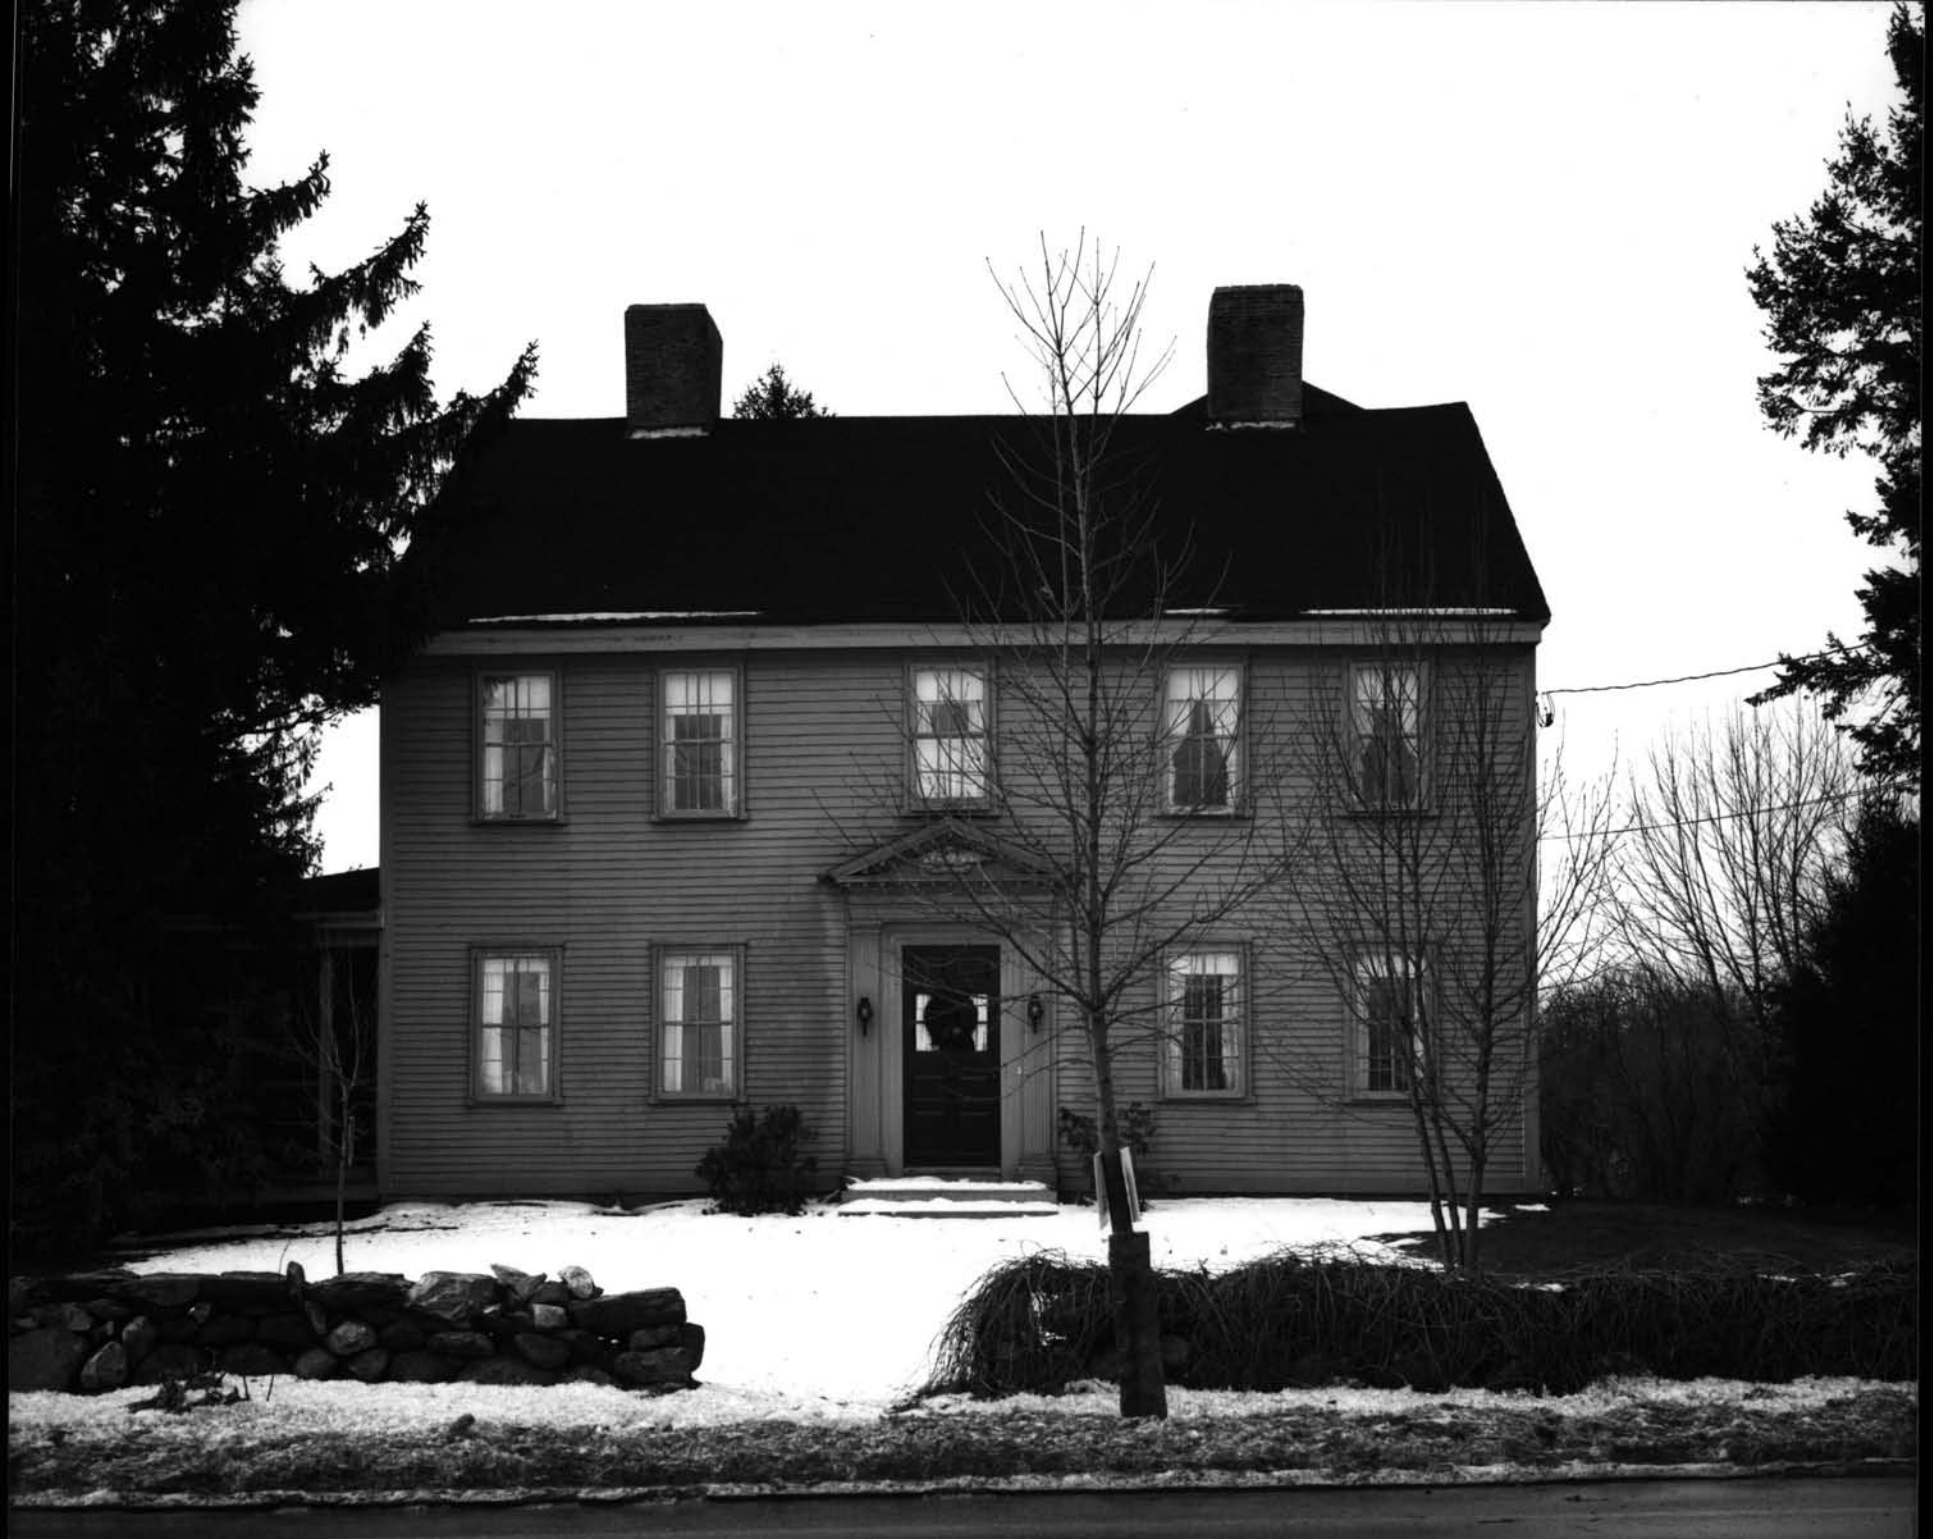
Photo #1.

Exterior view facing west.

The Luke Jillson House, set facing east toward Mendon Road on a one-acre lot, is a well preserved two-and-one-half-story, flank-gable-roof, clapboard-sheathed, late eighteenth-century dwelling with a five-bay facade containing a central entrance, a pair of brick interior chimneys, and a standard center-hall interior plan with two rooms on each side of the hall. There is a one-story, hip-roof porch with Tuscan columns on the south side of the house, added in the early twentieth century, and to the rear is a square-plan, four-story, pyramidal-roof, late nineteenth-century tower connecting the main block to a long one-story gable-roof ell which was once a blacksmith shop but which is now divided into a garage and a recreation room (Figures 1 and 2).

The focus of the facade is the entrance, composed of fluted pilasters supporting an entablature with a cushion frieze surmounted by a modillion-trimmed cornice and pediment. The house's six-over-six windows are set in heavy projecting frames, some with molded and some with flat-board caps. There is an entrance with a molded cap in the rear of the main block and an entrance with a shed-roof hood in the base of the tower, both fronted by a late twentieth-century stone terrace enclosed by a picket fence, and there are a modern overhead garage door and an entrance to the recreation room on the south side of the rear ell. The space partly surrounded by the house and ell is now a vehicle court, with a circular drive around a large stone watering trough. Behind the house is a small one-story, gable-roof, twentieth-century barn erected on the site of a larger, earlier barn. At the front the lot is bounded by a dry-laid stone wall, with a granite hitching post set in front of the wall at the curb, and a variety of shrubs and trees are informally planted around the grounds, with the remnants of an apple orchard northwest of the rear ell.

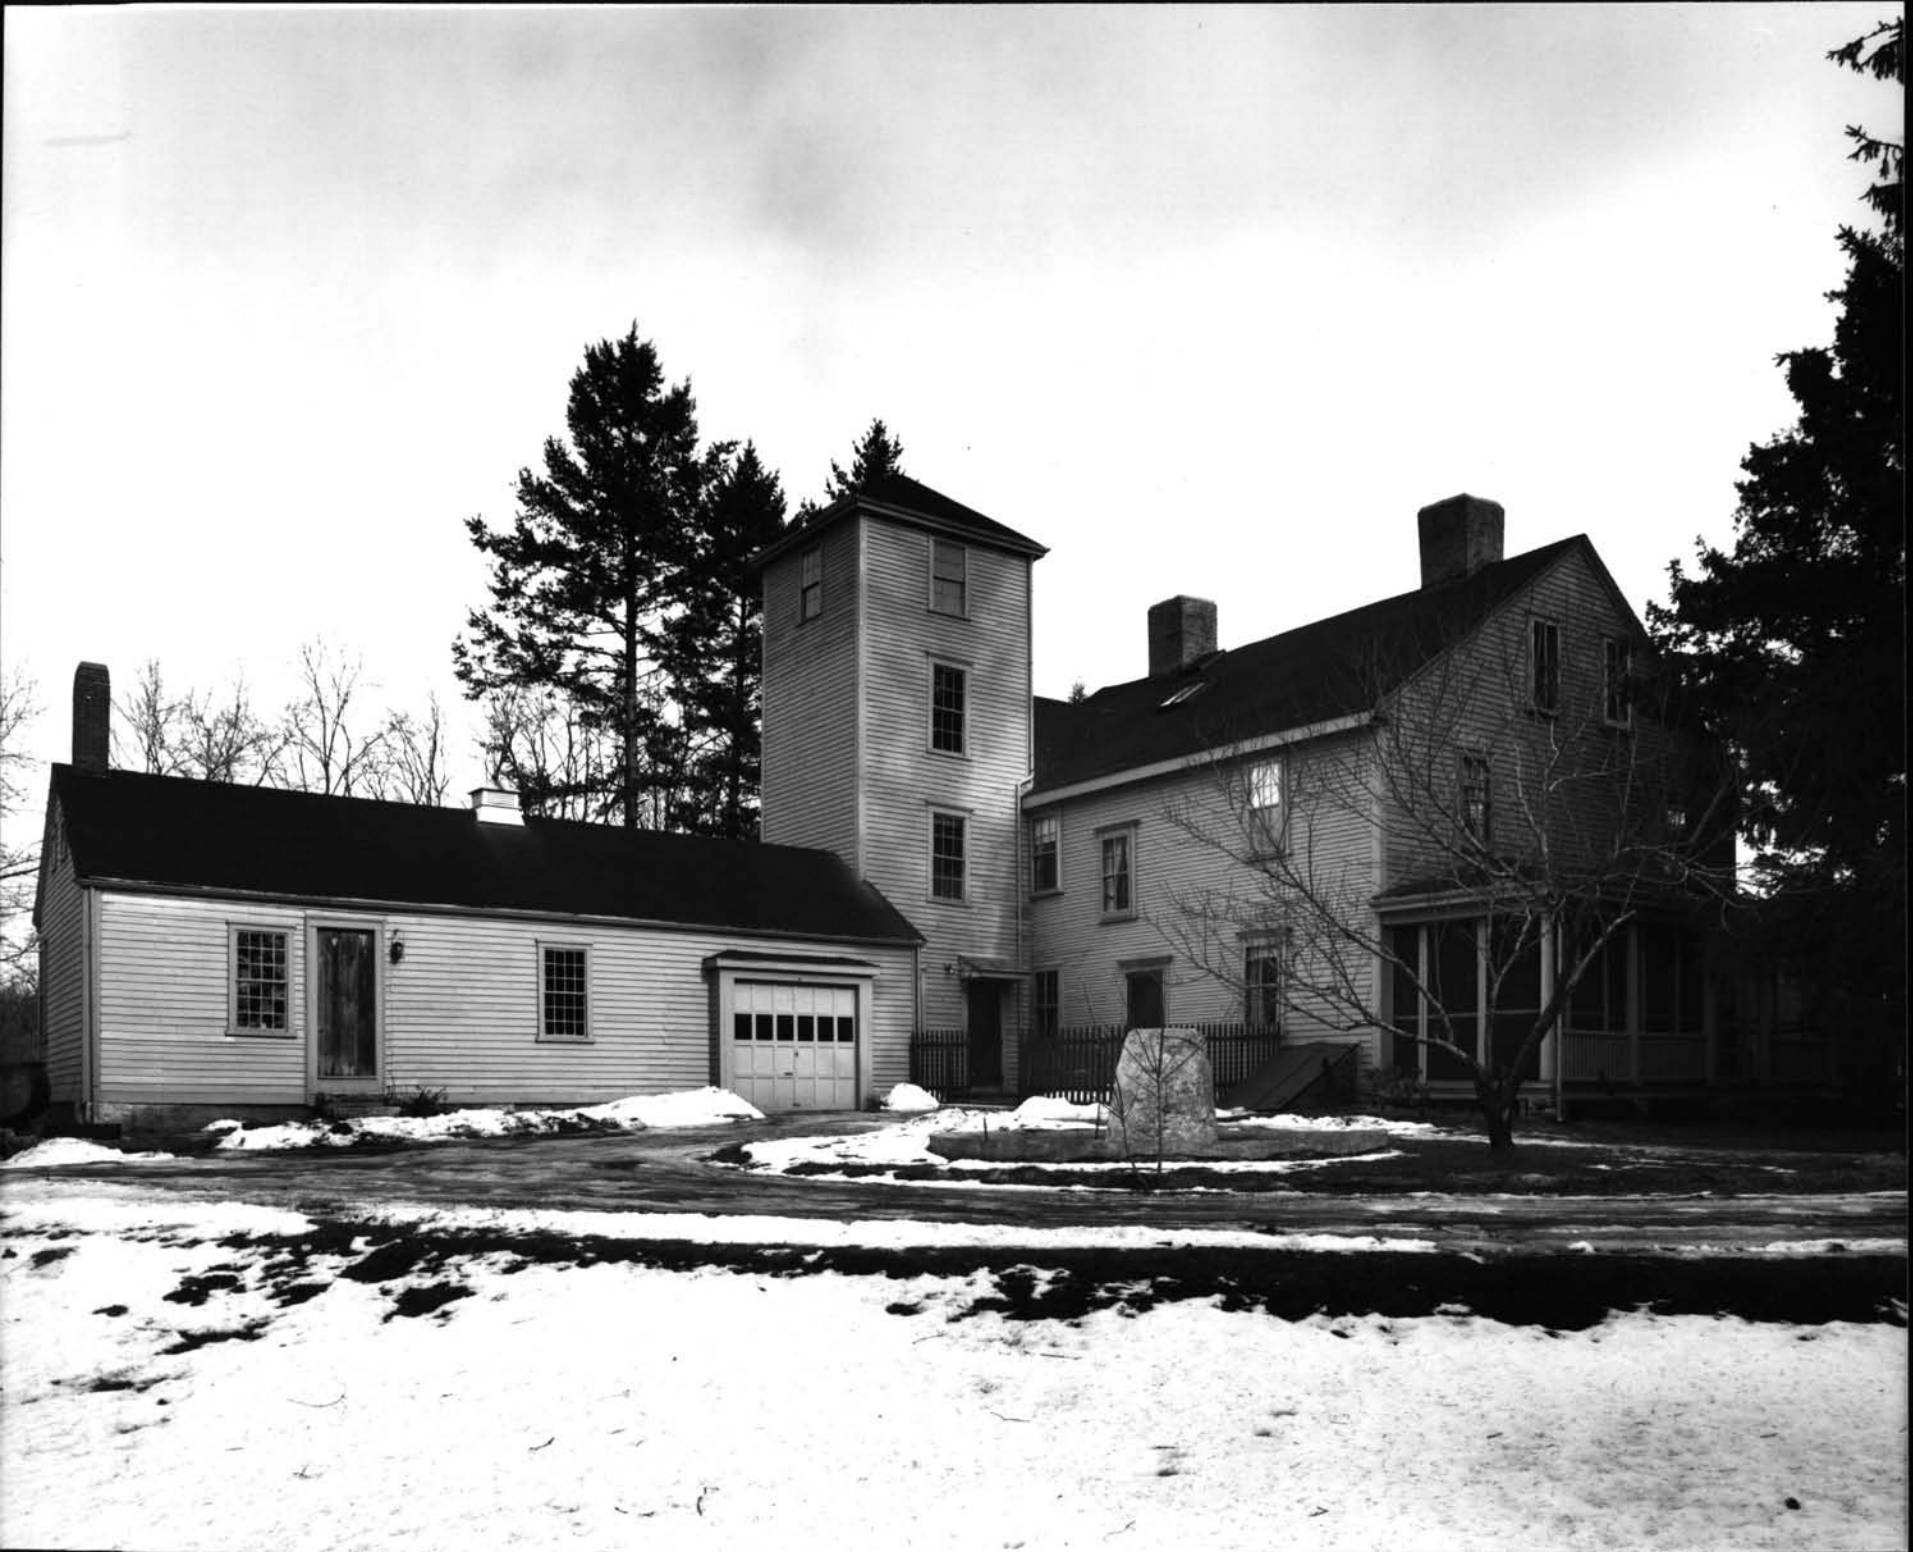
Photo #2.

Exterior view facing northeast.

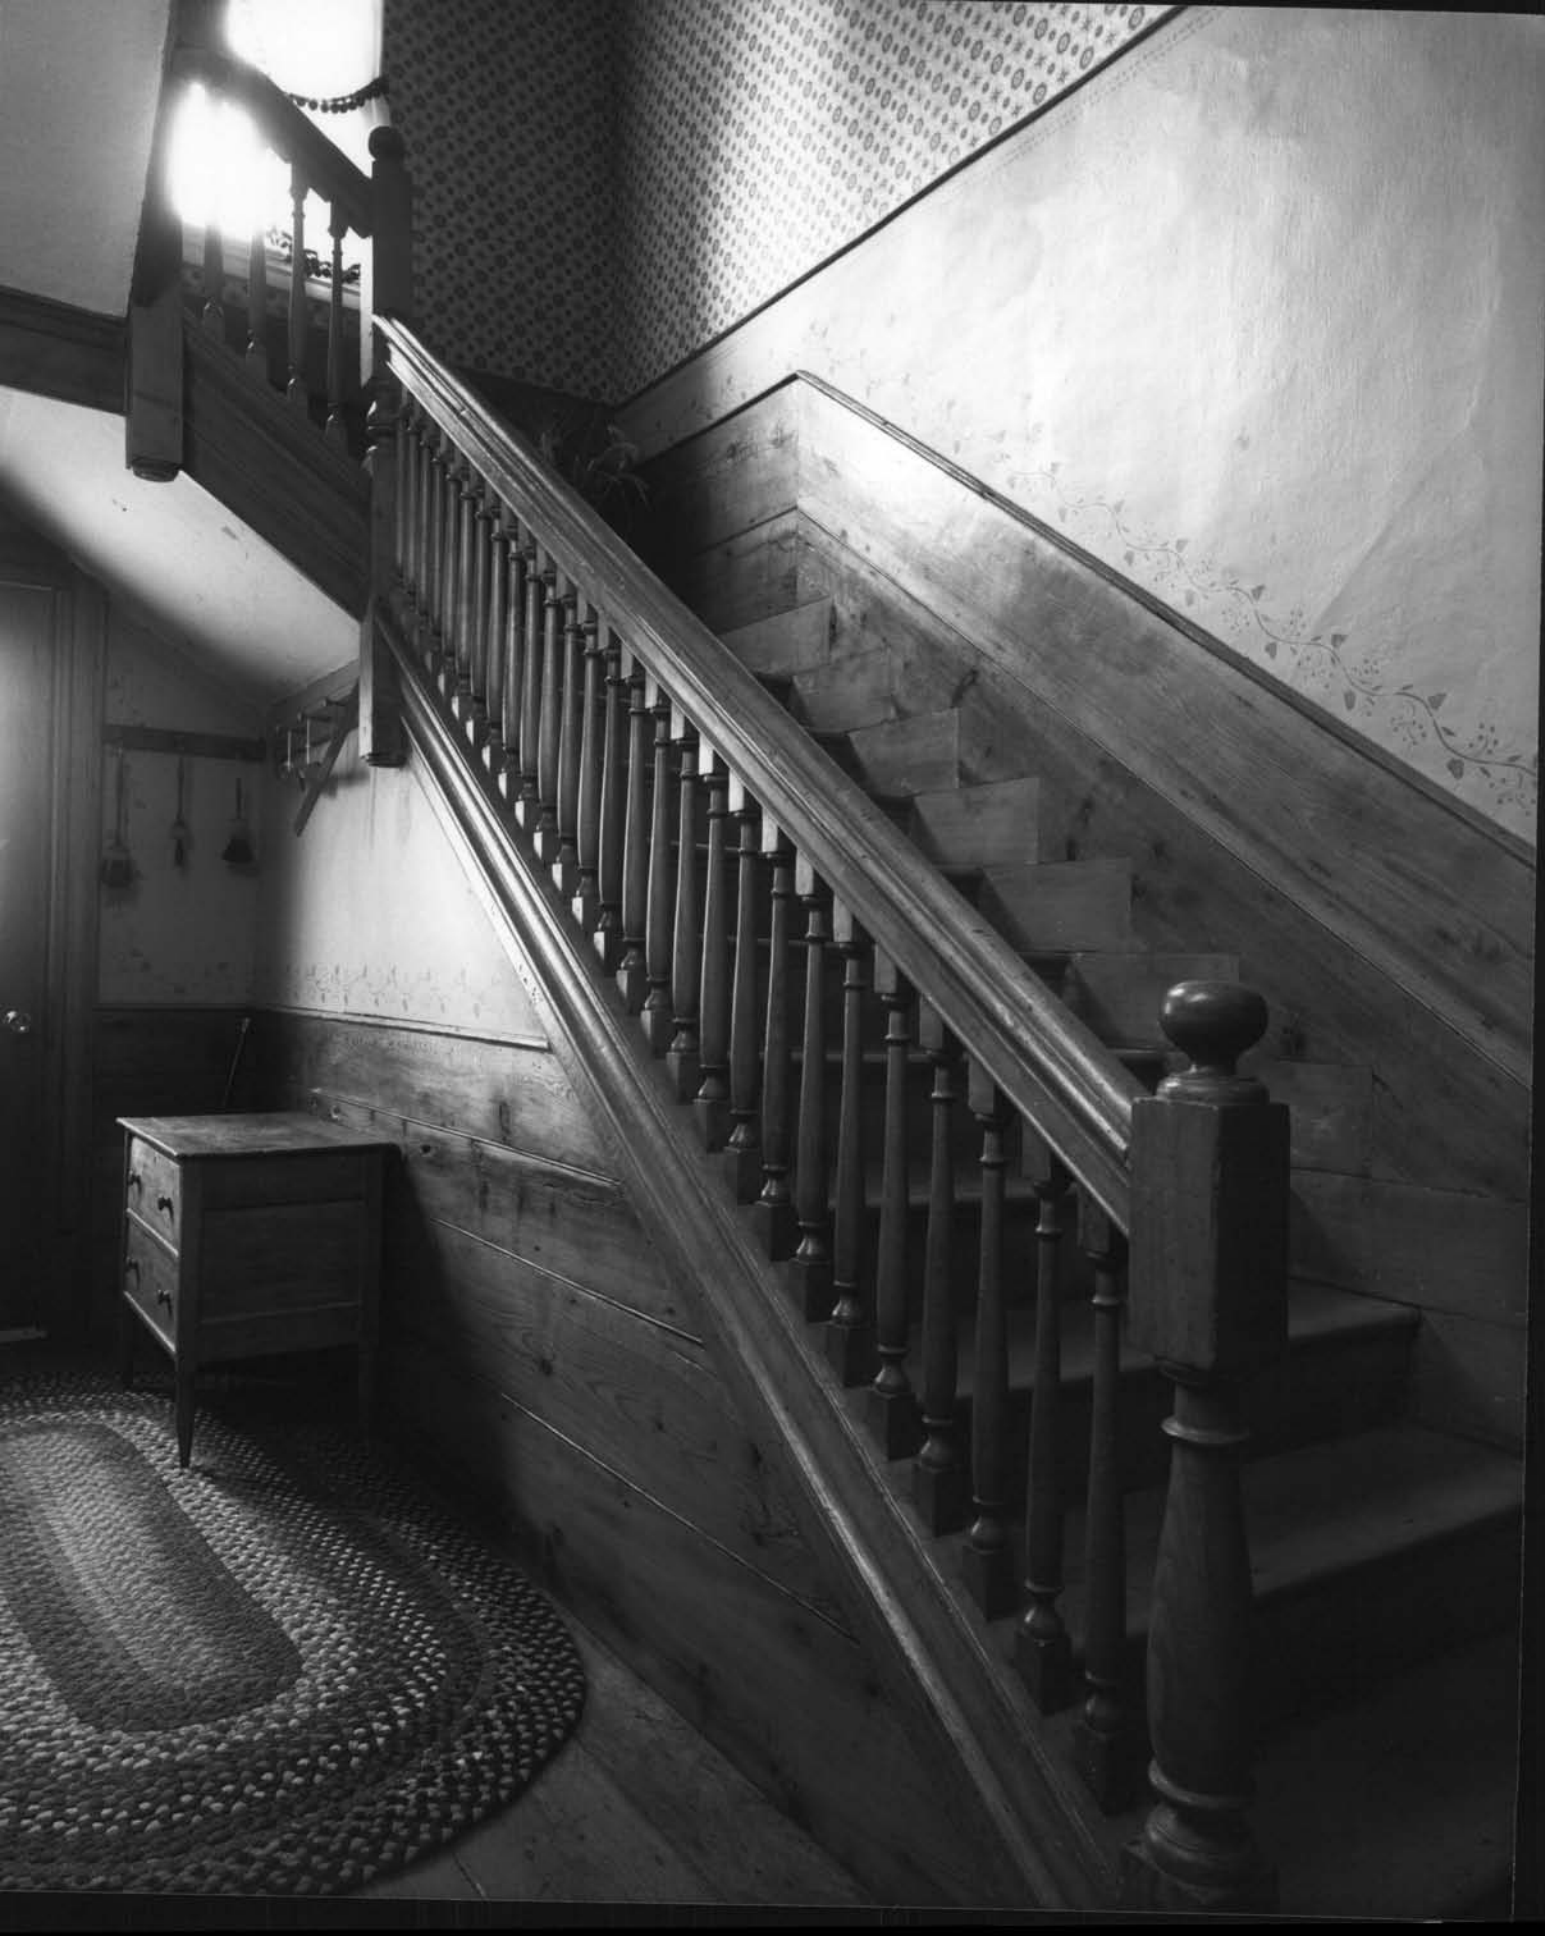
Photo #3.

View of staircase in center hall.

The interior of the house, though slightly altered over the years, retains much of its original character (see floor plan). At the rear of the hall, rising over the rear entrance, is a fine triple-run staircase with quarter landings, a heavily molded closed string, and turned balusters and newels (Figure 3). South of the hall are front and rear parlors, the former now used as a formal sitting room and the latter as an informal den or living room. North of the hall are a dining room in front and a kitchen in the rear. There are also small subsidiary spaces flanking each chimney. On the north side of each chimney are large closets opening through to the adjoining rooms. The space to the south of the southern chimney is divided into a shallow cupboard facing the front parlor and a tiny vestibule connecting the rear parlor to a door leading out onto the south porch. The space to the south of the north chimney contains a shallow cupboard facing the dining room and a larger closet off the kitchen which originally contained a very tight, winding service staircase to the upper floors. The first story of the tower contains a rear vestibule connecting to the kitchen and rear ell, a bathroom opening off the kitchen, and a closet opening off the vestibule. The portion of the ell nearest the house is occupied by a one-bay garage, while the outer portion has been

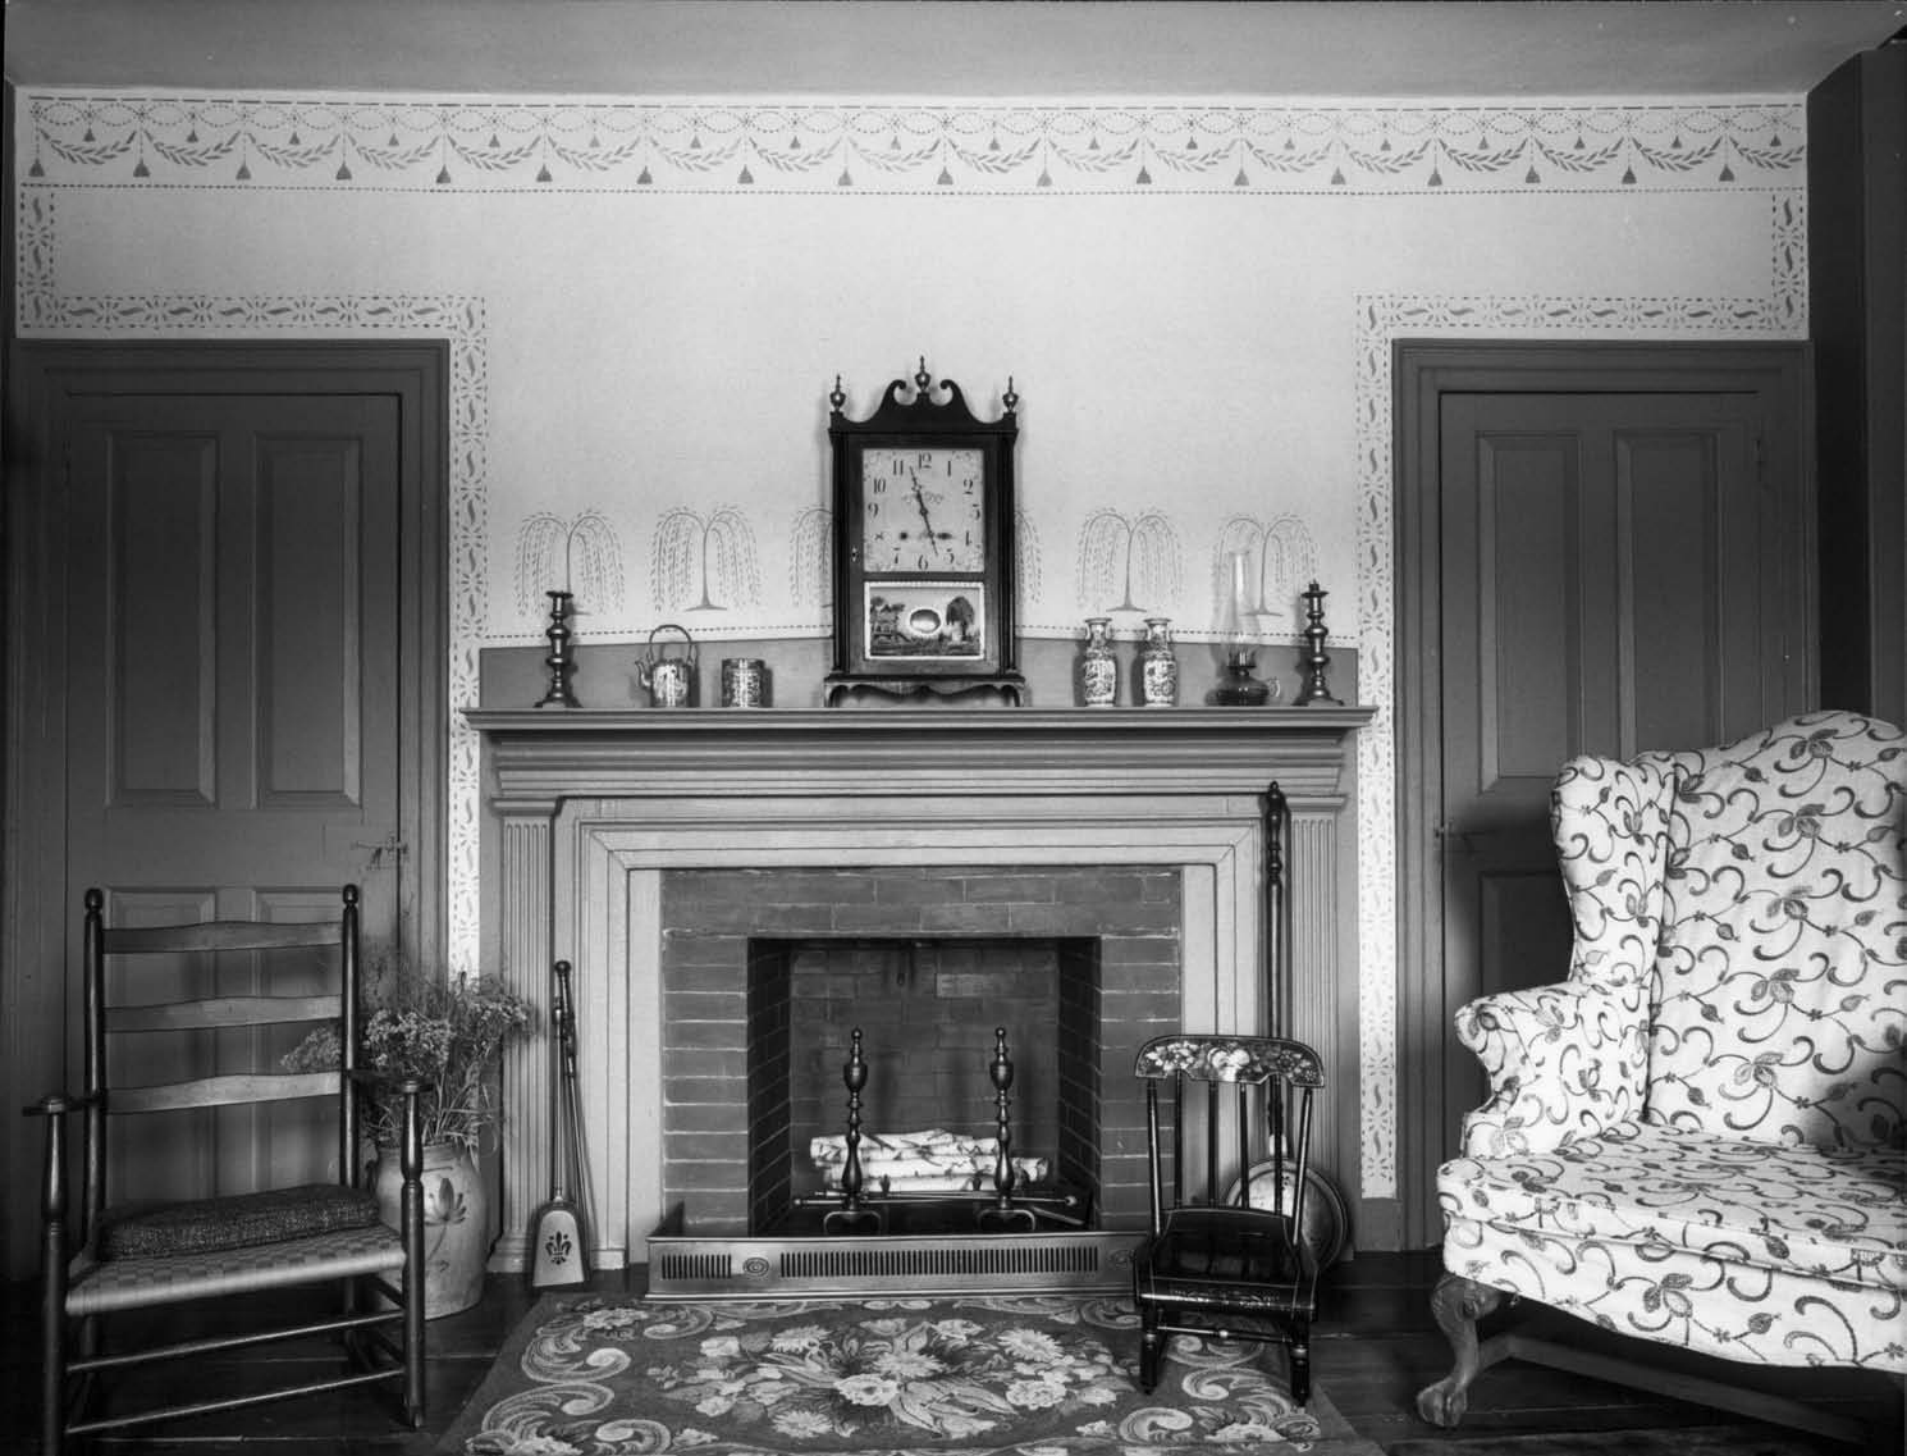
Photo #4.

View of fireplace in southeast parlor.

The first floor has the most notable interior finish. The fireplaces remain in all the rooms. Those in the dining room and front parlor (see Figure 4) have one-story mantels with rather flat molded architrave surrounds, fluted pilasters, and cushion-frieze entablatures supporting the mantel shelves. The rear parlor has a late nineteenth-century, Colonial Revival style oak mantel with an egg-and-dart firebox surround, fluted pilasters, and consoles supporting the mantel shelf, all surmounted by an earlier beveled-panel overmantel of pine (Figure 5). The flat-board mantel in the kitchen, with beveled-panel doors to one side covering the oven and wood box and paneling above, is not original and was taken from another Mendon Road house, the W.C. Ballou House, now demolished. All rooms have cased corner posts and all except the front parlor have cornice moldings. The front parlor and dining room have plastered walls and the hall, rear parlor, and kitchen have plastered walls above horizontal-board wainscoting. Plaster surfaces in the front parlor and hall are decorated with stenciling (Figures 3 and 4). This decoration is not original to these rooms, but is copied after stencil work discovered upstairs when the bedroom walls were repapered, and was painted here at the direction of the present owners by Shirley Houde Armstrong. Plastered ceilings

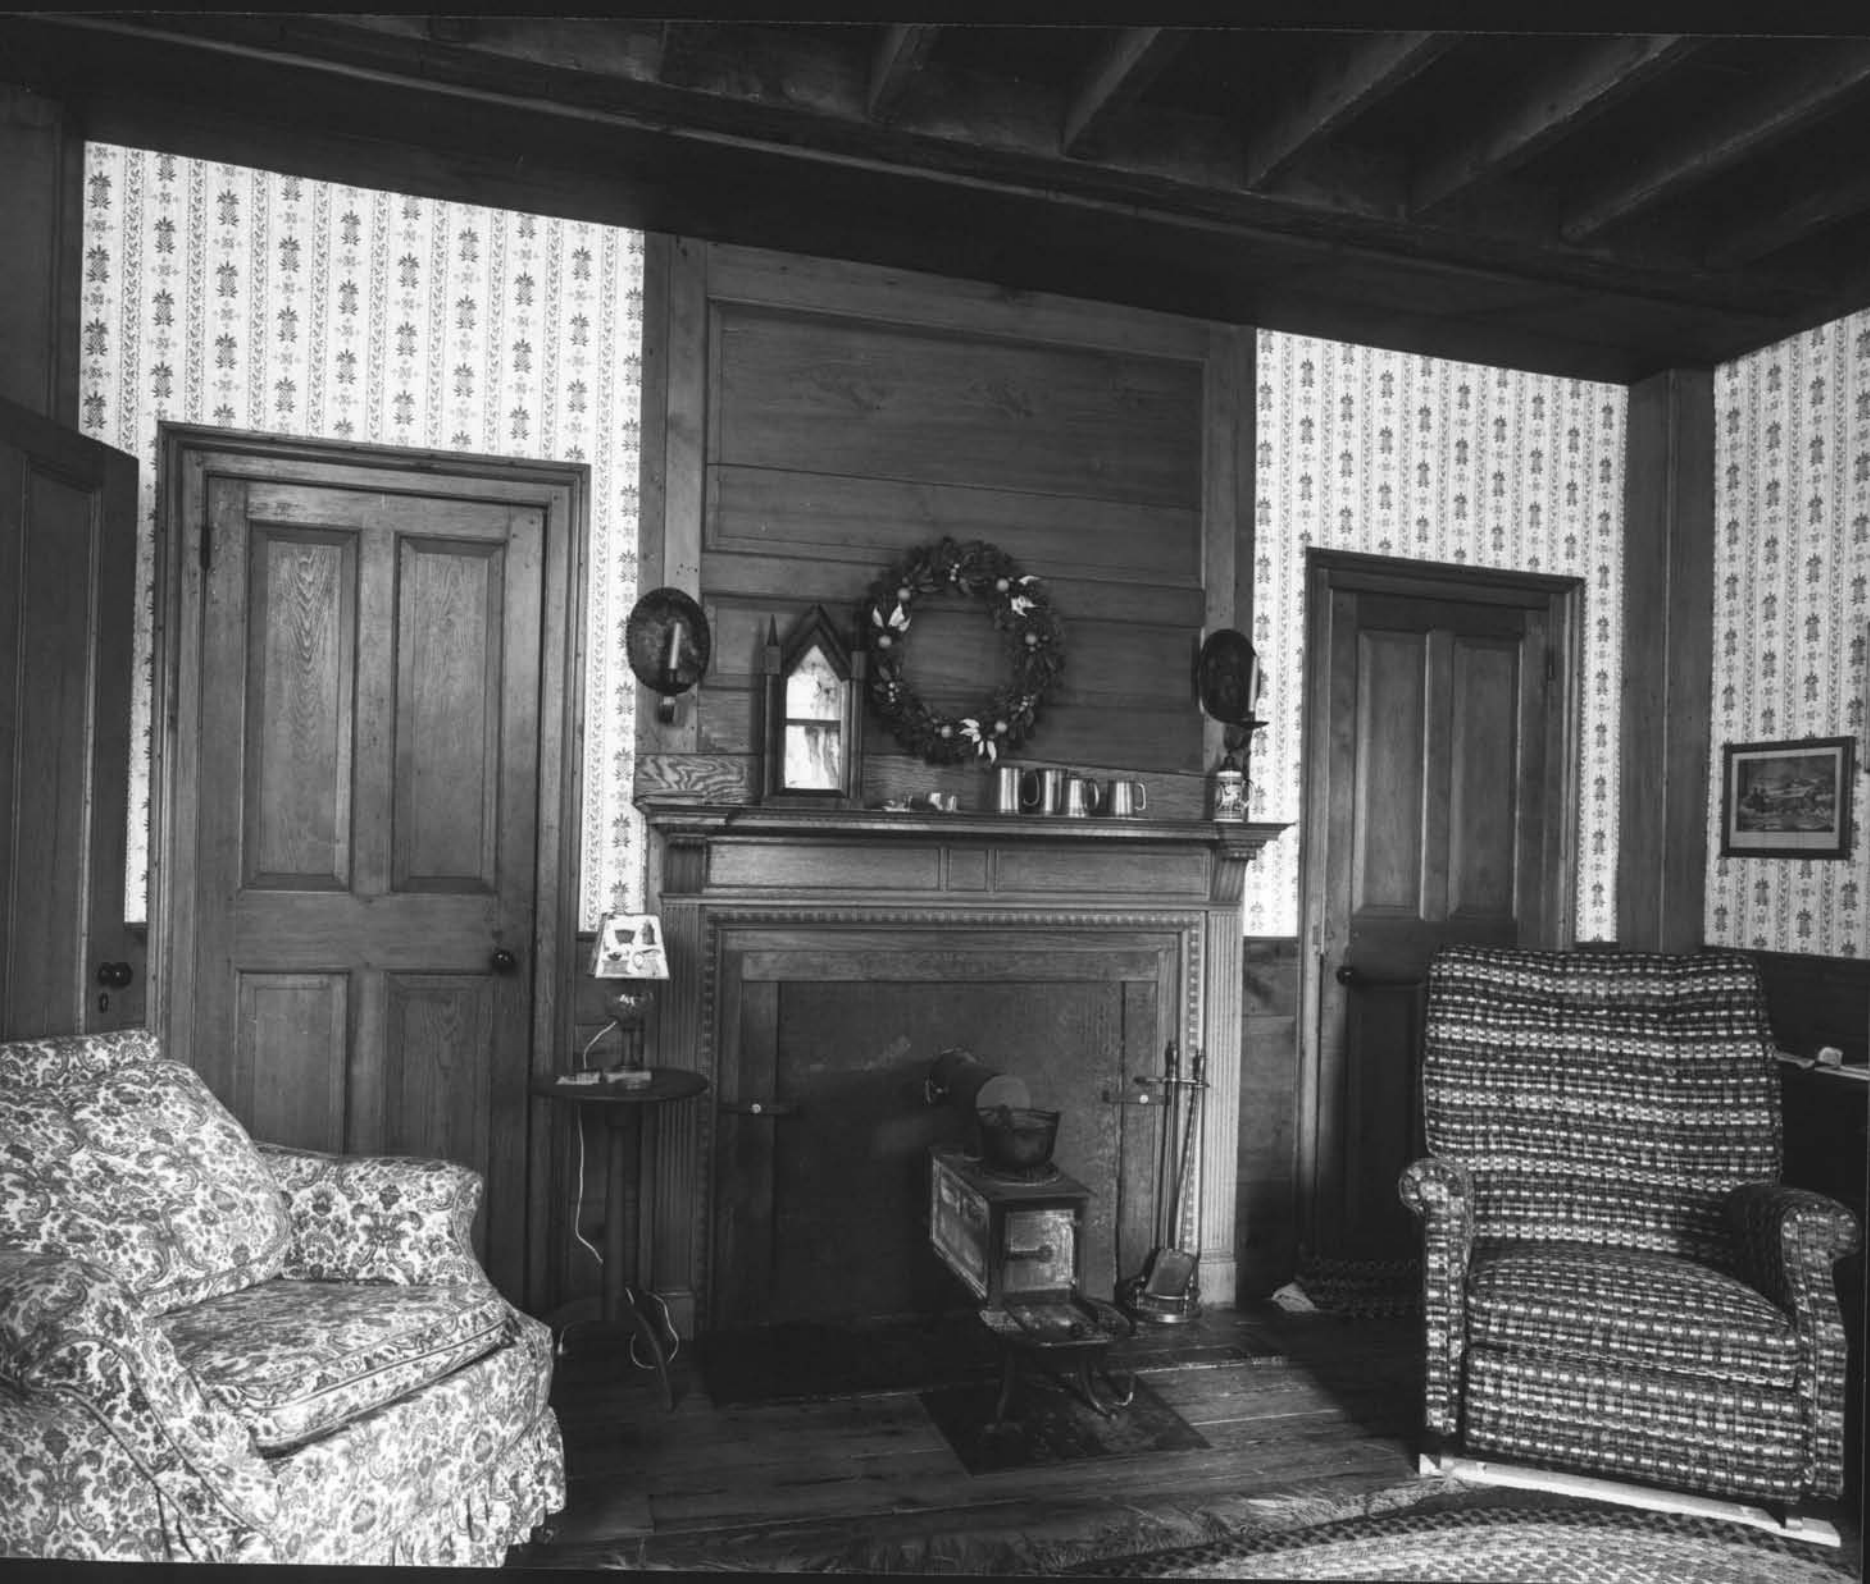
Photo #5.

View of fireplace wall in the library.
