**NATIONAL REGISTER OF HISTORIC PLACES
INVENTORY -- NOMINATION FORM**

John Cole Farm

Intervale Farm

Cumberland

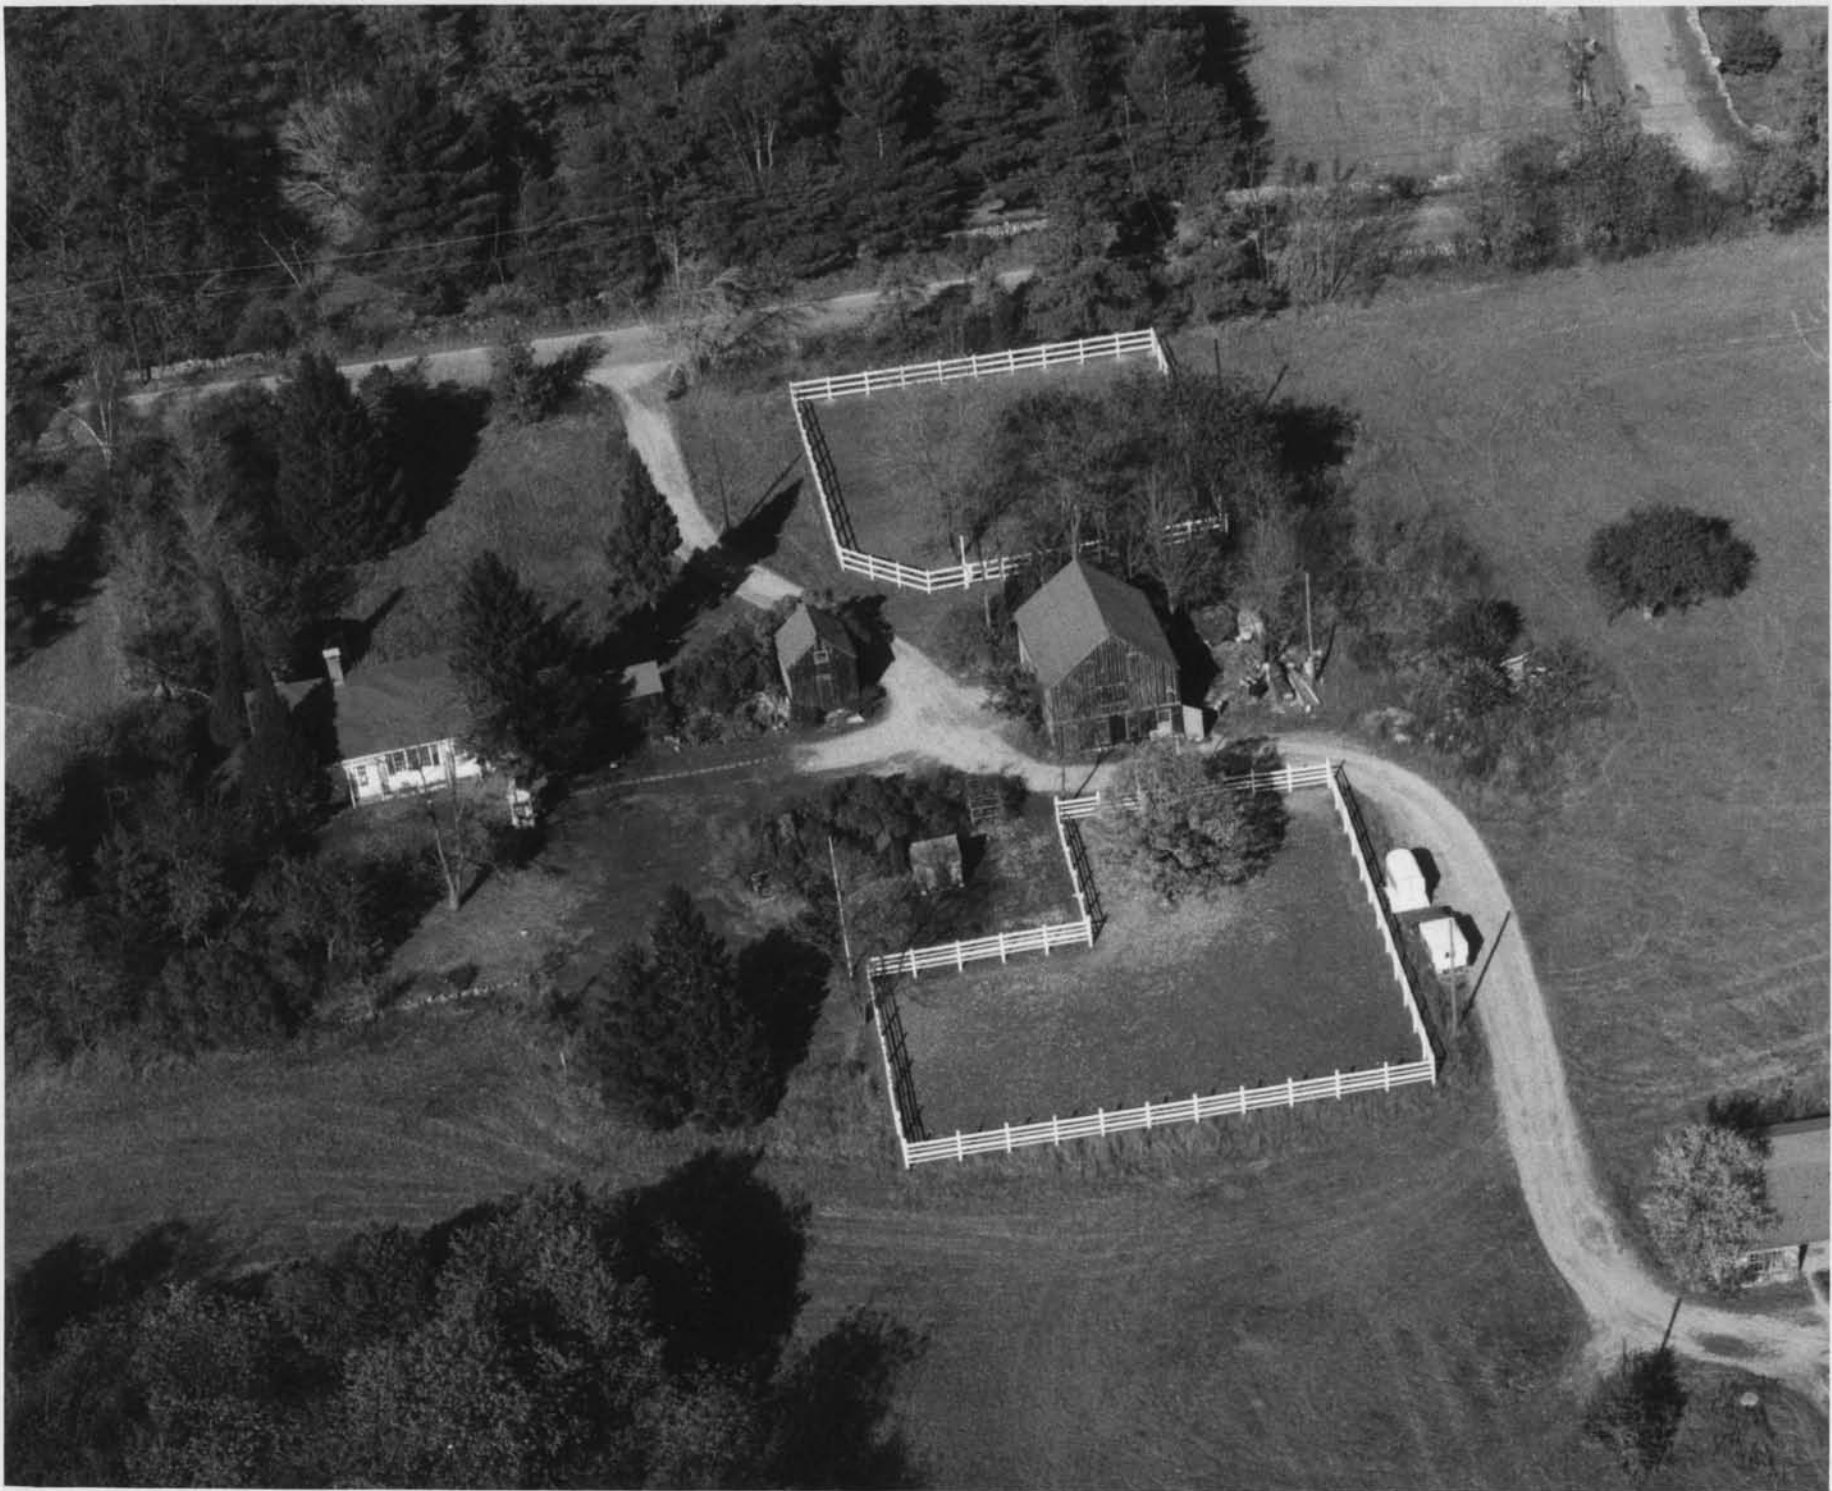
Photo # 1

Aerial view of Cole Farm, showing house at left,
well, sheds, outhouse, corncrib, barn, and pad-
docks.

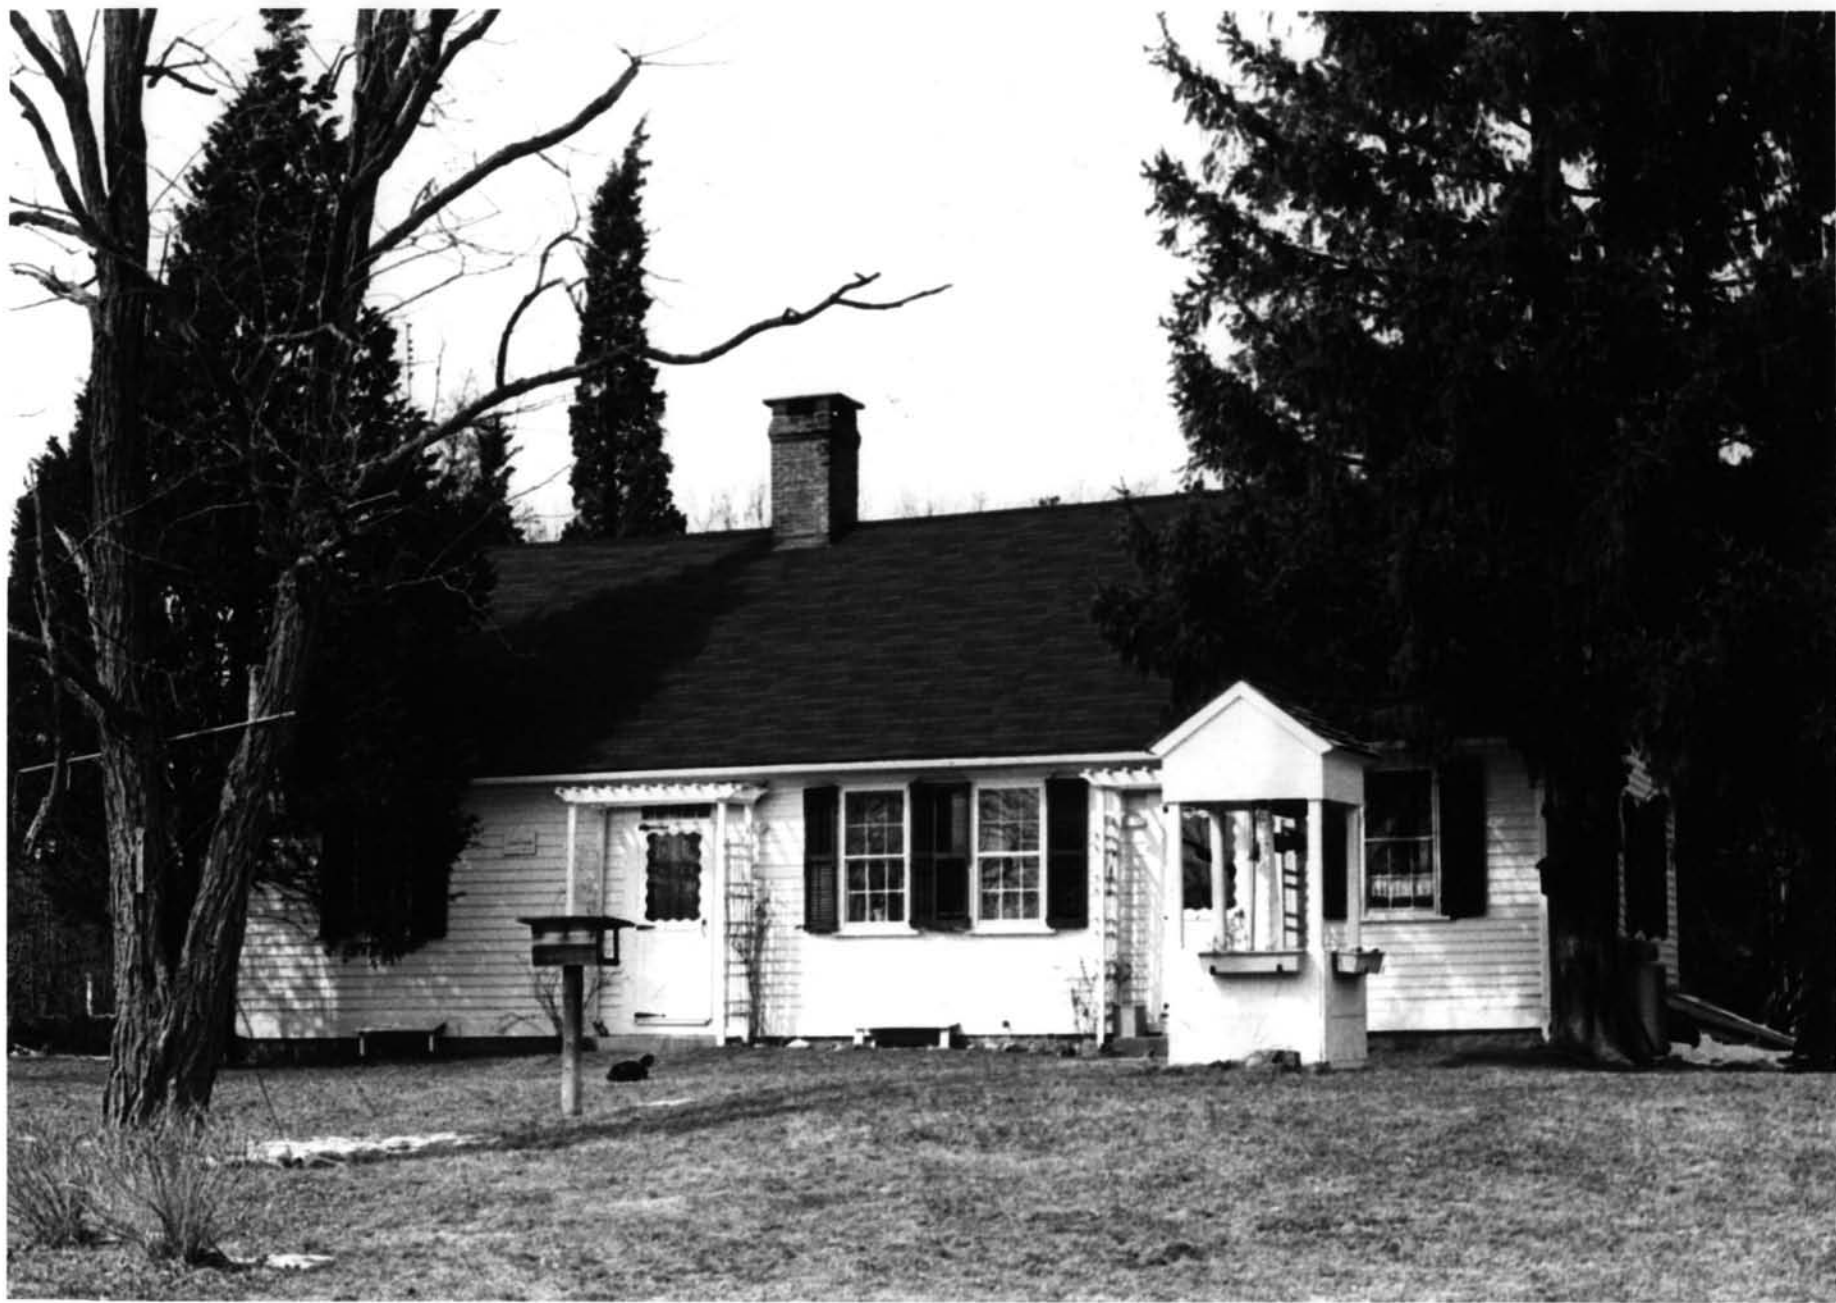
Photo #2

South front of John Cole house, with earlier
section shown at left (west).

The farmhouse is a one-and-one-half-story timber-framed clapboard structure set upon a cellar of random fieldstone faced with long slabs of granite. The long axis of the structure runs east-west, and both entrances are on the south side, facing neither Reservoir Road nor the drive in from it (see plot plan). The earlier part of the house (it had a two-bay eastern extension in the late eighteenth or early nineteenth century) is of five-room, central-chimney plan and is simply treated. The south elevation shows the c.1770 house with its plain central doorway, with transom lights, flanked on the west by one window (where one might generally expect two) and on the east by two windows. To the east of this older portion, and fully conforming in appearance, runs the later, two-bay extension with one doorway and one window. On this front and also at the rear, the roof overhangs the walls by about nine inches, and this overhang is finished underneath by lengths of wide boarding. Beneath this overhang runs an "eaves-cornice" of simple rounded mouldings; this breaks out over the protruded enframements of each opening on front and rear of the earlier part of the house. Windows at the ends of the house, however, have no capping mouldings whatsoever, but only long, flat "dripboards." End windows and some at the rear and in the gables retain twelve-over-twelve-paned sash, but elsewhere sash is six-over-six, a characteristic nineteenth-century modernization. The two southern entrances have large single-slab granite stoops, and each is now sheltered by a vine-grown trellis, probably added c.1925-1945.

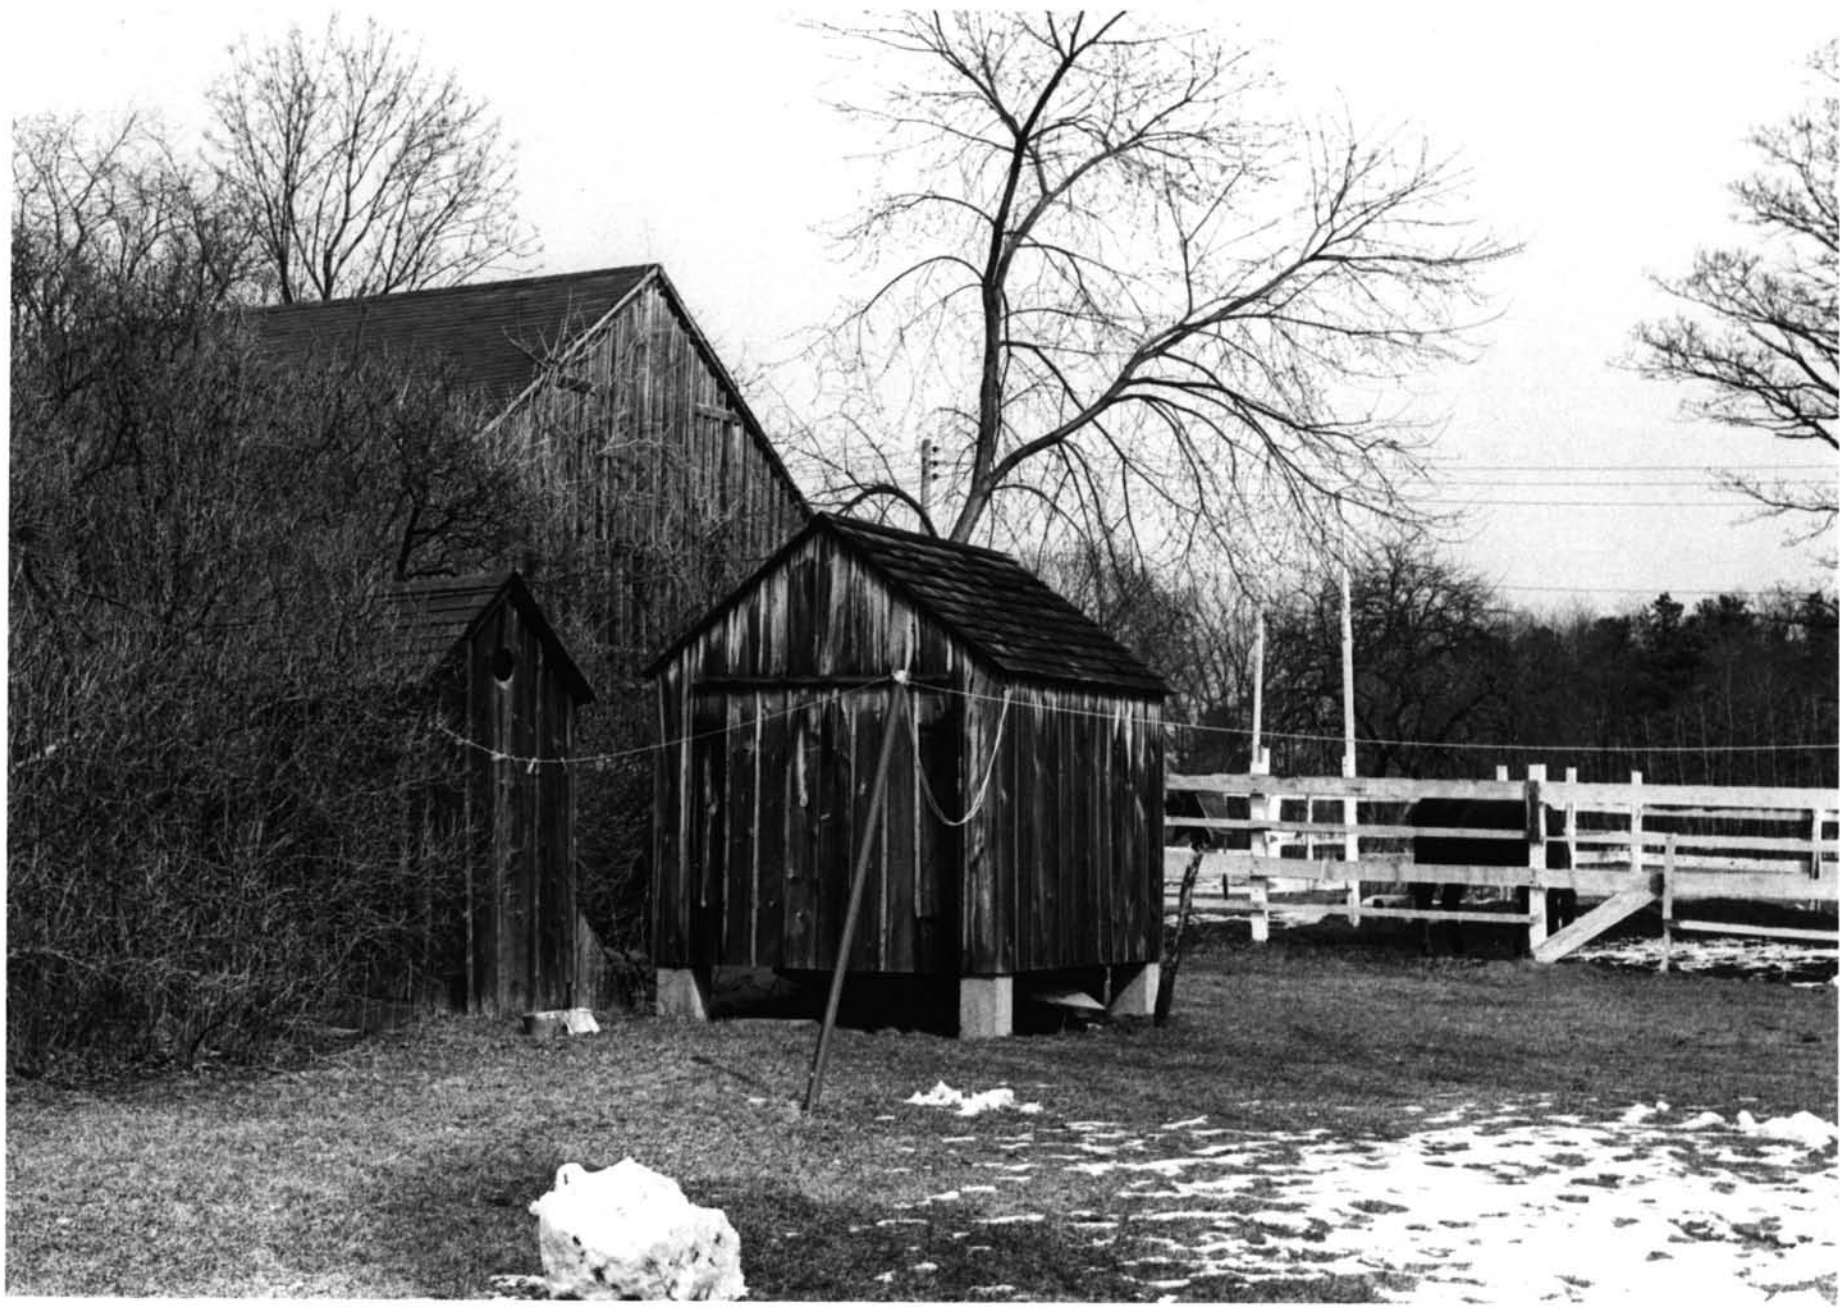
Photo #4

View east toward lilac-surrounded outhouse,
corncrib, and barn.

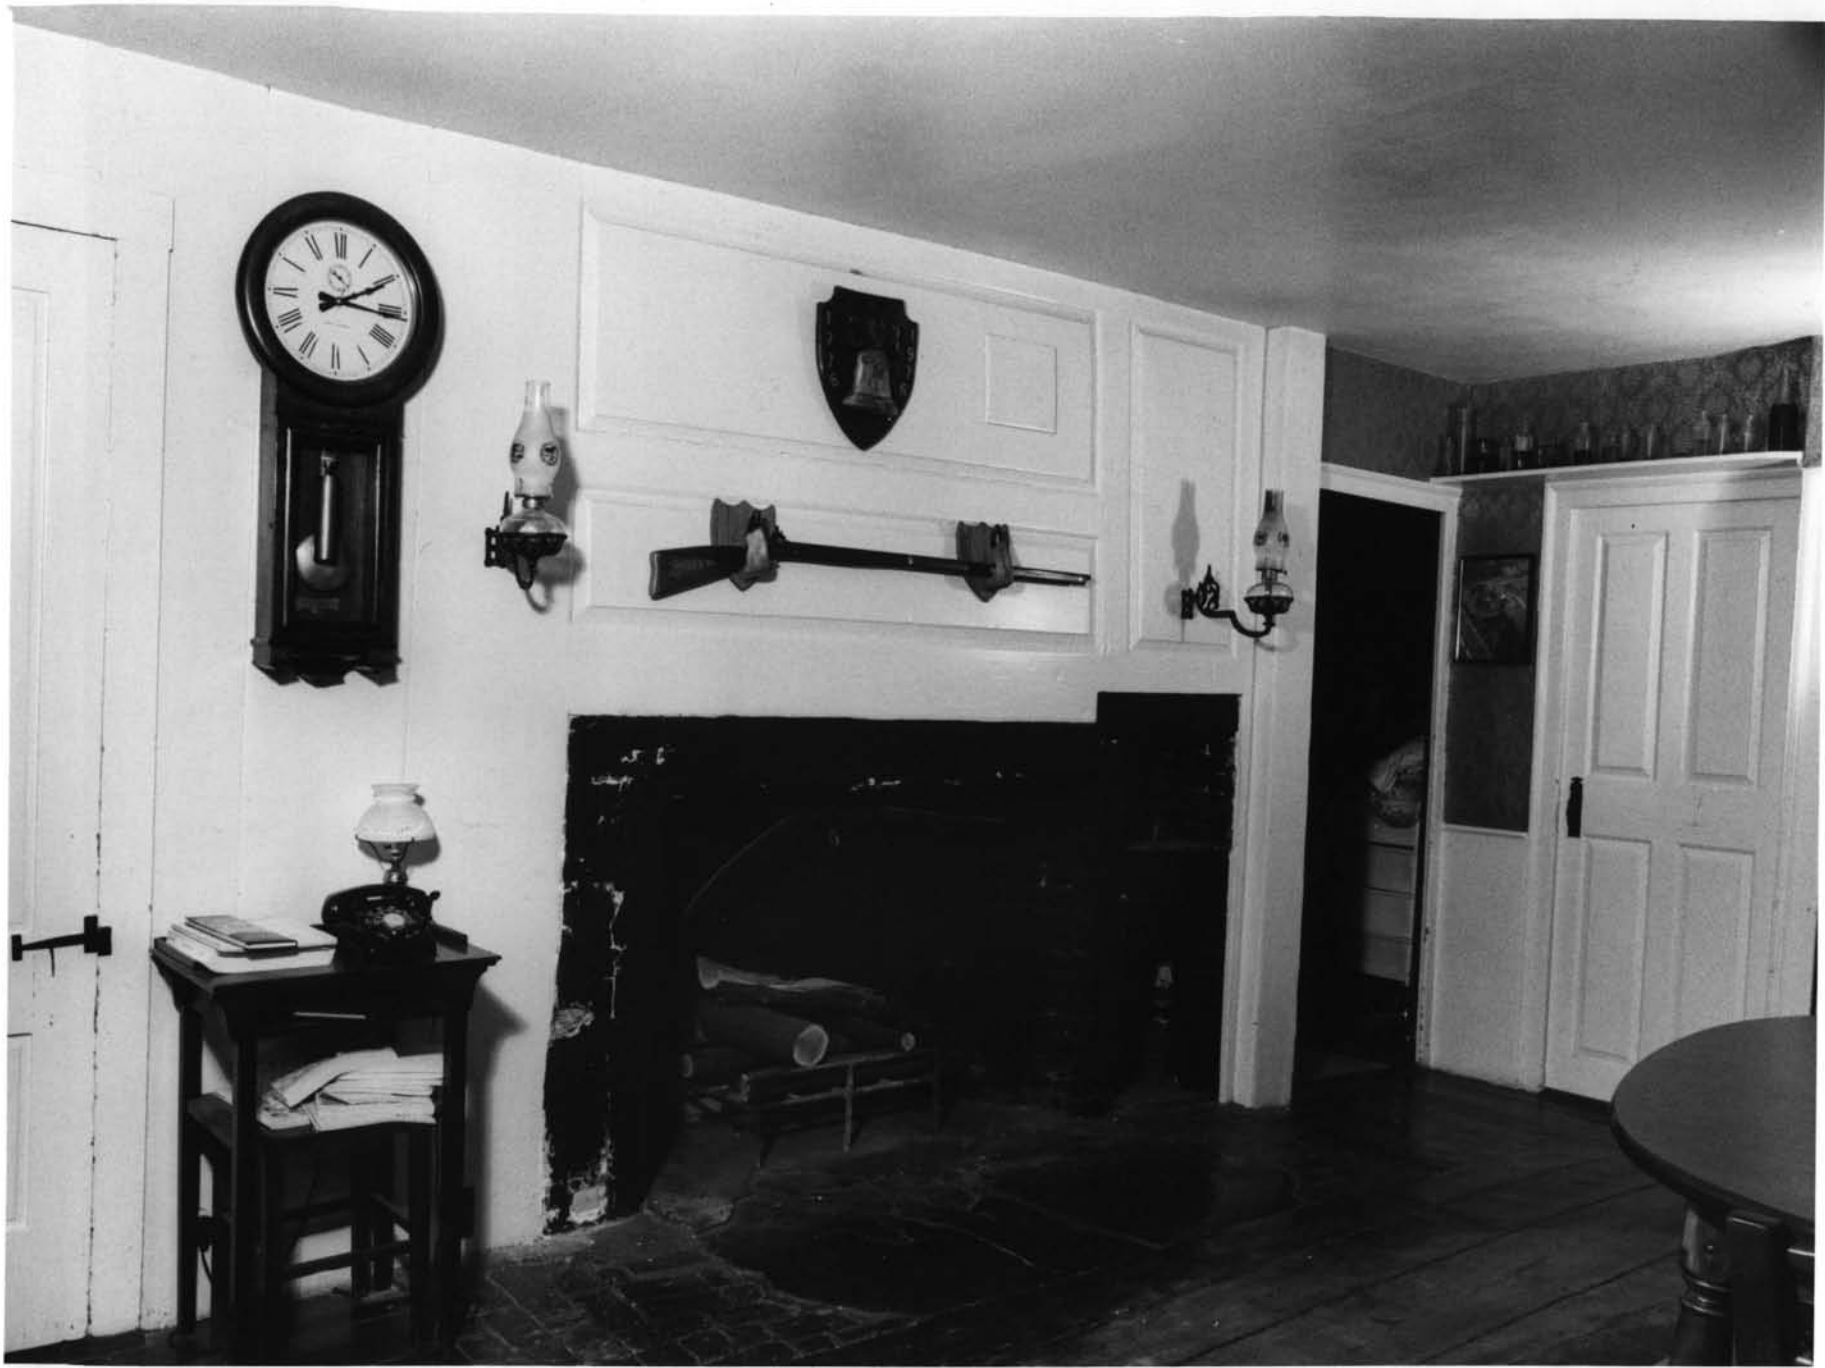
Photo #5

View of fireplace wall in dining room.
