The Battey-Barden House is a large, two-and-a-half story, center-chimney, frame Federal farmhouse with a small one-and-a-half-story mid or late-nineteenth-century kitchen ell at the rear. The house is typical for the period in both construction and plan.

**NATIONAL REGISTER OF HISTORIC PLACES
INVENTORY -- NOMINATION FORM**

BATTEY-BARDEN HOUSE
PLAINFIELD PIKE
SCITUATE, RHODE ISLAND

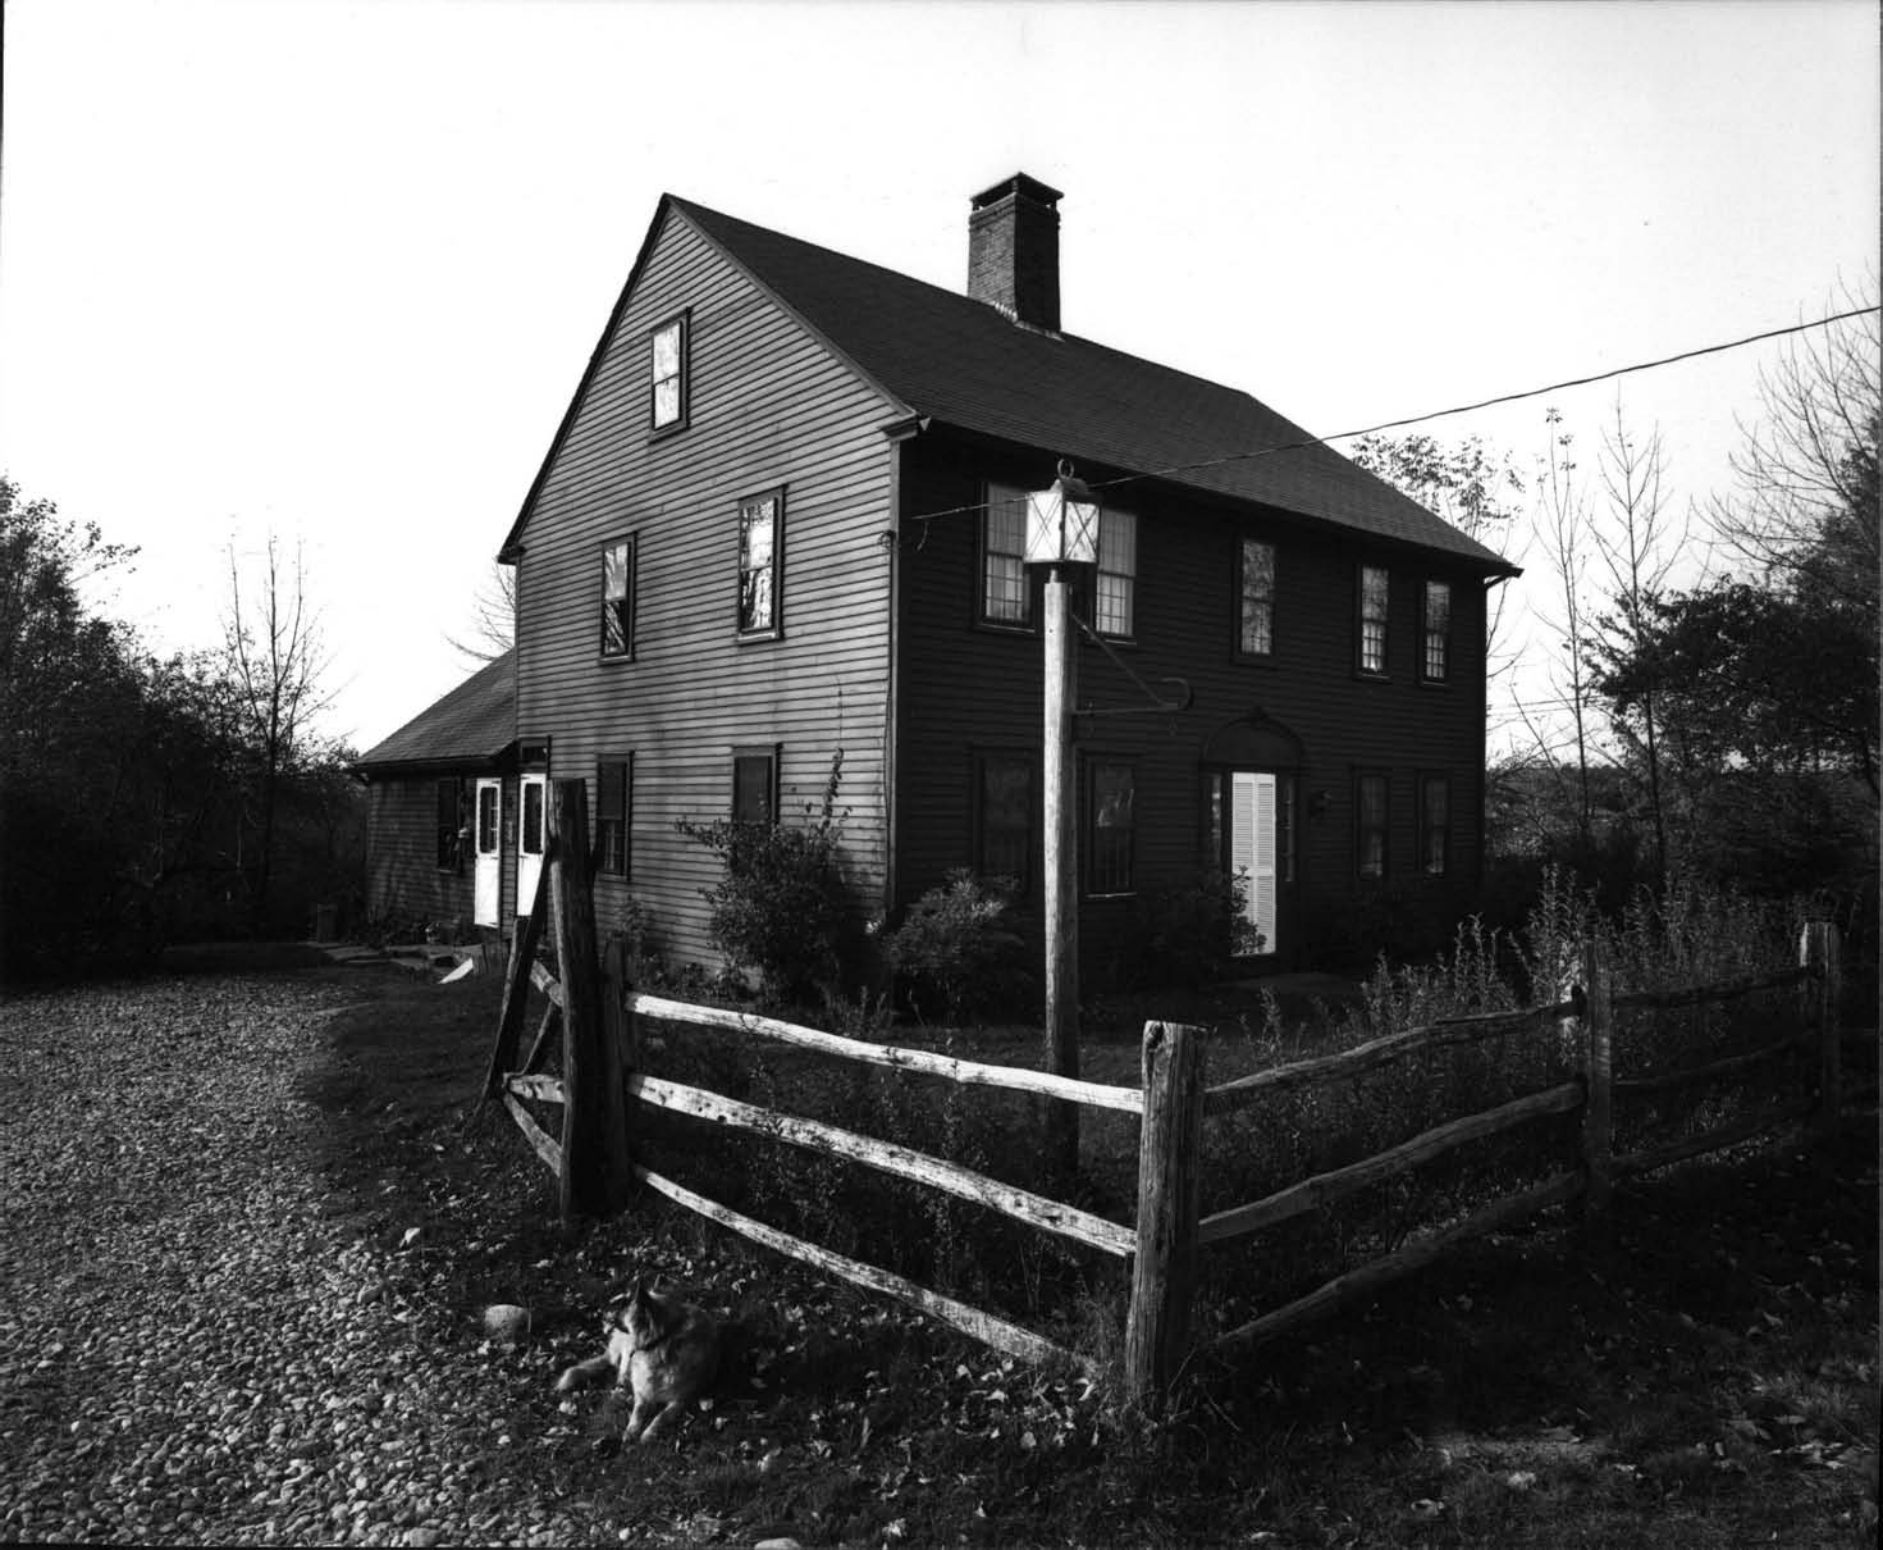
Photo #1

View of house from north northeast.

Five bays wide and two deep (see photo 1) the house is framed with traditional mortise-and-tenon joints and the cornerposts, encased, are exposed on the interior; however, the walls are studded and carry diagonal sheathing to which the clapboards are nailed, an indication* of early nineteenth-century construction. Window frames, filled with reproduction 12/12 sash (even on the front), are of simple pegged heavy plank construction with slightly projecting flat drip caps above. The facade, which faces north (oriented toward Plainfield Pike which passes about twenty feet away), is symmetrical and features a fairly unusual doorway treatment: narrow reeded pilasters framing four-pane sidelights flanking what appears to be the original six-panel door and supporting a semi-elliptical wooden fan above. The fan appears to have been carved from a single piece of wood and is capped with a moulding and a heavy, slightly awkward modillion-like central keystone. Both the fan and the reeding are typical federal motifs, but the solid wooden fan is a treatment not too frequently seen on Rhode Island houses.¹

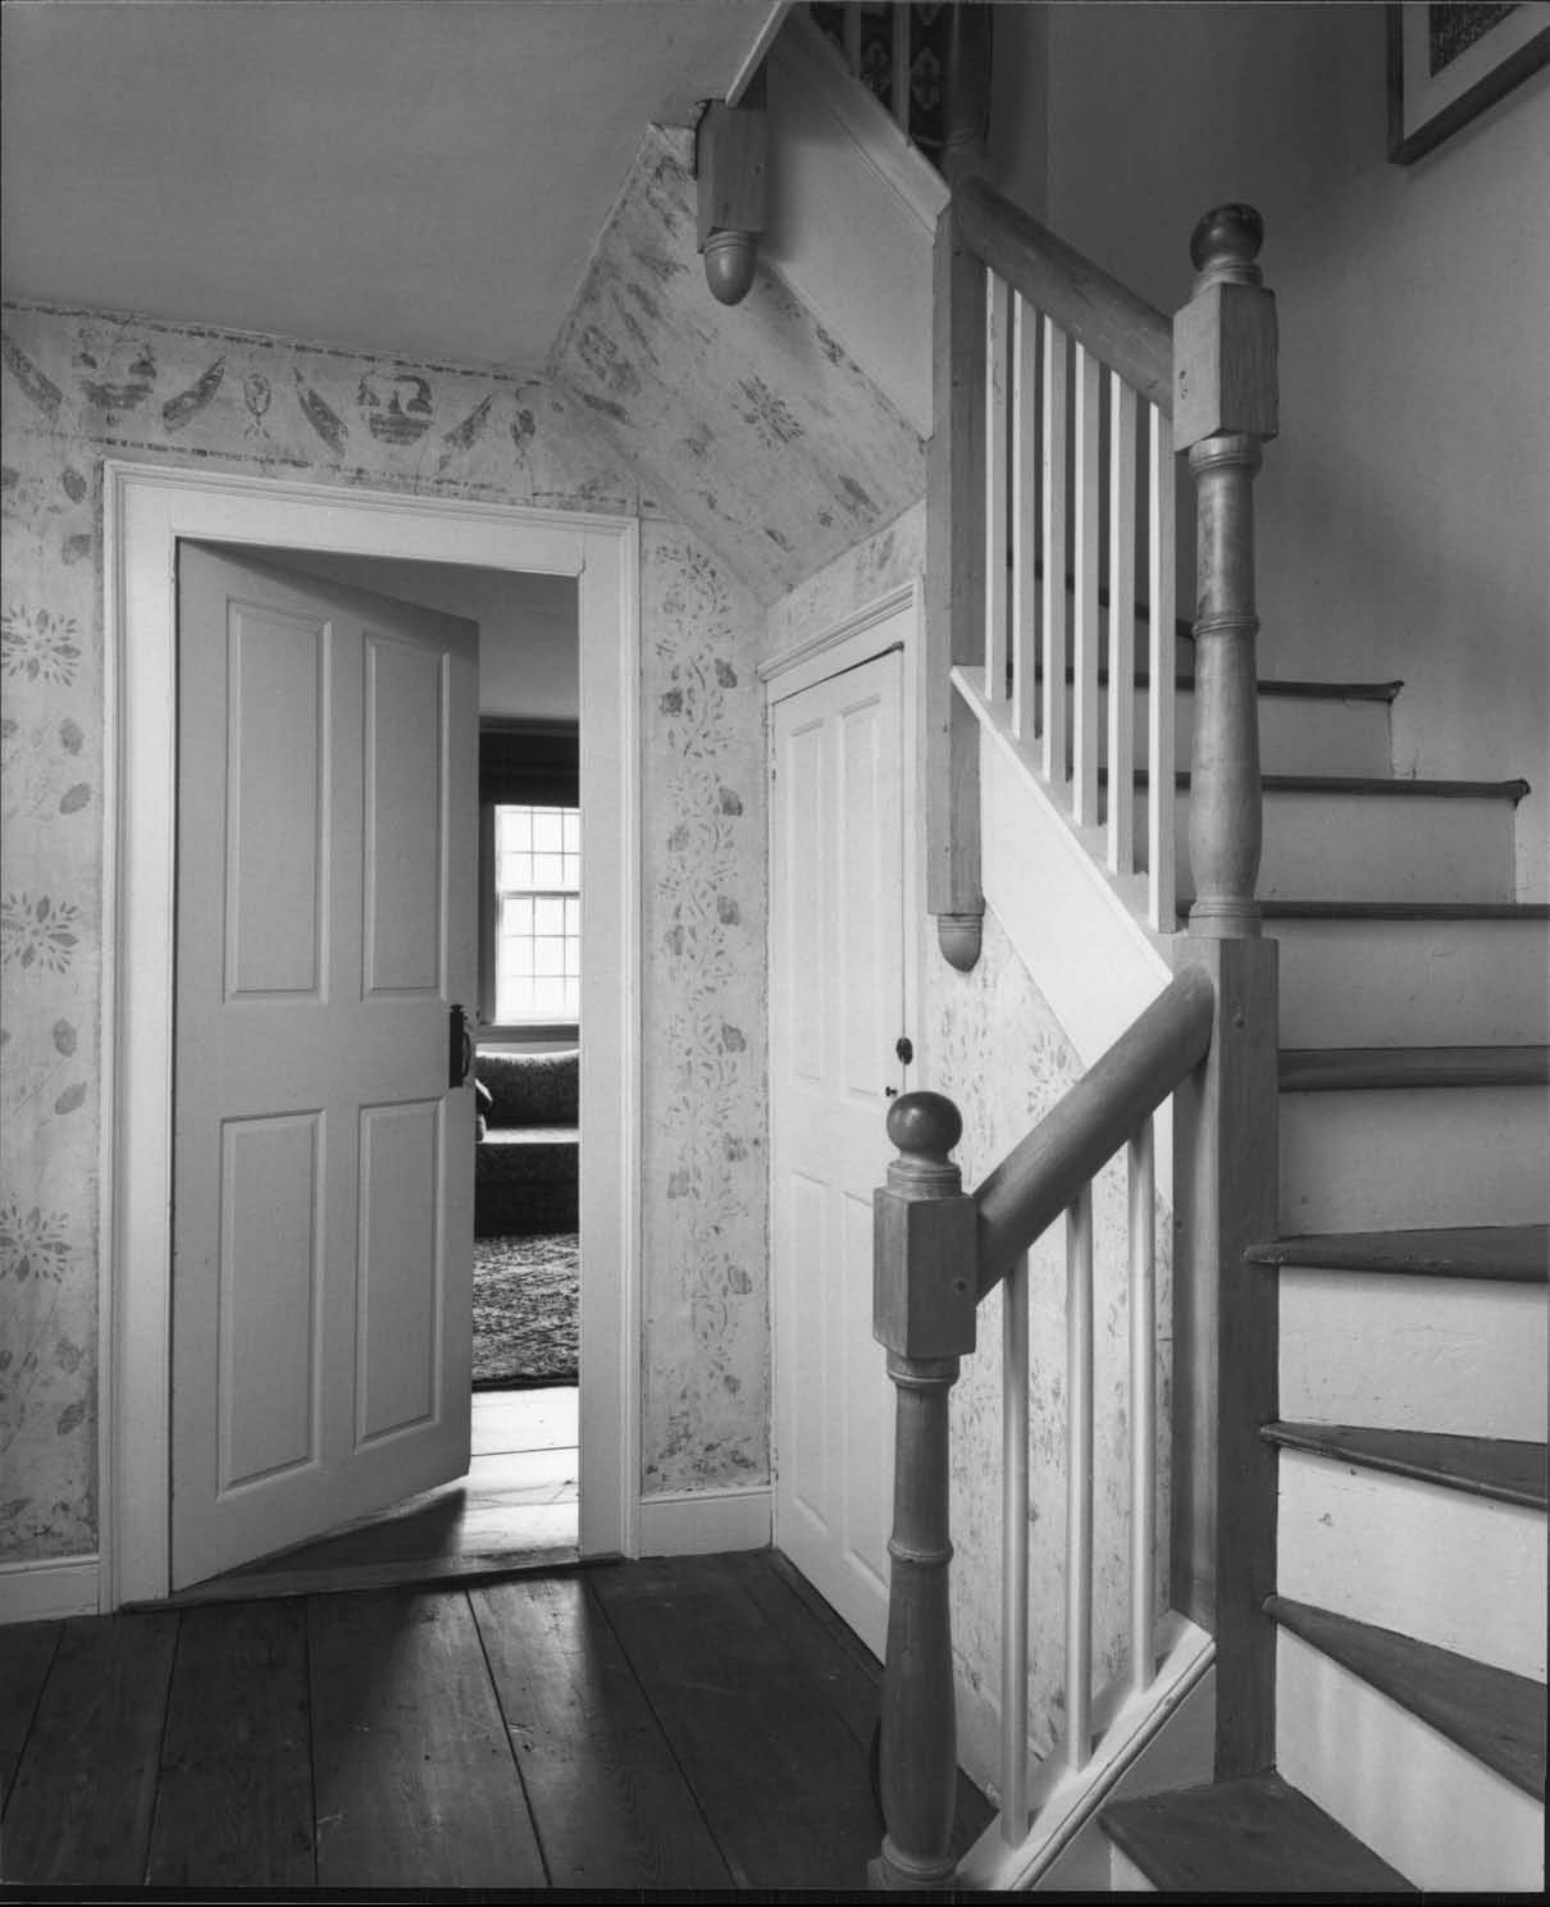
Photo #2

Front stair hall looking east, showing staircase and
remaining original stencil patterns.

The prime interest of the Battey-Barden House--other than its good condition and its typicality--is its wall stencilling. Stencilled patterns were a typical decorative treatment for the period, particularly in Rhode Island's rural communities; examples have been documented in Scituate, Foster, Smithfield, Johnston, and Cranston; but each year fewer and fewer examples survive as walls carrying them become dirty, water-damaged, or cracked, and owners tastes change. In the Battey-Barden House most of the original stencils survive in the stair hall (first floor), executed in red and green on a yellow ground (see photo 2). In the two front parlors, the present owner documented the stencils that existed and repainted them. In the northeast parlor (see photos 3 and 4) the pattern has been reproduced almost in toto: the owner left blank the spaces over the mantel, below the chair-rail, and behind the full-width, full-height bookcase on the south wall. In the northwest parlor only the cornice pattern was reproduced and it was extended to include the southwest section of the room, originally a back corner room and stencilled with a different pattern. Mrs. Hibbitt has used varying shades of red and green on a white ground in both parlors, as well as in the kitchen, the first floor bathroom, and one upstairs bedroom. Patterns in the kitchen (see photo #5) were adapted from those in the Willard House in Still River, Massachusetts.² The bathroom and upstairs bedroom bear stencil patterns devised and adapted by Mrs. Hibbitt from a variety of sources.

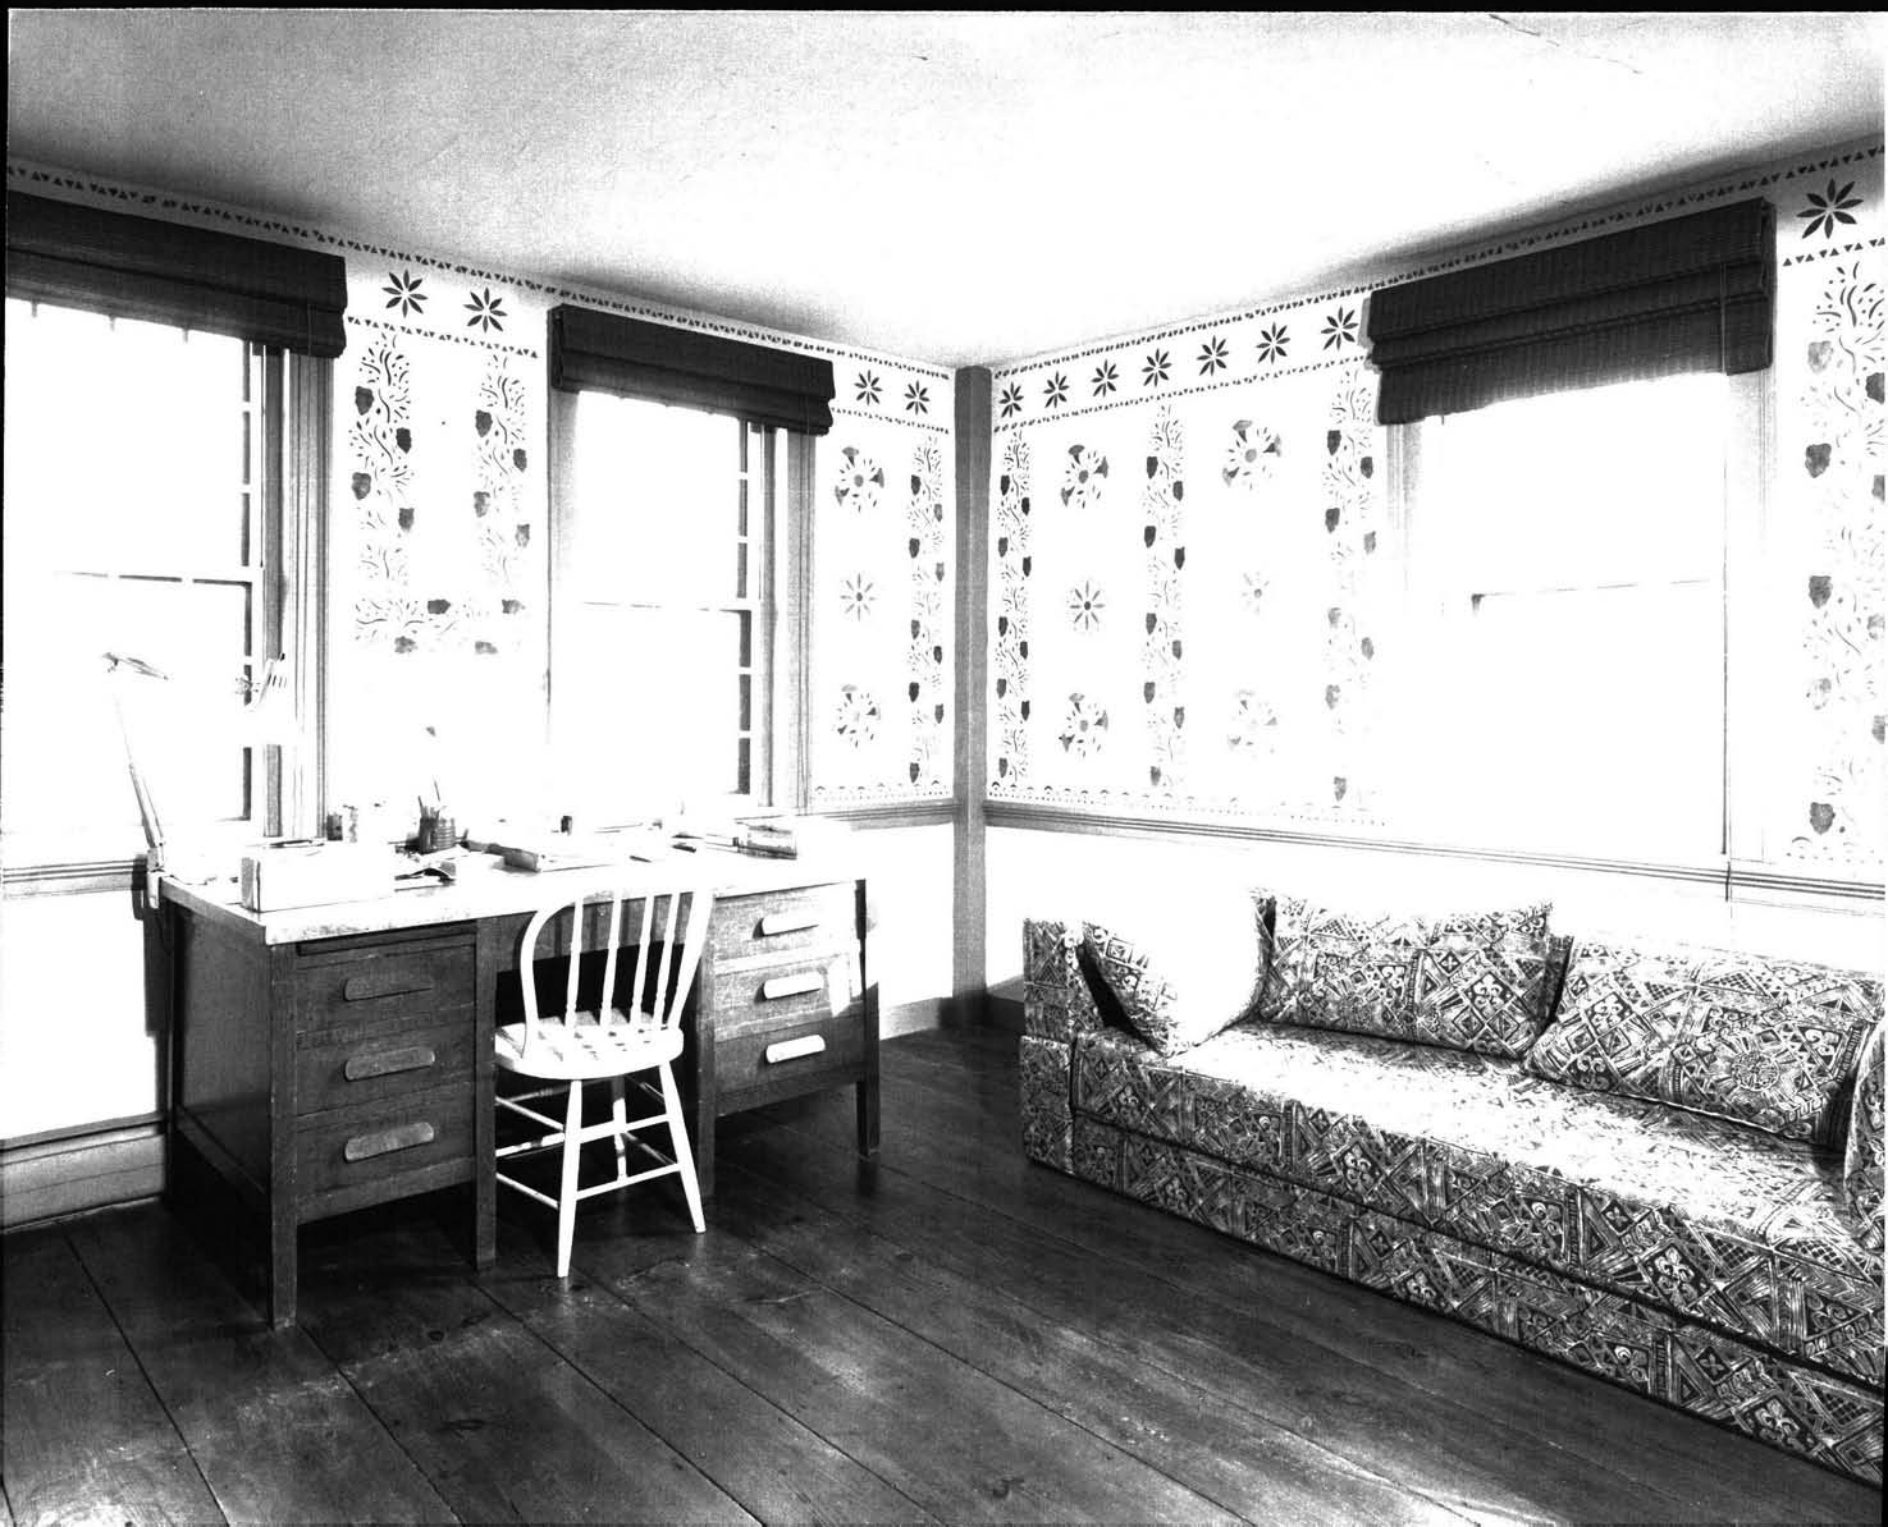
Photo #4

Northeast parlor: view northeast, showing fields of
stencil patterns; original patterns repainted.

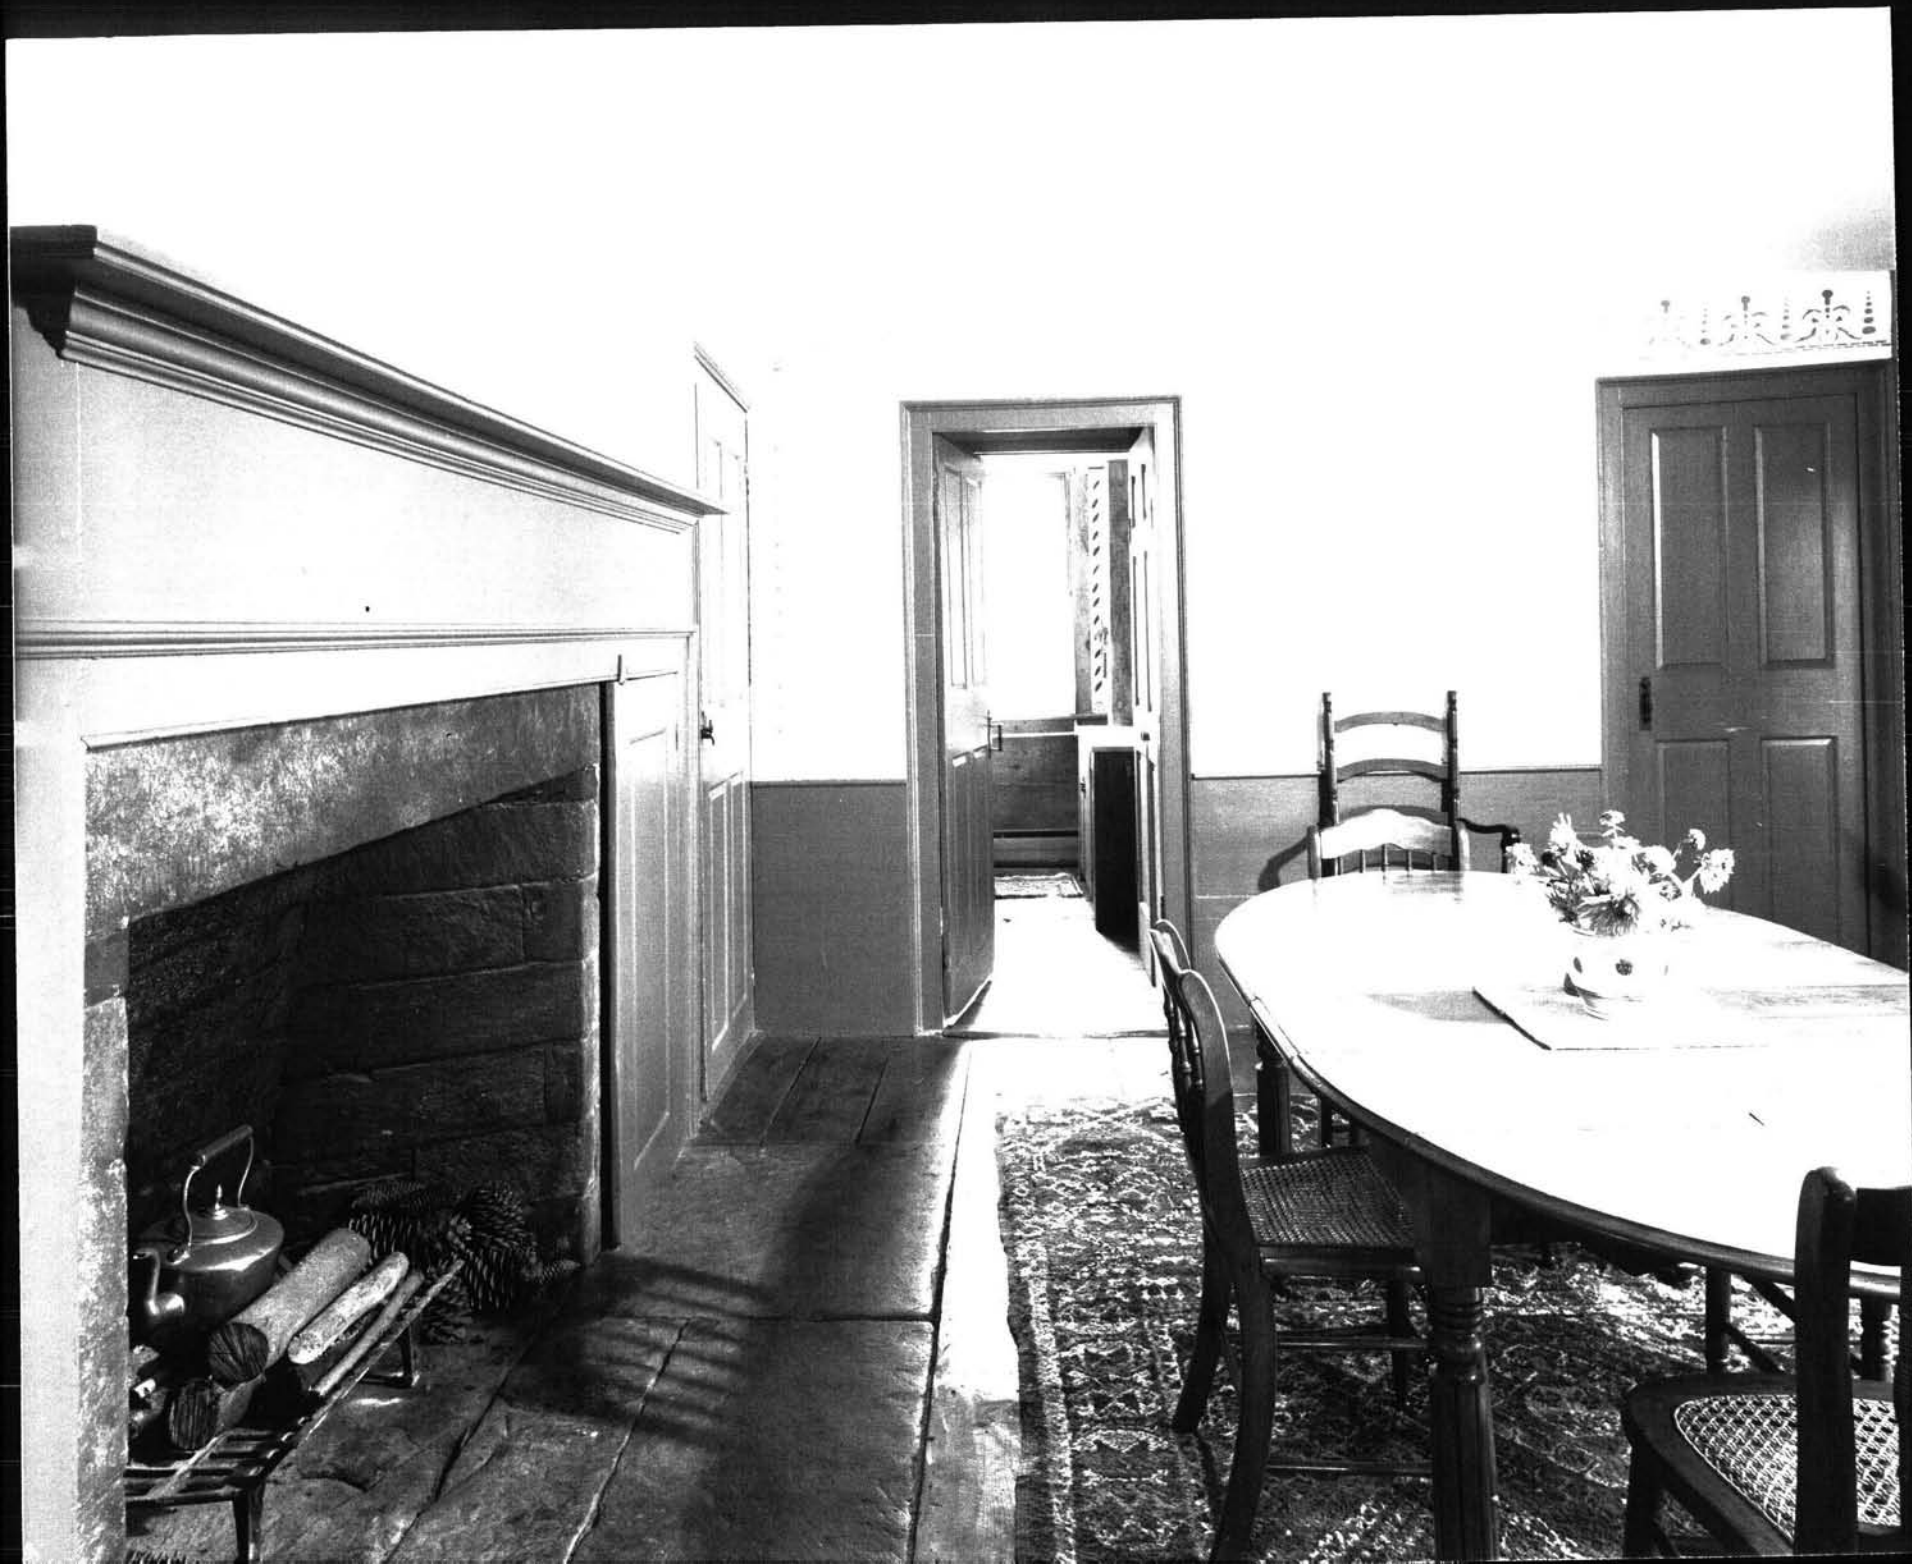
Photo #5

Kitchen: view east, through to present bathroom.
Stencil pattern adapted from Willard House, Still River,
Massachusetts. Note typical fireplace with cut granite
hearth.

The rear ell--built apparently some years after the main portion of the house--has been made into a modern kitchen with all that such conversions imply. The present owners plan to make it more in keeping
