National Register of Historic Places
Inventory—Nomination Form

historic Lewis Tower House

street & number 2199 Mendon Road

city, town Cumberland

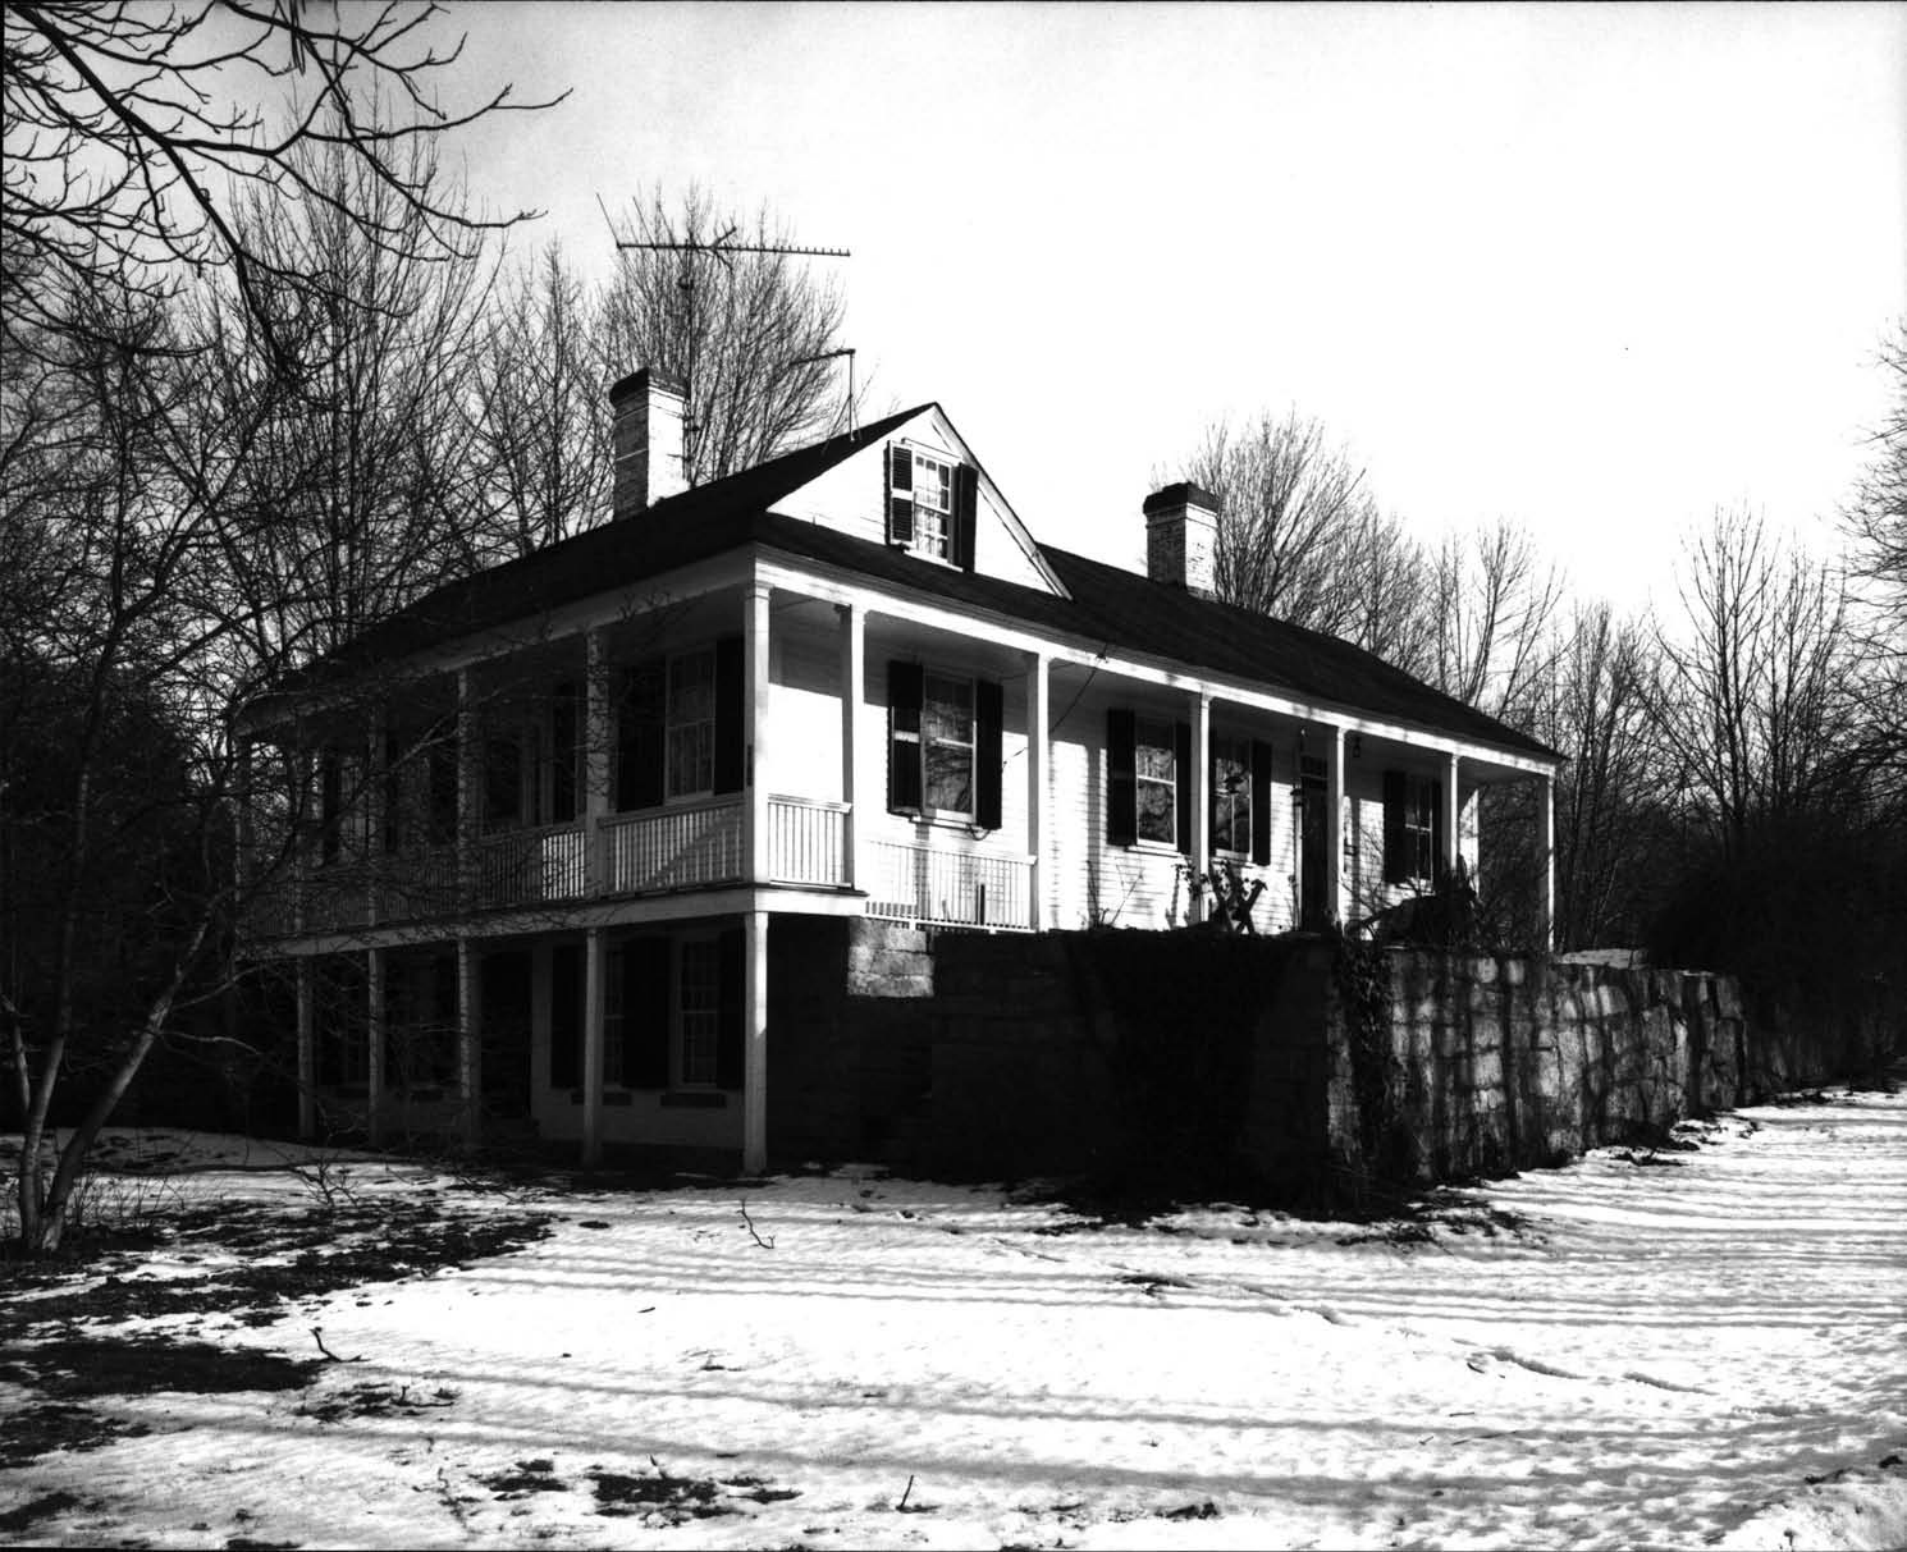
Photo #1.

Exterior view facing northeast

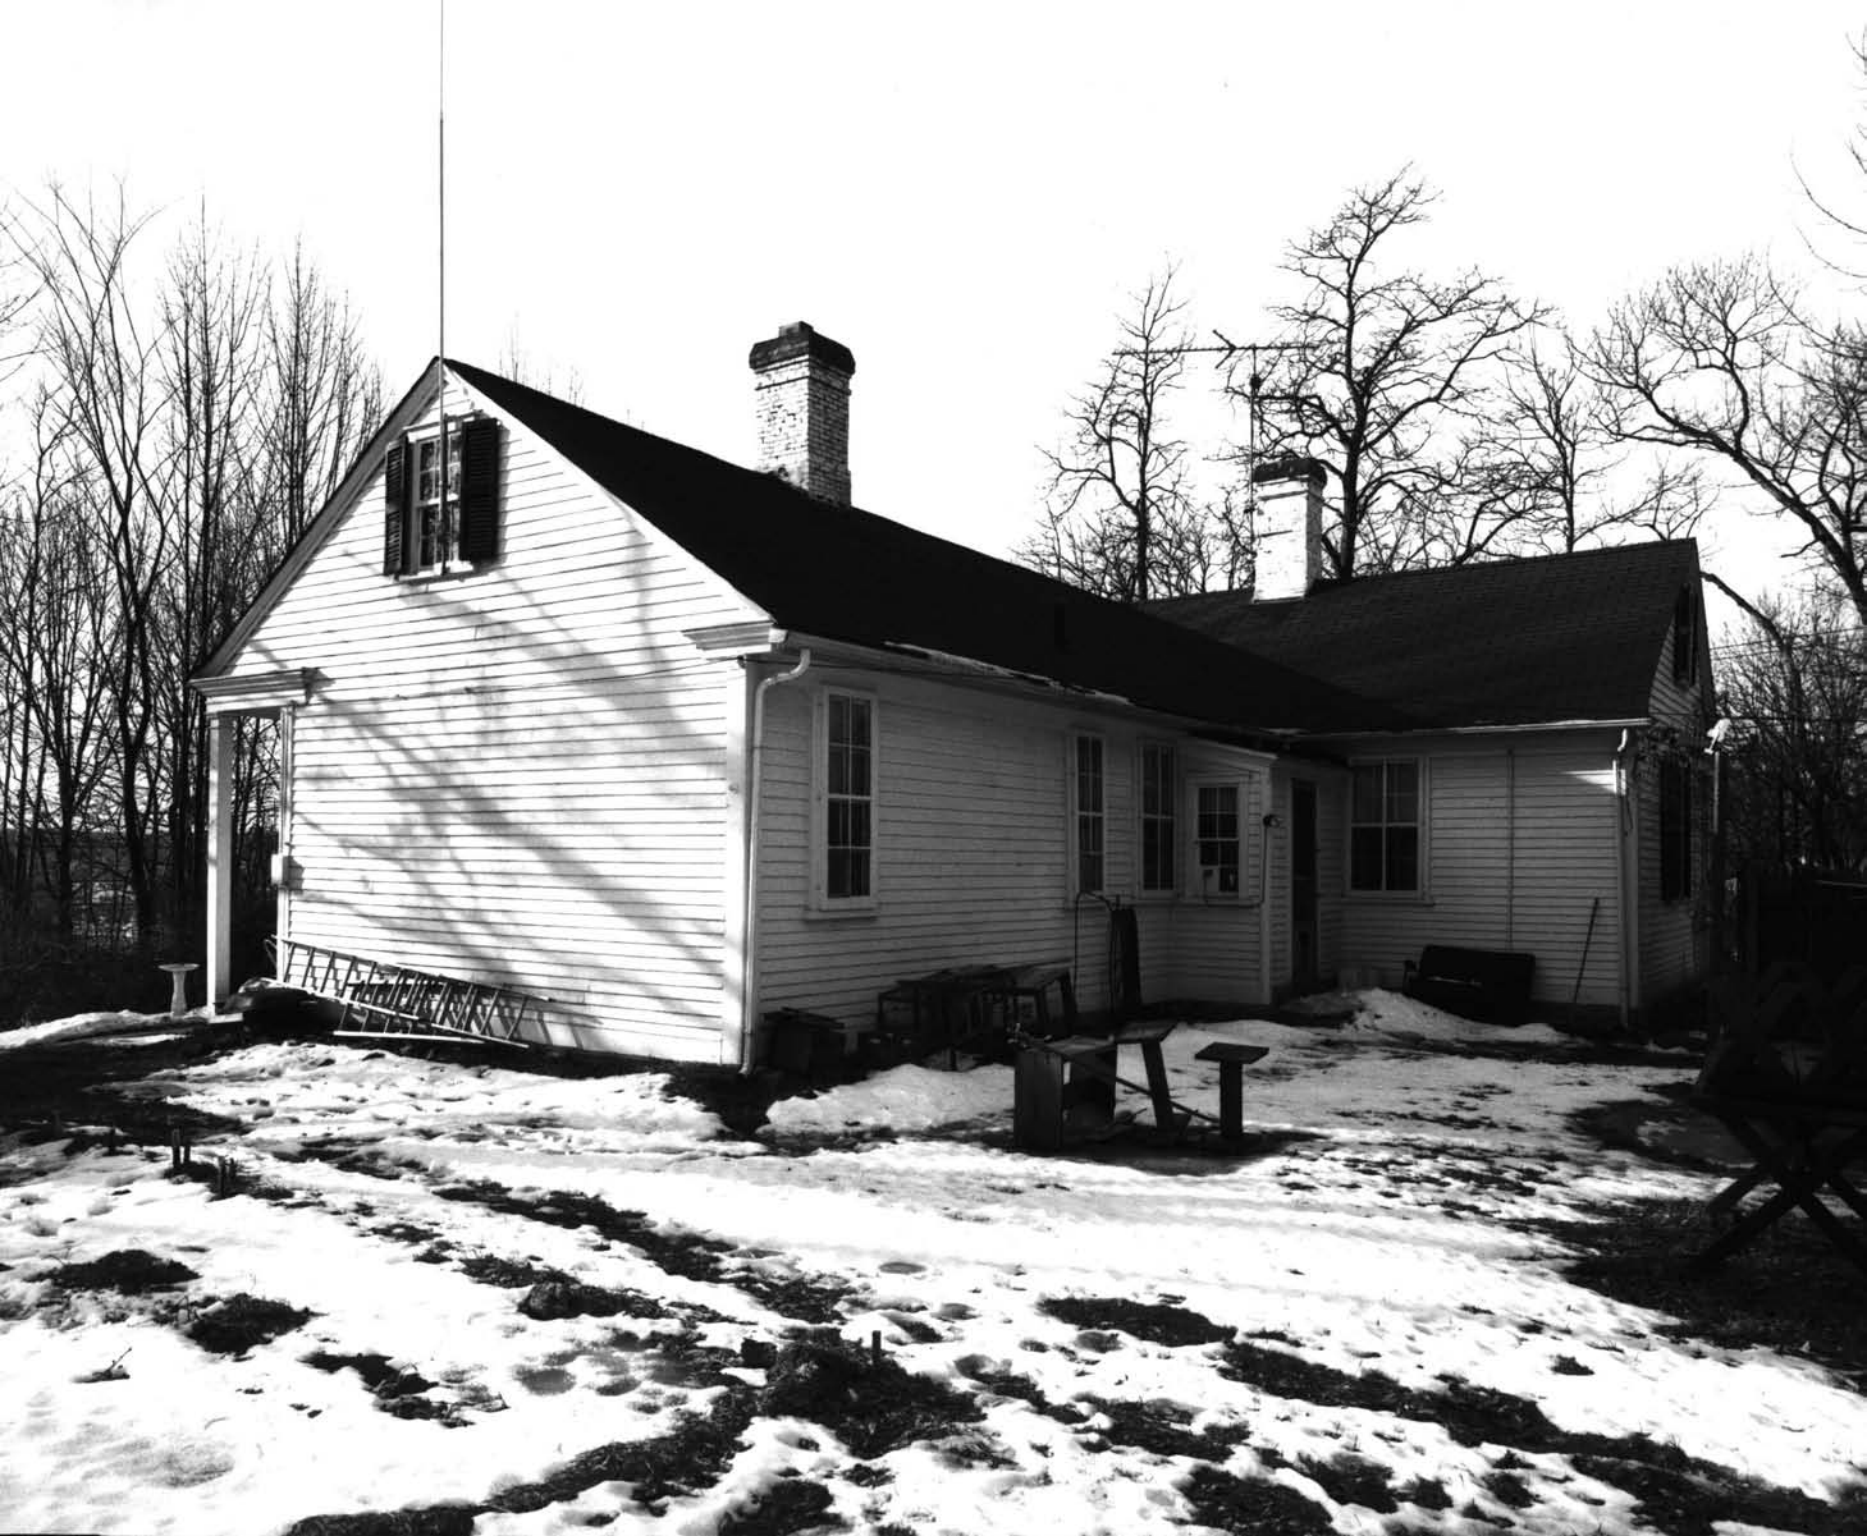
Photo #2.

Exterior view facing southwest.

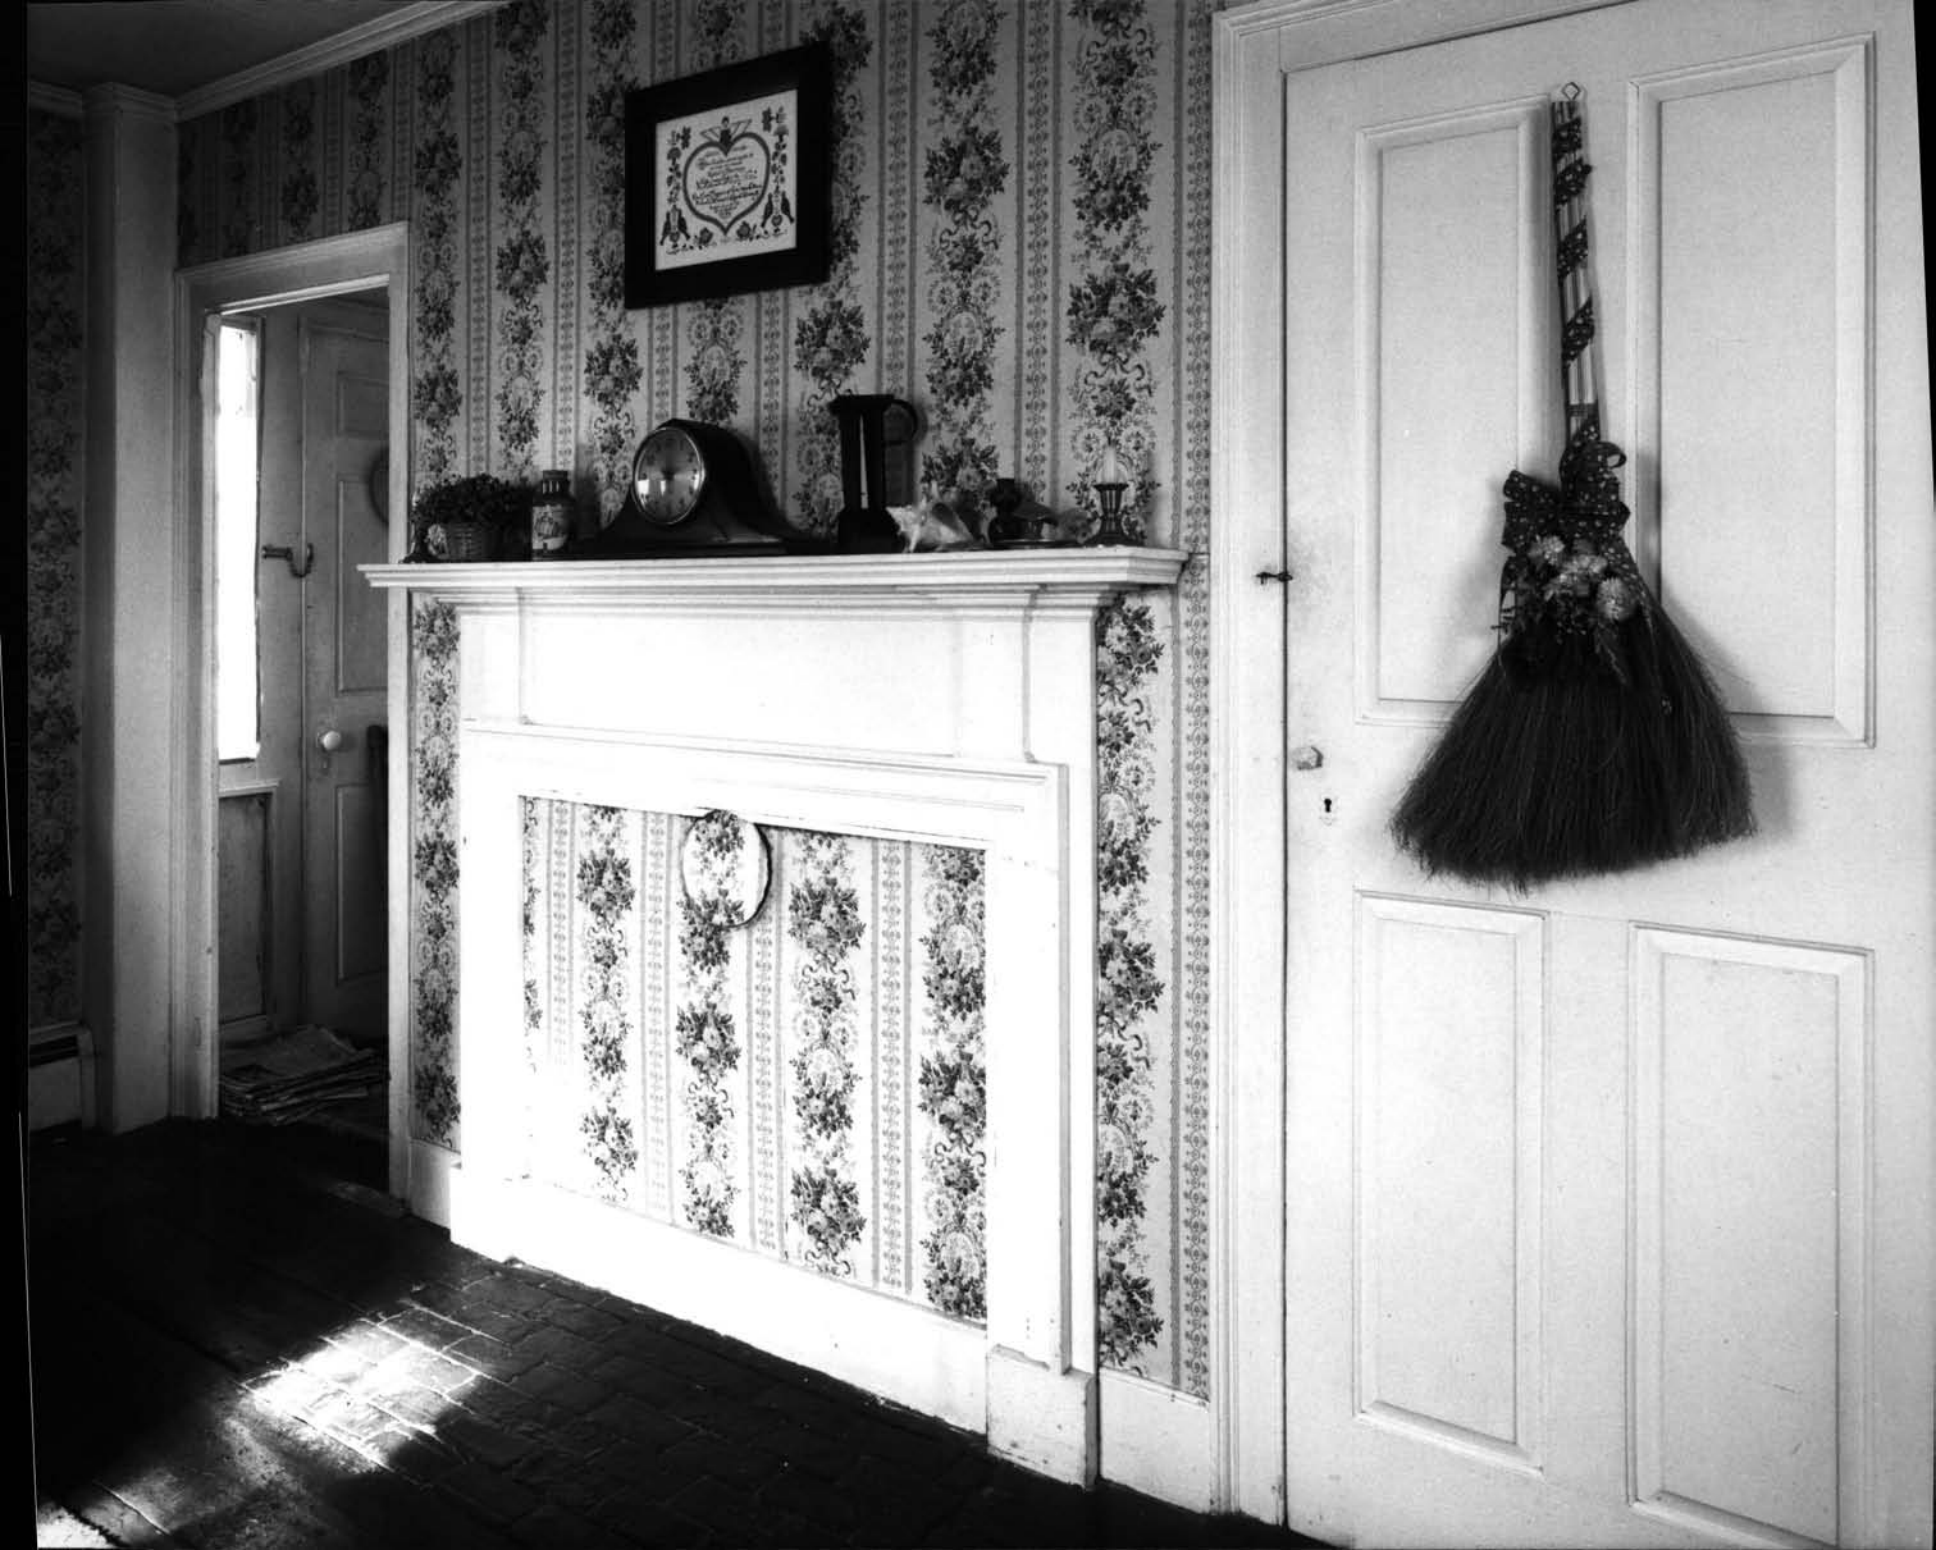
Photo #3.

View of fireplace wall in present living room.

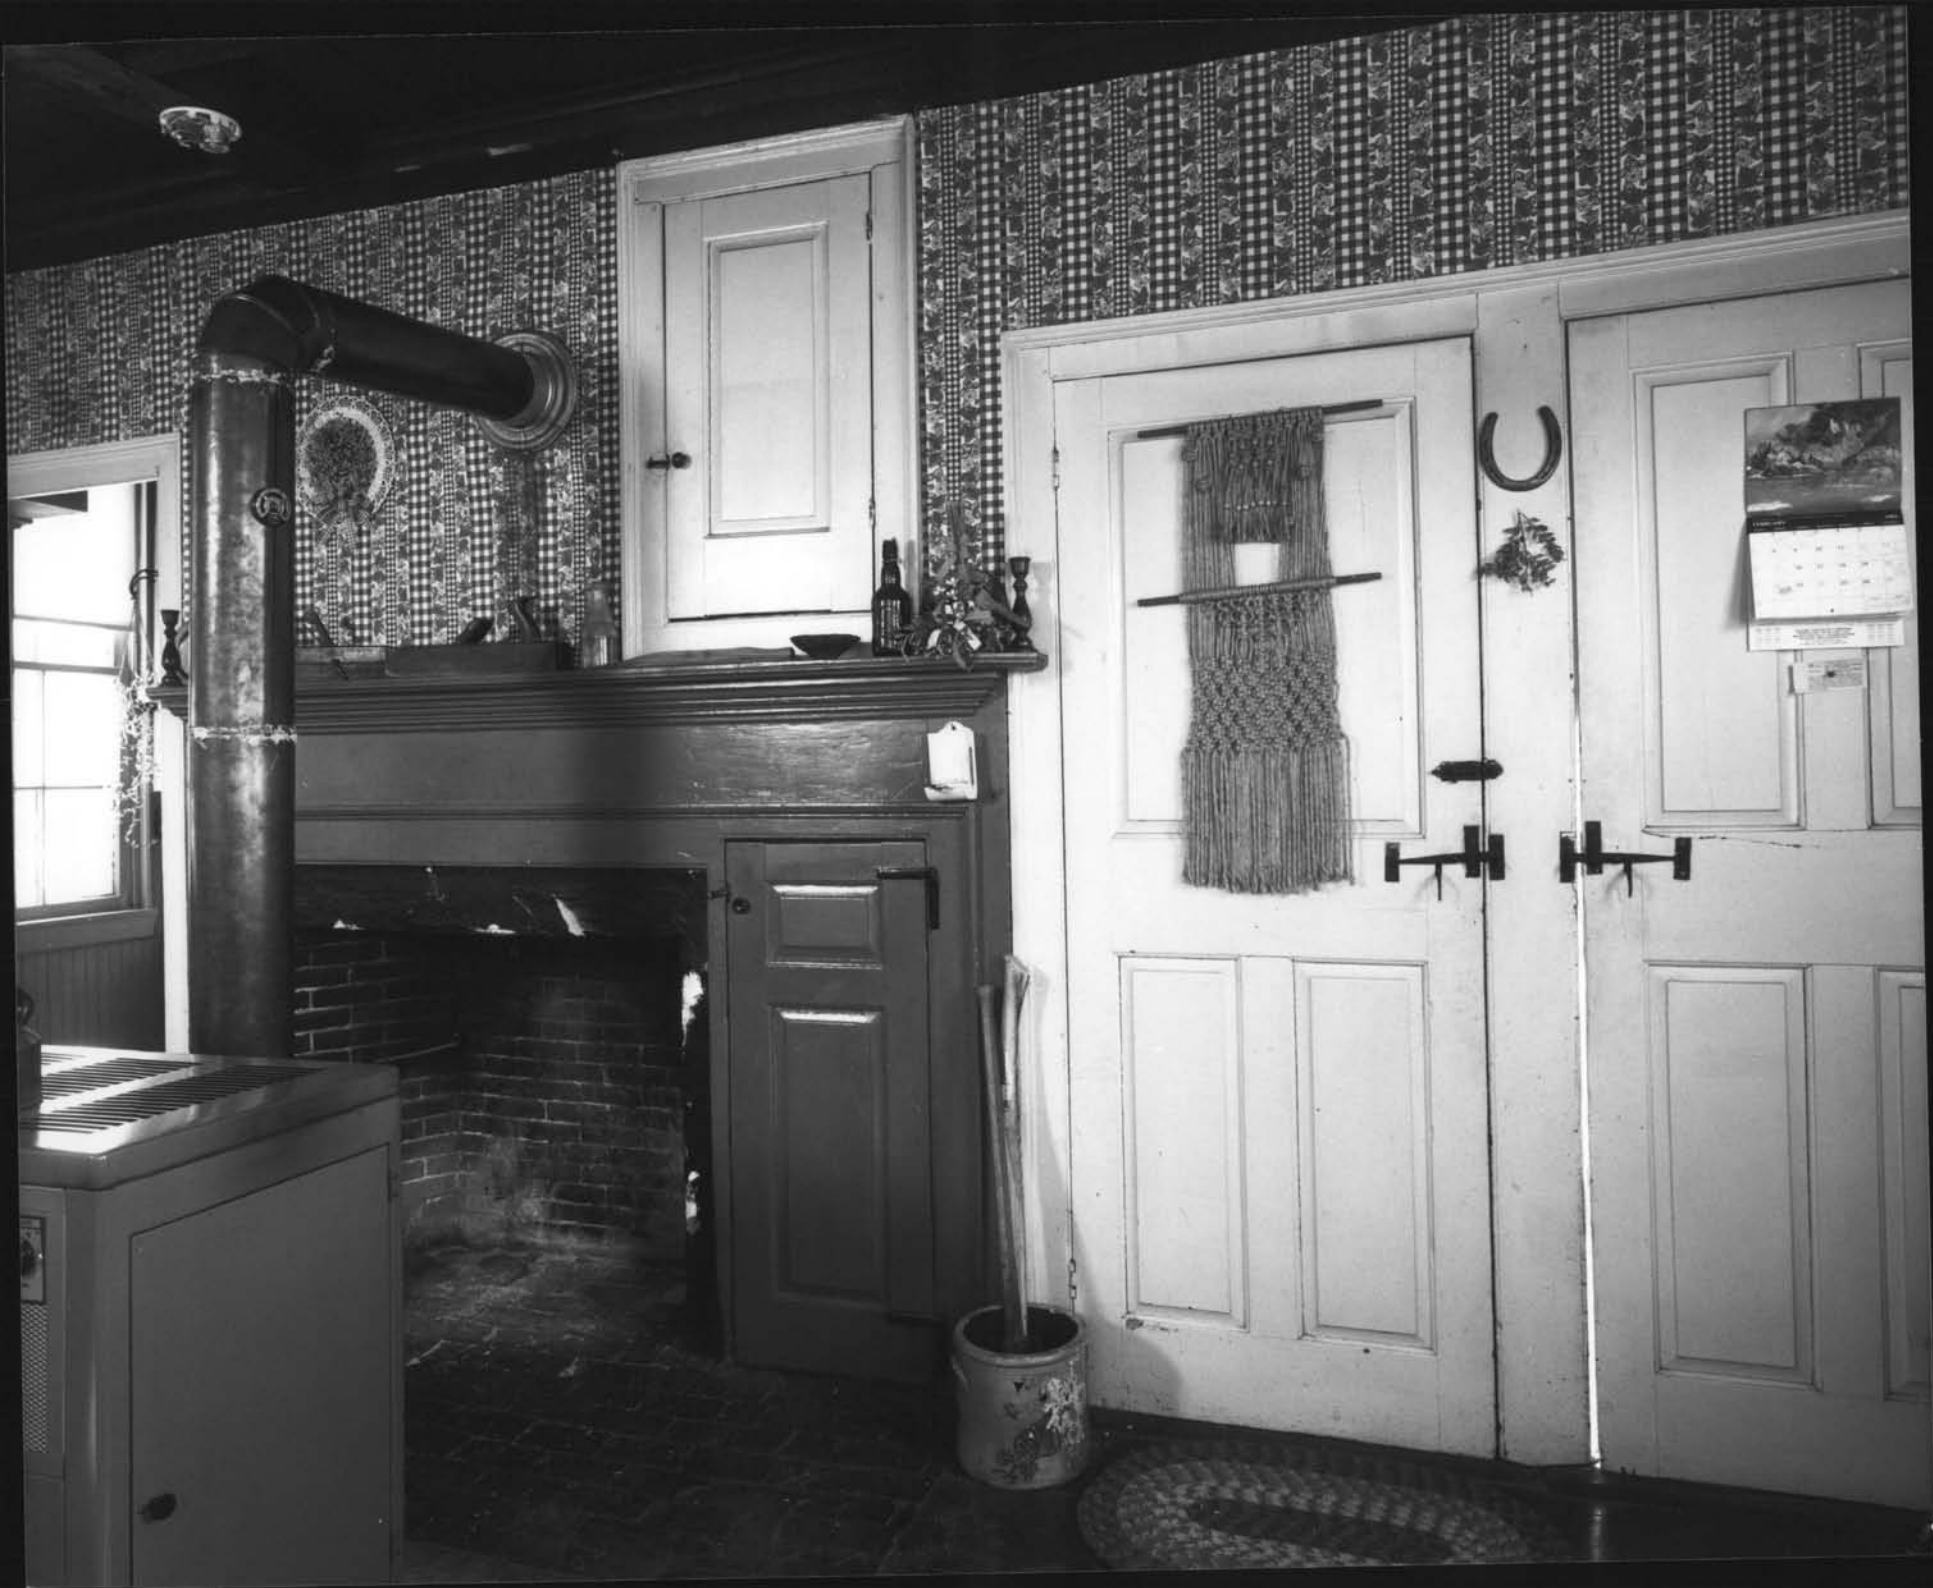
Photo #4.

View of fireplace in the kitchen.

In the ell the southern entrance, topped by a transom light, opens into a vestibule and stair hall containing an enclosed, steep staircase with winders leading up to the attic. The attics of the ell and front section are connected and have plastered ceilings and partitions dividing the space into bedrooms arranged en suite, now used only for storage by the present occupants of the house. On the first floor, the room to the left (west) of the vestibule is the kitchen. It has plastered walls and cased corner posts and the plastered ceiling has been removed to expose the joists above. Behind a modern wood stove the original cooking fireplace remains intact, with a bake oven and wood box to one side behind a paneled door and a cupboard over the mantel (photo #4). A small pantry opens off the northwest corner of the kitchen, occupying space in the front section behind the chimney. The room to the right (east) off the ell vestibule is a small bedroom and a bathroom is located in the small space behind the chimney between the kitchen and bedroom. The bedroom has a fireplace with a cupboard above it. Both the kitchen and bedroom fireplaces have simple flat-board mantels.
