**NATIONAL REGISTER OF HISTORIC PLACES  
INVENTORY - NOMINATION FORM**

Taylor-Chase-Smythe House

Quarters NB-1

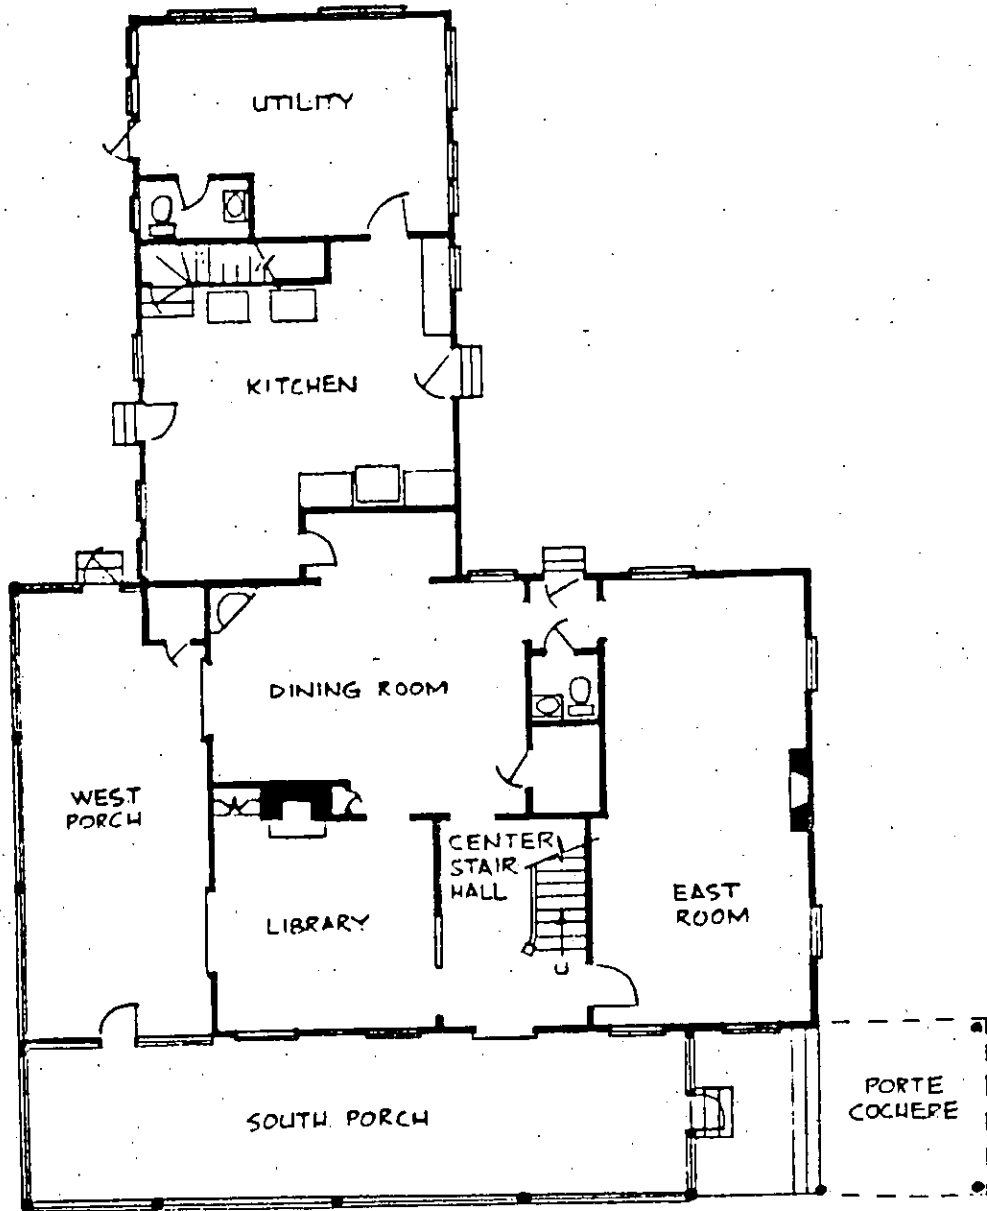
EXISTING CONDITION  
 • FIRST FLOOR PLAN •

TAYLOR-CHASE-SMYTHE HOUSE

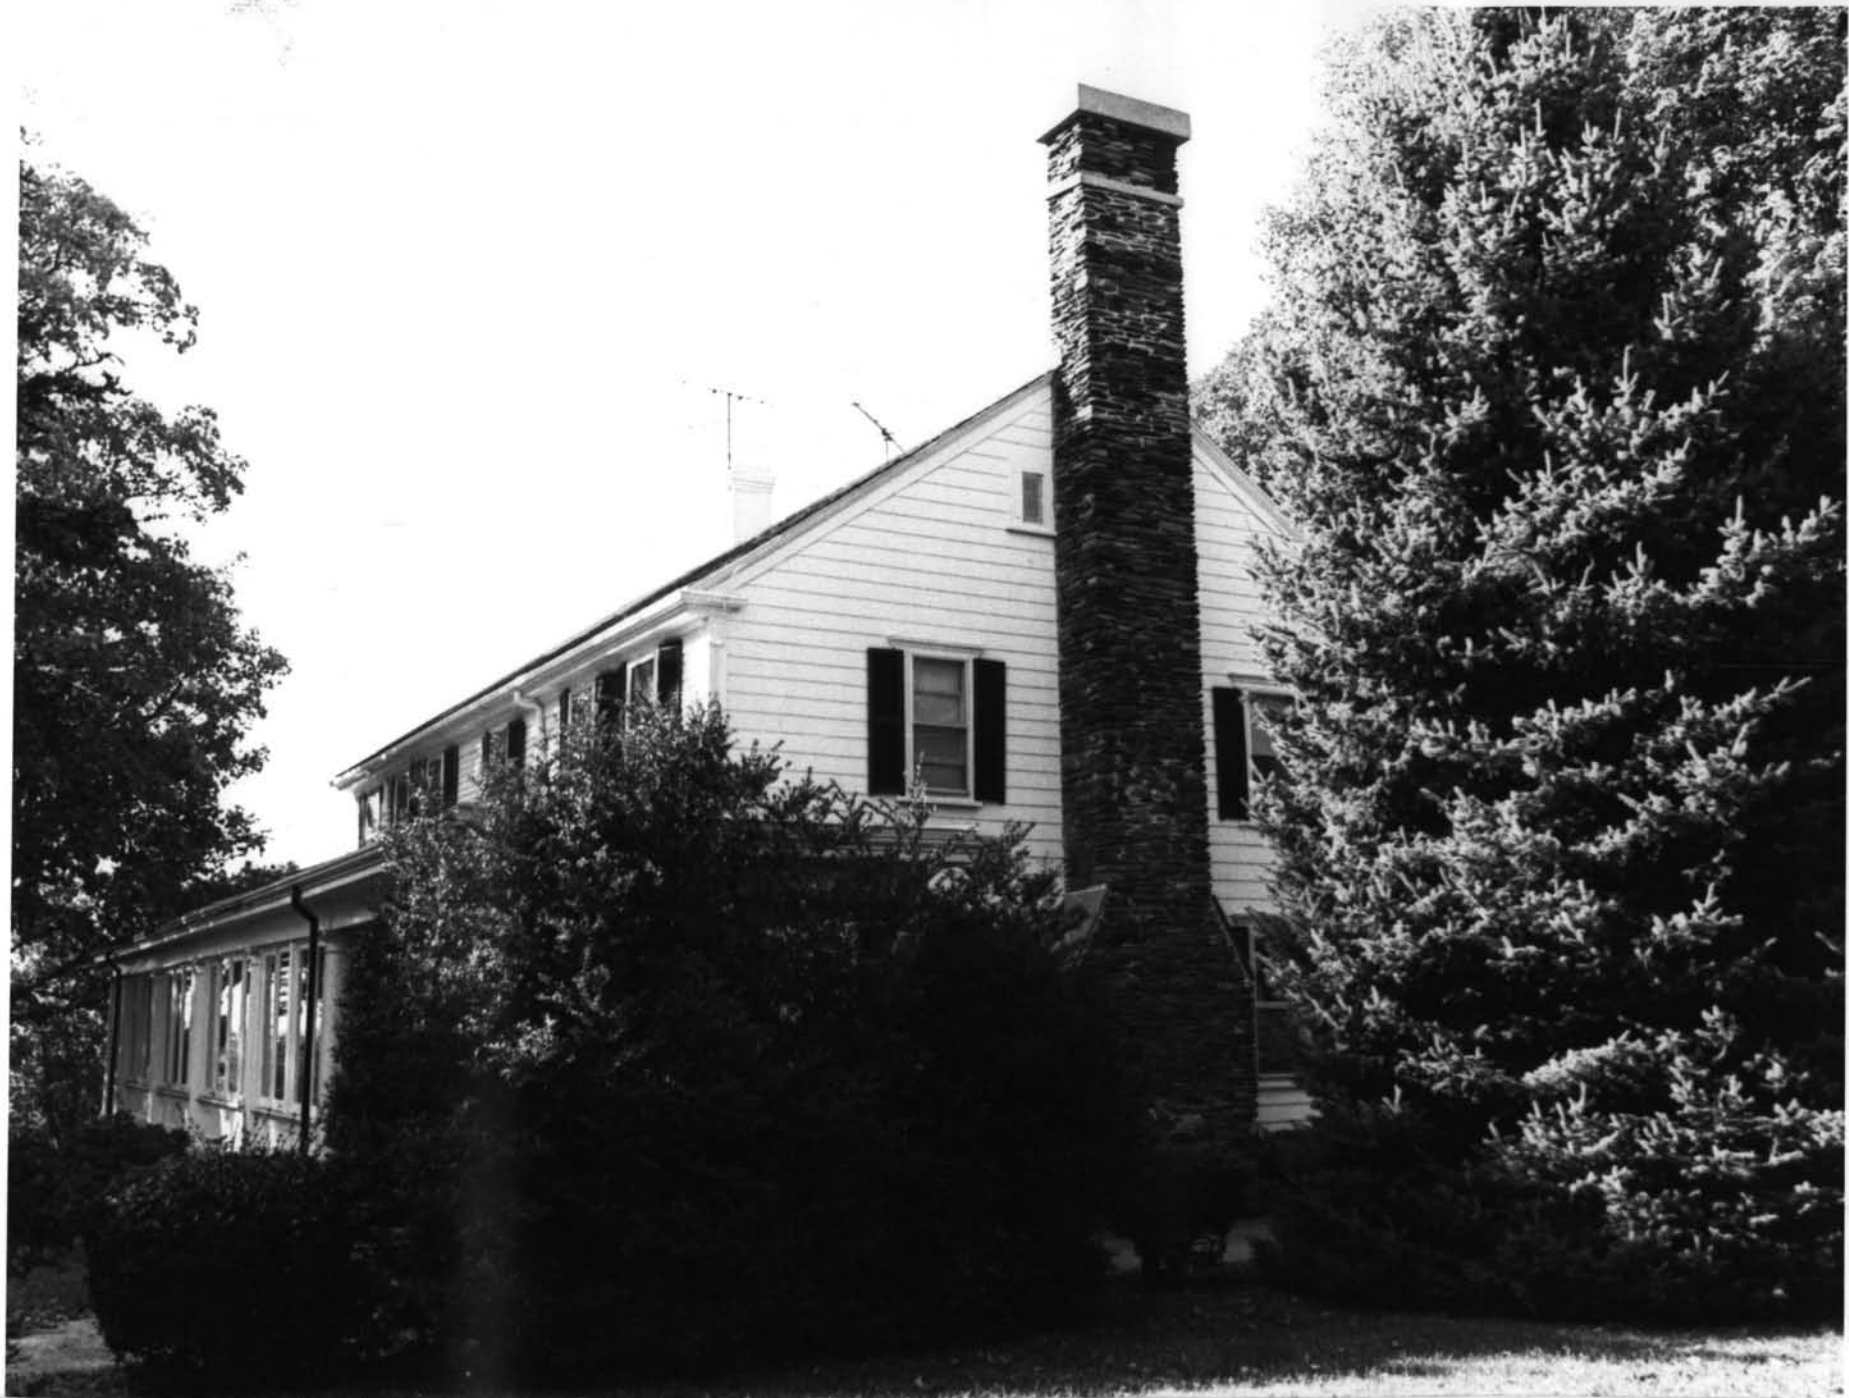
Taylor-Chase-Smythe House: East facade showing end chimney added in 1930s. Porte-cochere is behind shrubbery.

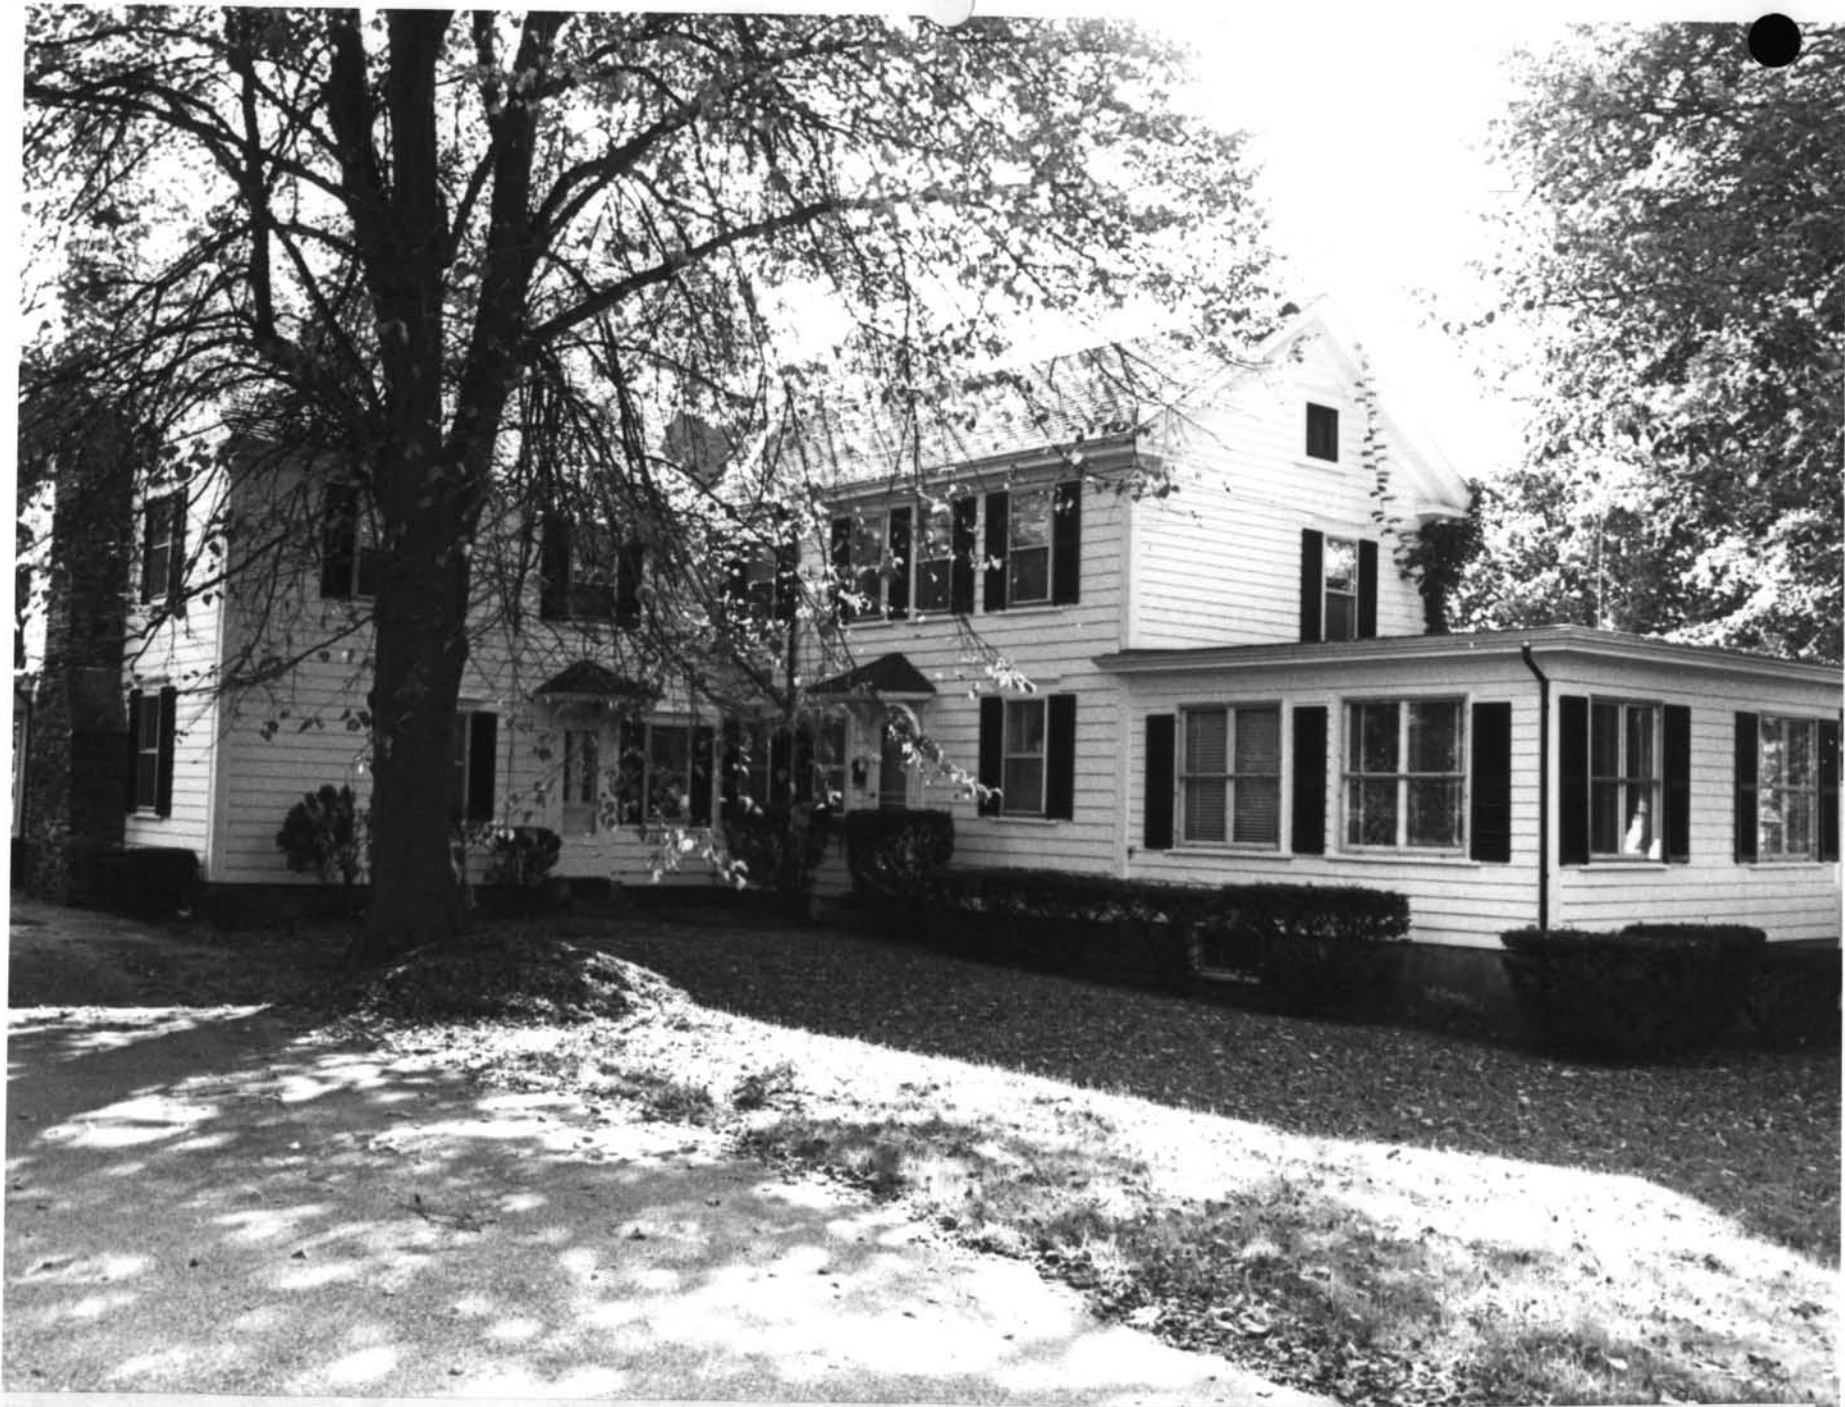
Taylor-Chase-Smythe House: North facade, showing, from left: original 18th century house, 19th century gabled ell, 20th century laundry addition.

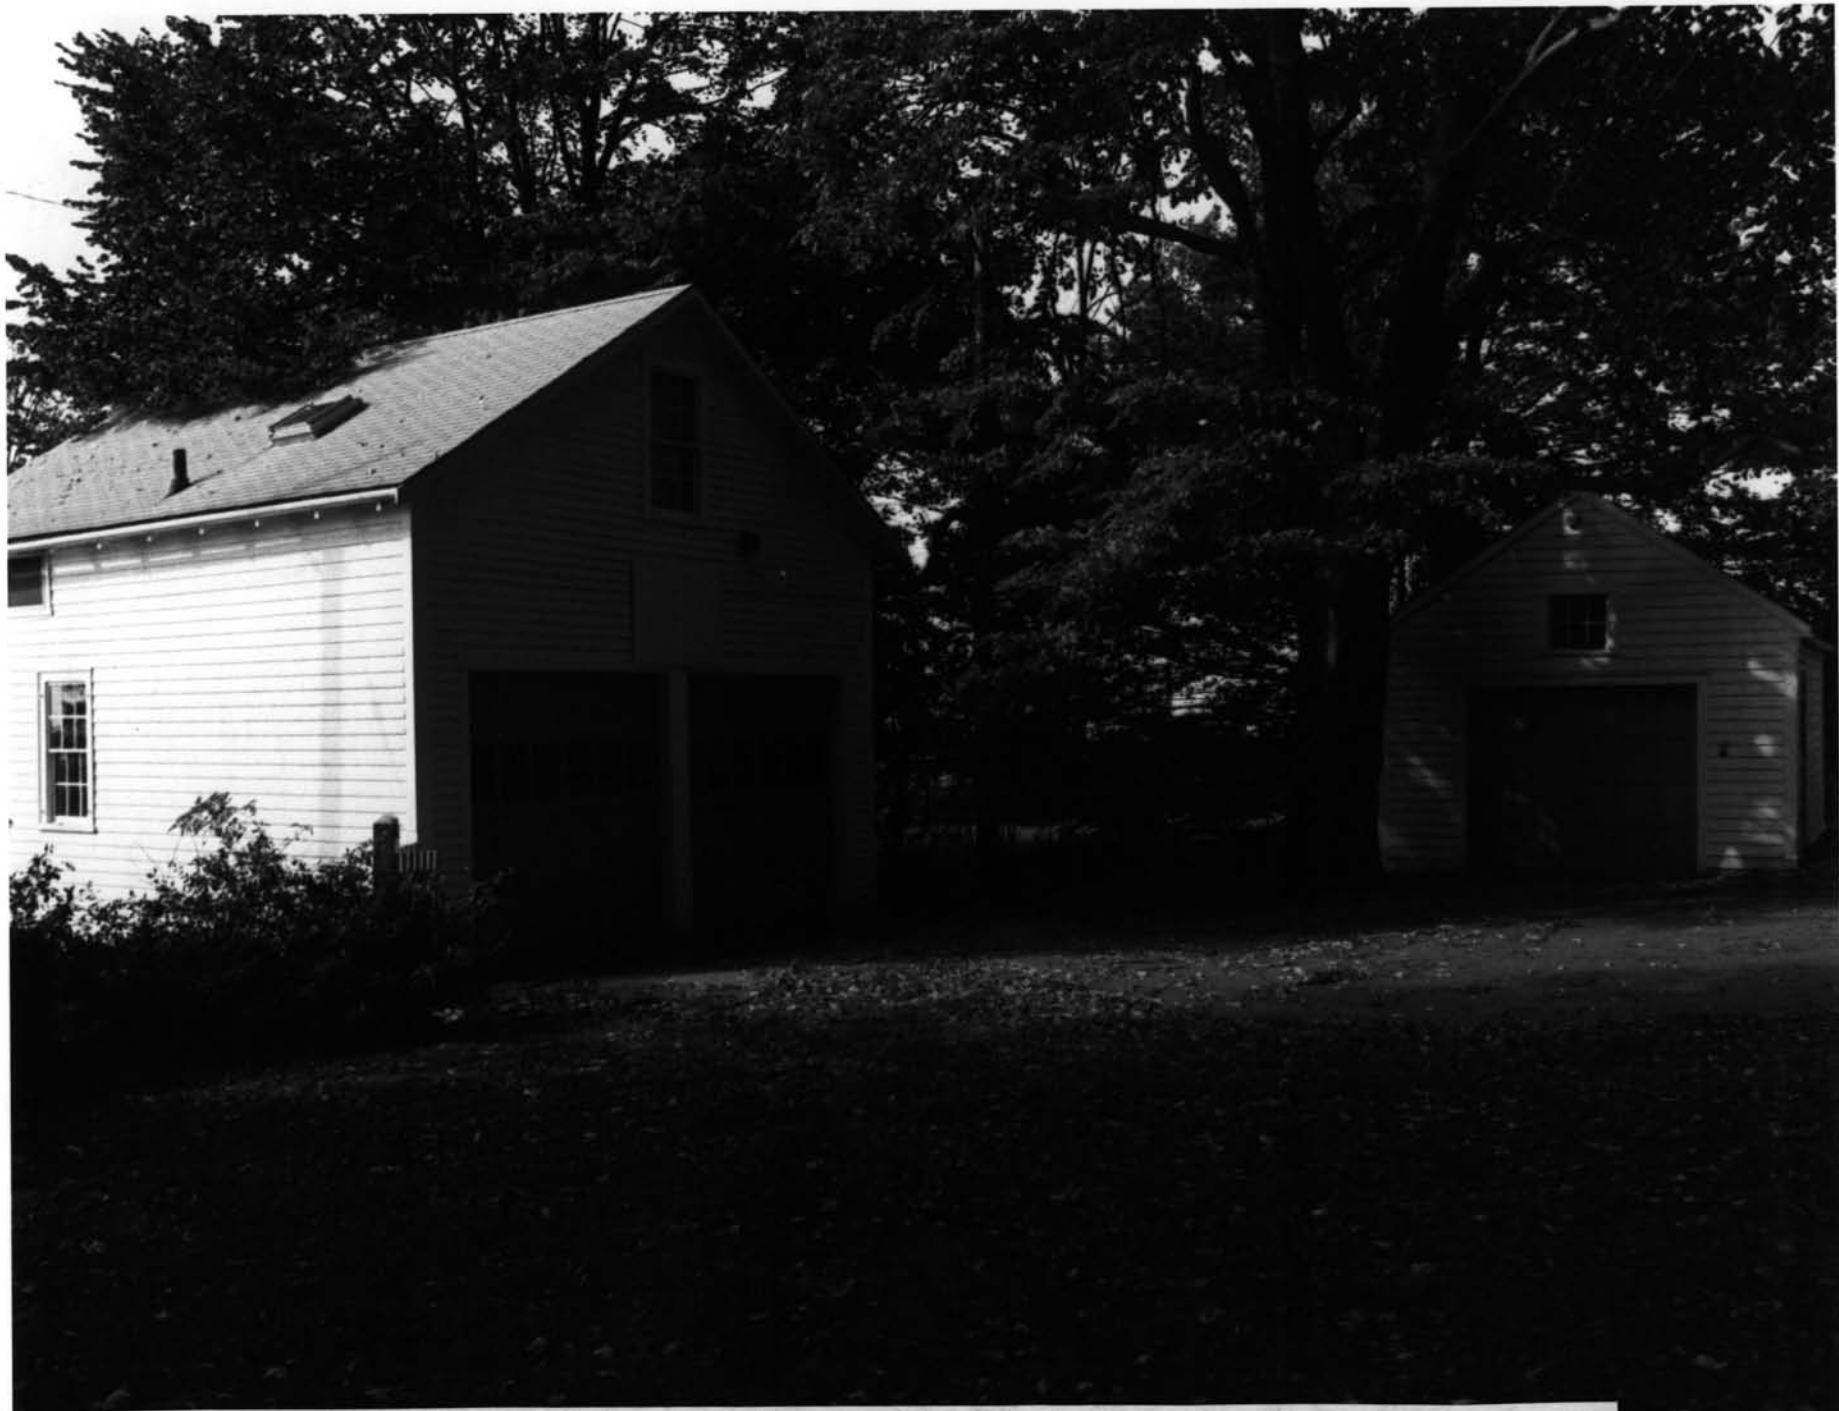
Taylor-Chase-Smythe House Grounds: View of back yard, showing 19th century outbuildings.

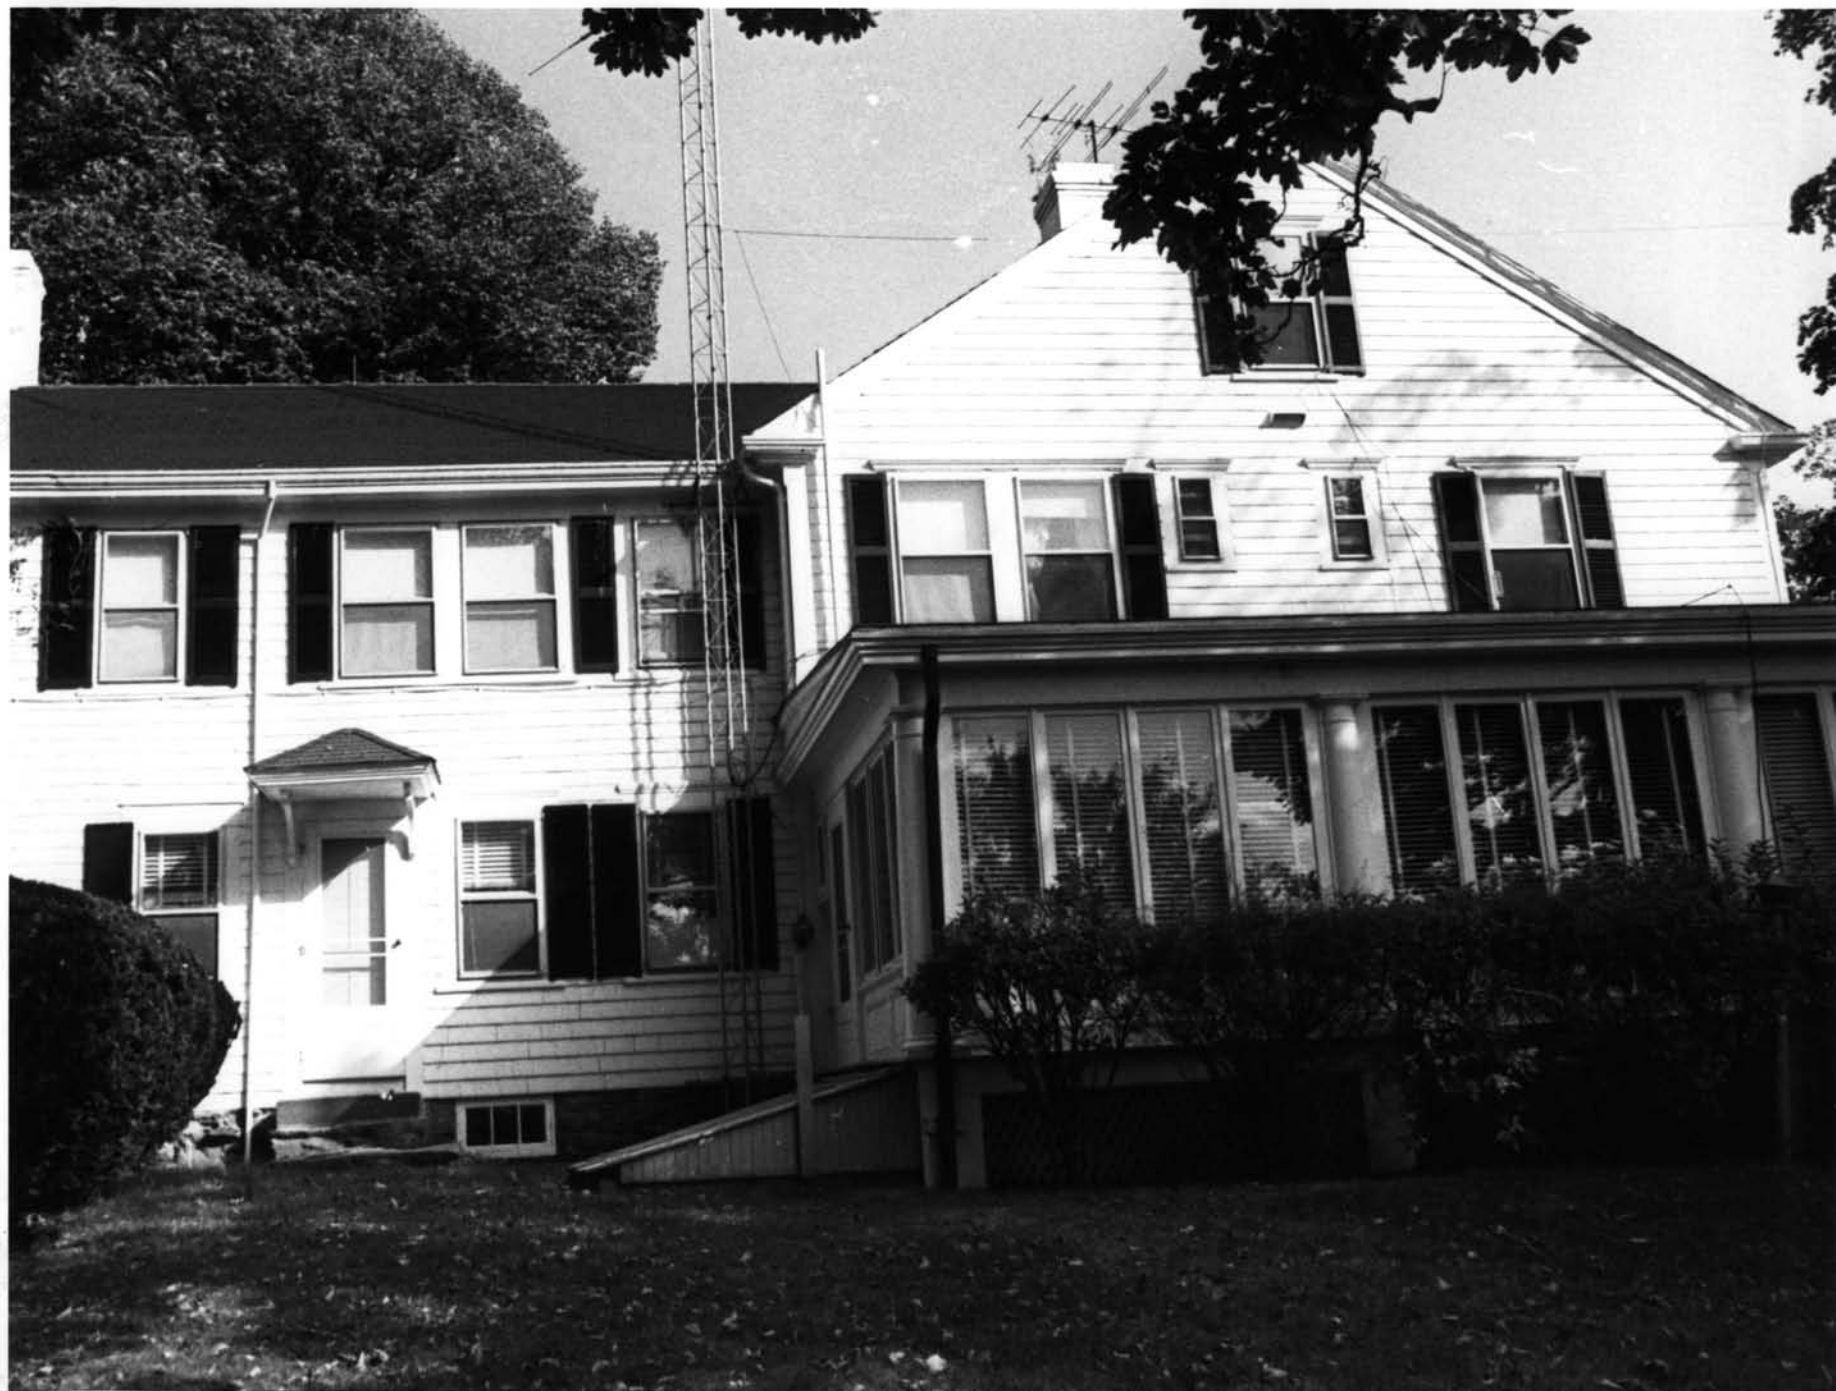
Taylor-Chase-Smythe House: West facade, showing gable-end of 18th century house with 20th century porch and 19th century ell.

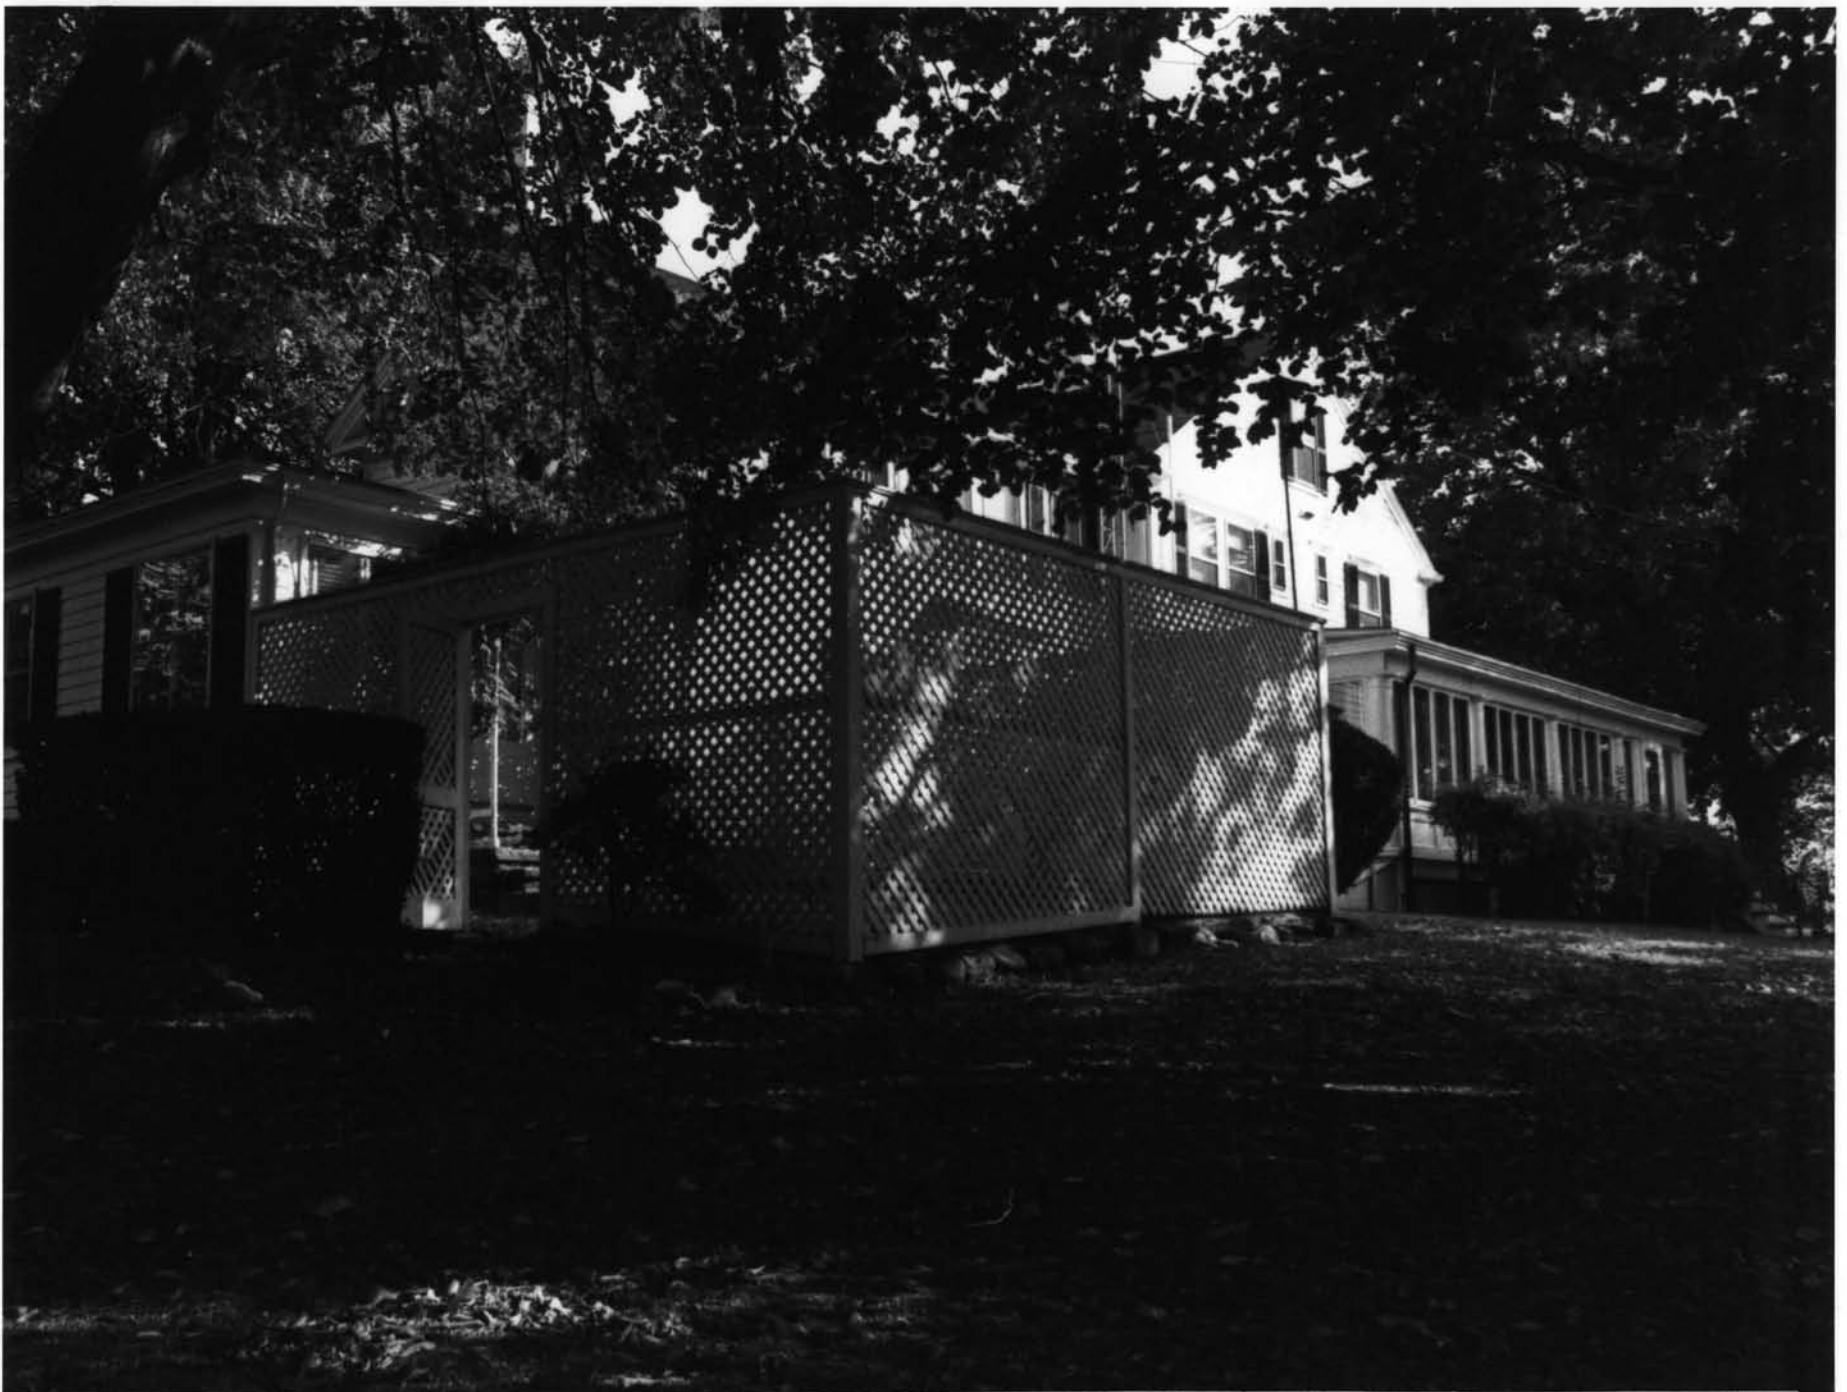
Taylor-Chase-Smythe House: View from northwest, showing 20th century laundry addition and drying yard in foreground.

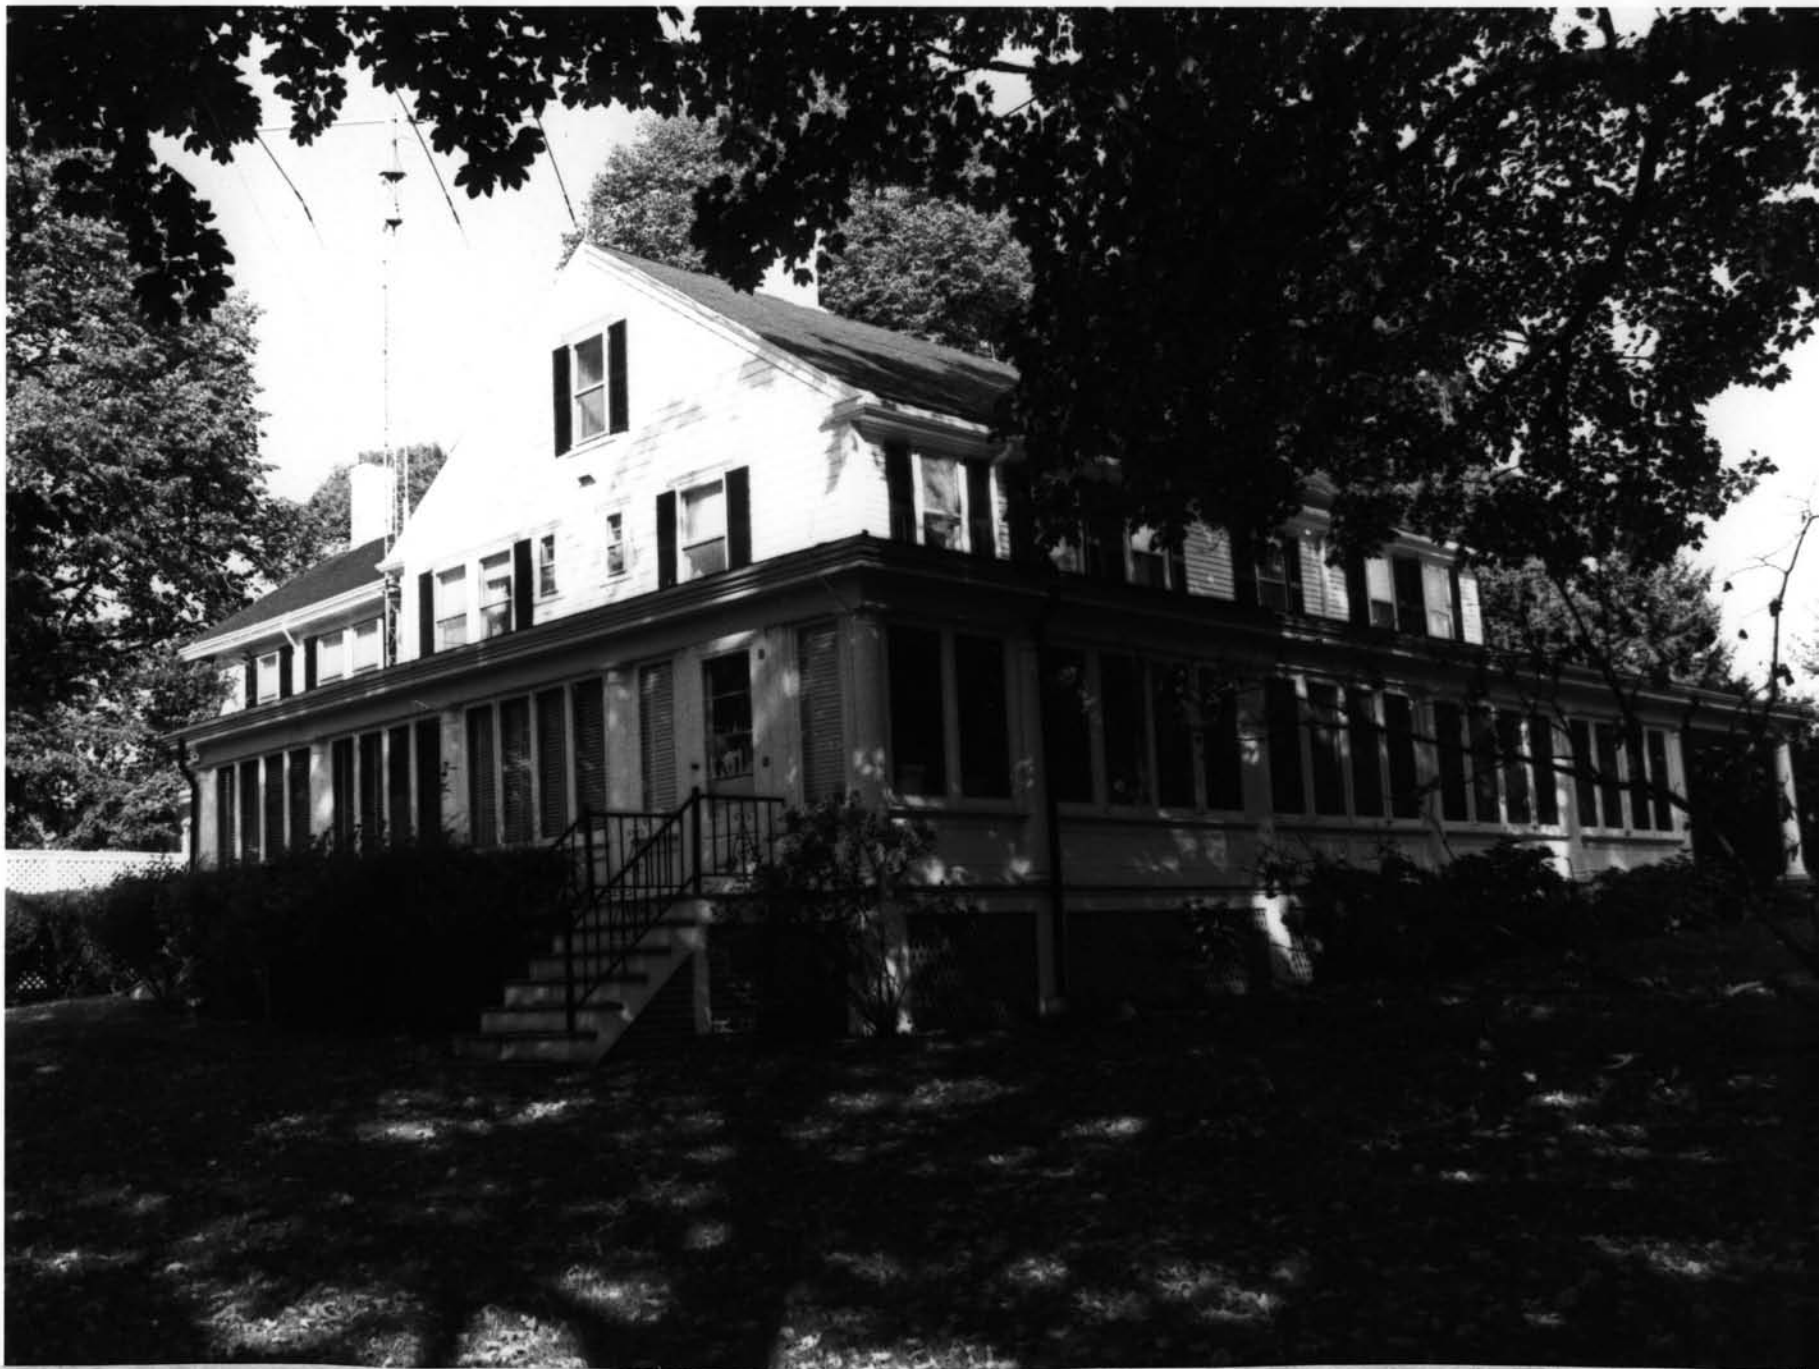
Taylor-Chase-Smythe House: South and west facades, showing original mass of 18th century house surrounded by glassed-in porch added in 20th century. Porte-cochere visible at far right.

The large, one-story porch that spans the entire south (front) elevation, links into the west enclosed porch and forms a porte-cochere in the southeast corner. It is supported with wood, Doric columns set directly on the porch floor and was probably constructed ca. 1919. Infill casement windows were added in the late 1970s, thus creating an additional living space.
