NATIONAL REGISTER OF HISTORIC PLACES INVENTORY -- NOMINATION FORM

HISTORIC Central Falls Congregational Church
AND/OR COMMON St. Joseph's Parish Center

STREET & NUMBER 376 High Street

CITY, TOWN Central Falls

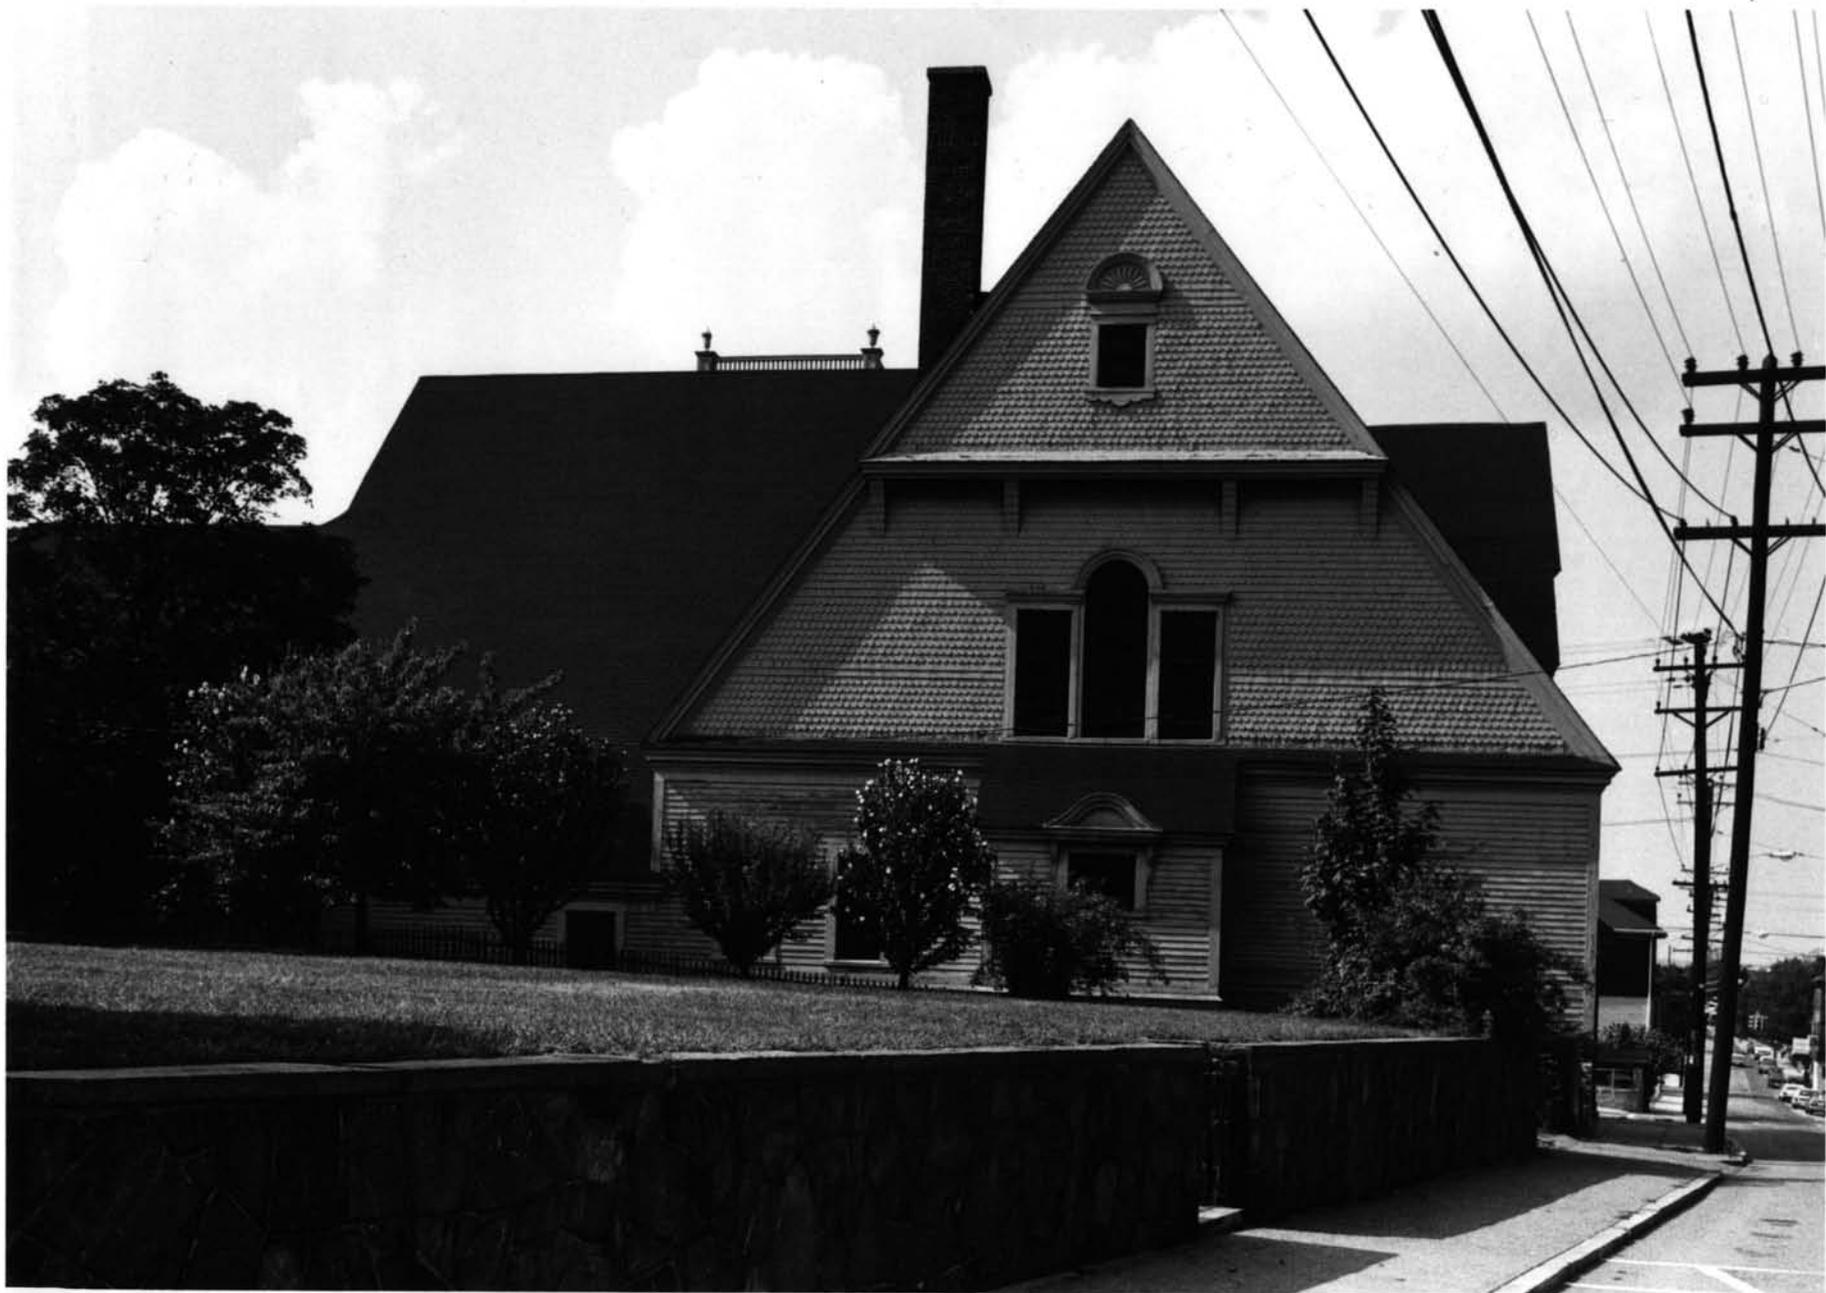
Photograph #2

Description: Southern facade, showing gable end of
north/south roof axis.

The southern facade of the building has a central door leading into the social room. To the left is a set of triple windows; to the right is a shallow, shed-roofed extension, lighted by a small window with a curved pediment. Above the extension on the second level is a set of Palladian windows. High in the peak of the gable is a small window topped by a wooden sunburst design.

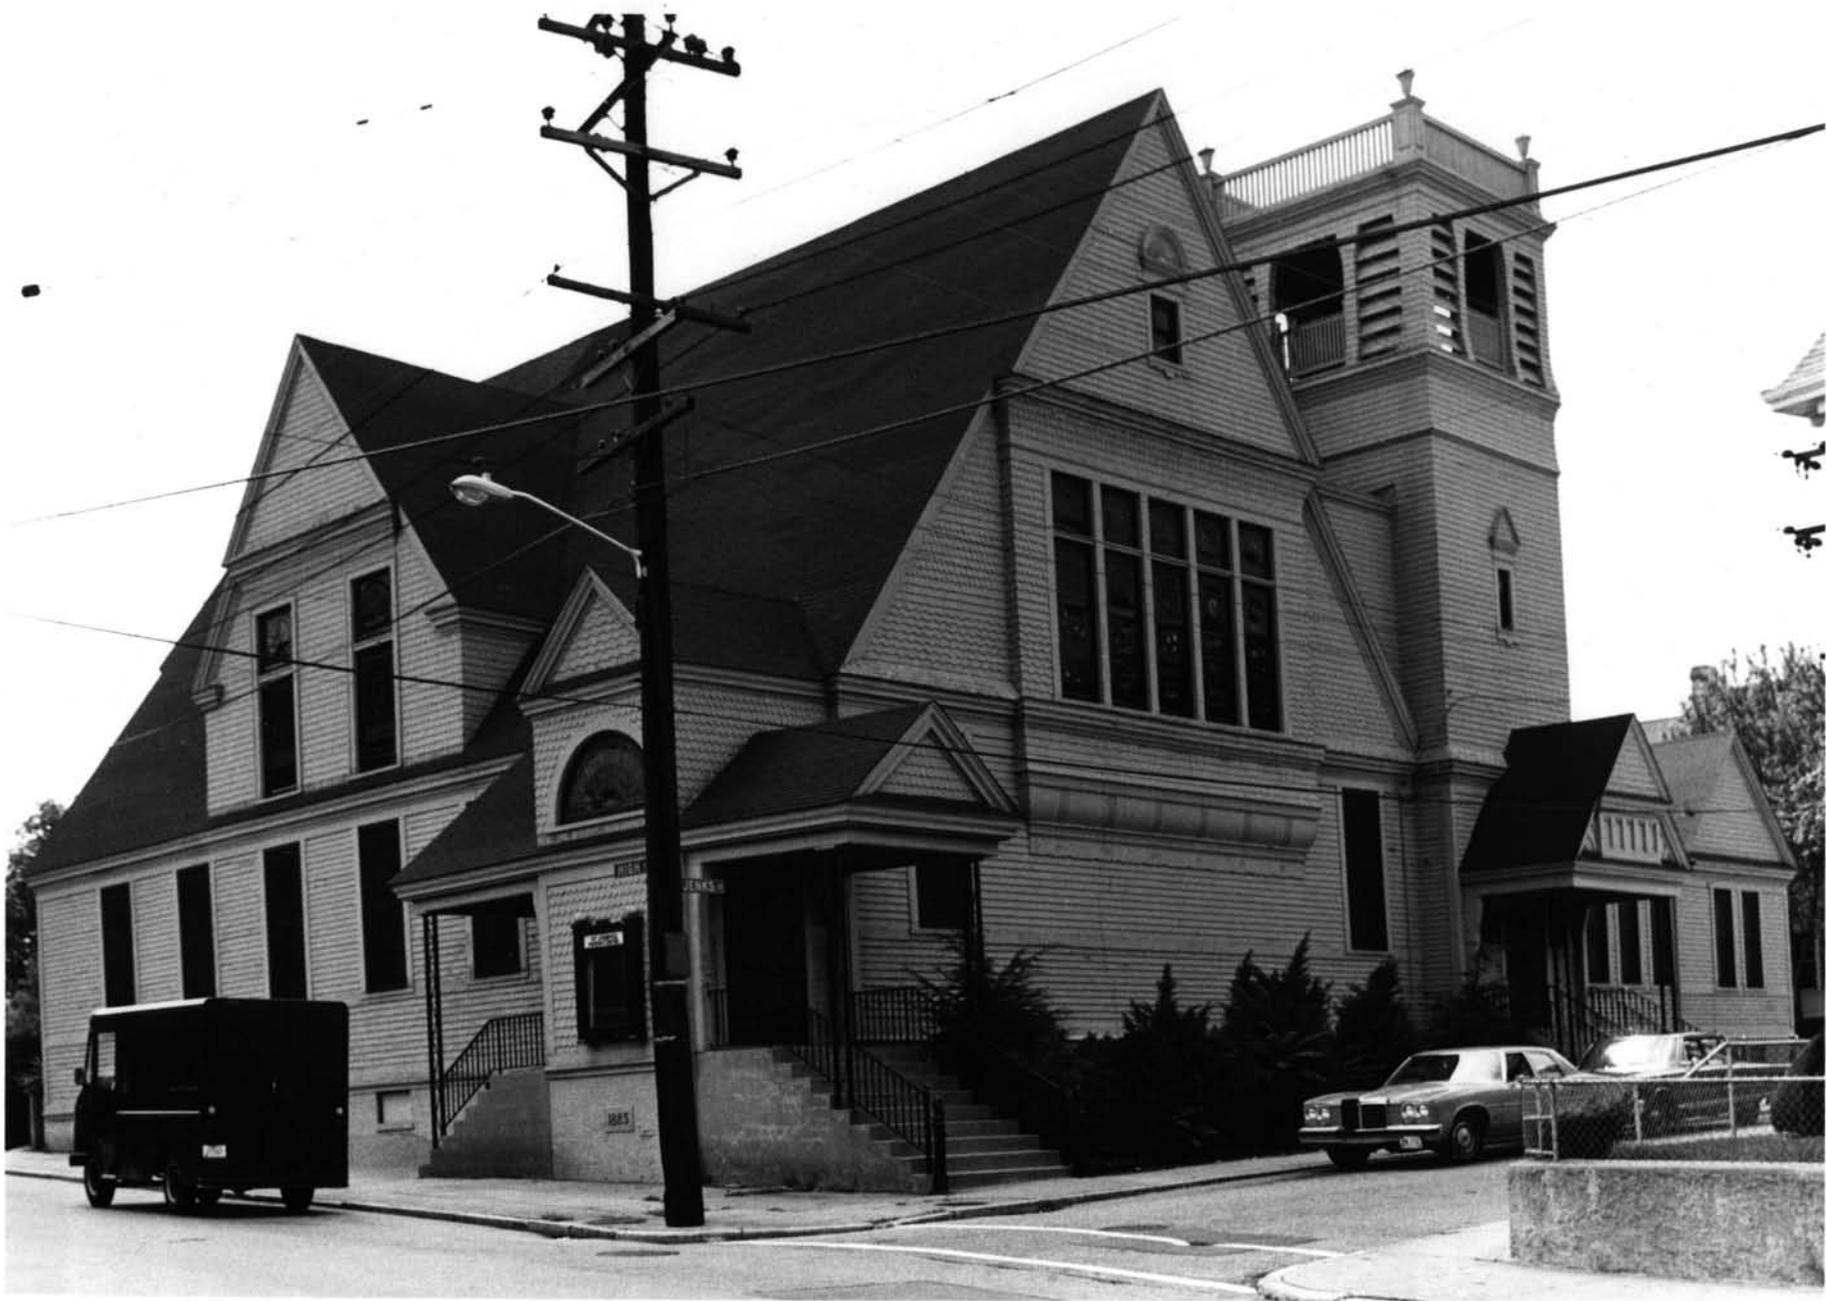
Photograph #1

Description: Northern and eastern facades, showing main
entrance to right under tower and northeastern
corner entrance porch.

A three-level, flat-roofed tower rises from the northern Jenks Street facade. West of the tower the roof rises into the high gable of the north/south roof axis, while the length of the east/west axis is visible along the east side. The tower was originally topped by a spire (damaged in the 1938 hurricane and later removed); it has two small windows on the second level; the third level originally held the church bell. A balustrade surrounds the top of the tower. The main entrance to the church is in the tower's first level and is set under a gabled porch. The upper portion of the gable is covered with patterned shingles, the lower with panelling. The porch was originally supported by four heavy posts, but the front two have been replaced by stock, wrought-iron supports, as have the porch railings. This northern facade has two sets of stained glass windows. Six windows line the wall right of the tower. The left side of the facade is divided by a concave band of shingles which form a shallow bay filled by a row of windows, five small squares set over five rectangles. The bay crosses the middle section of the gable and rests on a convex molding. The upper level of the gable contains a small window topped by a semi-circular molding. A row of ground-level basement windows are also visible, as the site slopes up slightly toward the south and west.

At the northeastern corner are the side entrances to the church. Two sets of double doors are set at opposite ends of a porch covered by an extension of the main roof. As in the main entrance, three of the porch posts have been replaced by stock, wrought iron. Above the entrance porch is a gabled dormer with a semi-circular window.
