National Register of Historic Places Inventory—Nomination Form

historic District Schoolhouse #2

street & nur	nberOld Old Post Road	(Route 1A)		not fo	r publicati	on [']
	•	Cross Mills				
city, town 🕤	Charlestown	vicinity of	congressional district	#2(Rep.	Edward	Beard)

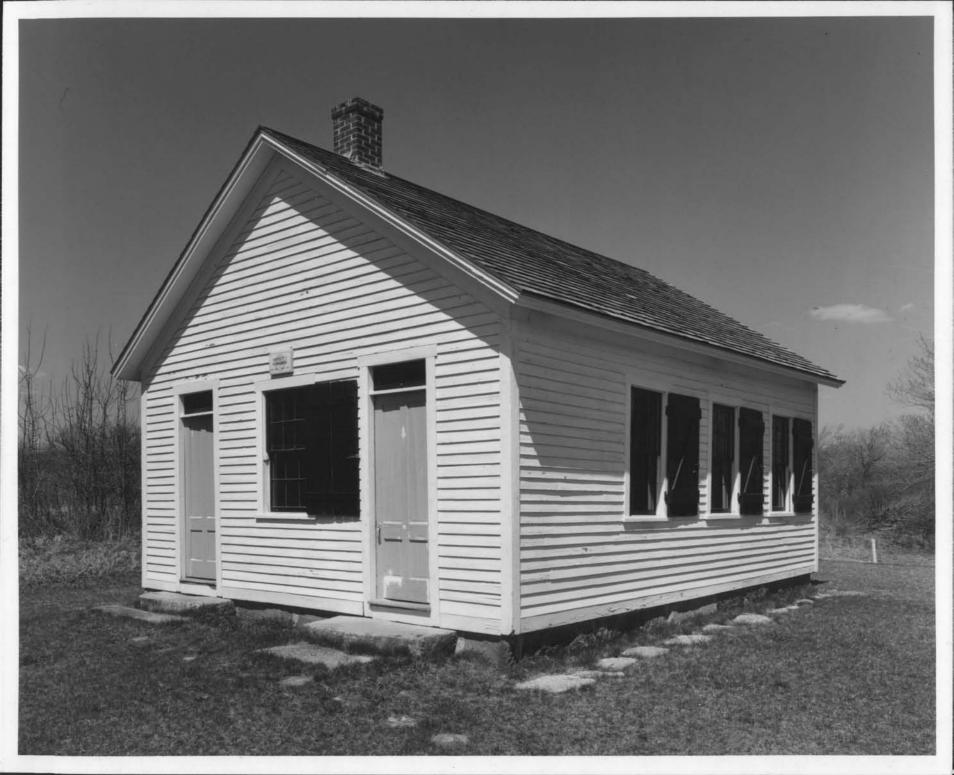
photograph #1

View from the southeast

The school is a small (20.5 feet wide by 26 feet deep) clapboardsheathed structure with a wood-shingled gable roof. It rests upon a foundation of rock-faced granite and has no cellar. Except for two small vestibules it contains only one room. The front elevation has a central window flanked by two doorways; there are three windows on each side elevation, and no opening at all in the rear wall. A single short, slim brick chimney rises through the peak of the roof near the building's A plain fascia board runs under the eaves and up the gables; front. door and window openings have plain flat-board enframements. Both doors are hung on strap-hinges and contain four flat inset panels, are fitted with thumb-latches, and have three-pane transoms. In front of each door are two large oblong granite blocks forming a "stoop" and a step--these, except for one replacement, also brought from Quonochontaug. Windows are double-hung, with six-over-six sash, and each is equipped with a single, strap-hinged board-and-batten shutter. The shutters do not show in a nineteenth century photograph of the school, although they appear in one taken in this century.) The building is painted white, found to be its original color; the two doors, window sash and shutters are Close to each side wall of the schoolhouse is a row of large black. flat drip stones--also brought from the old site.

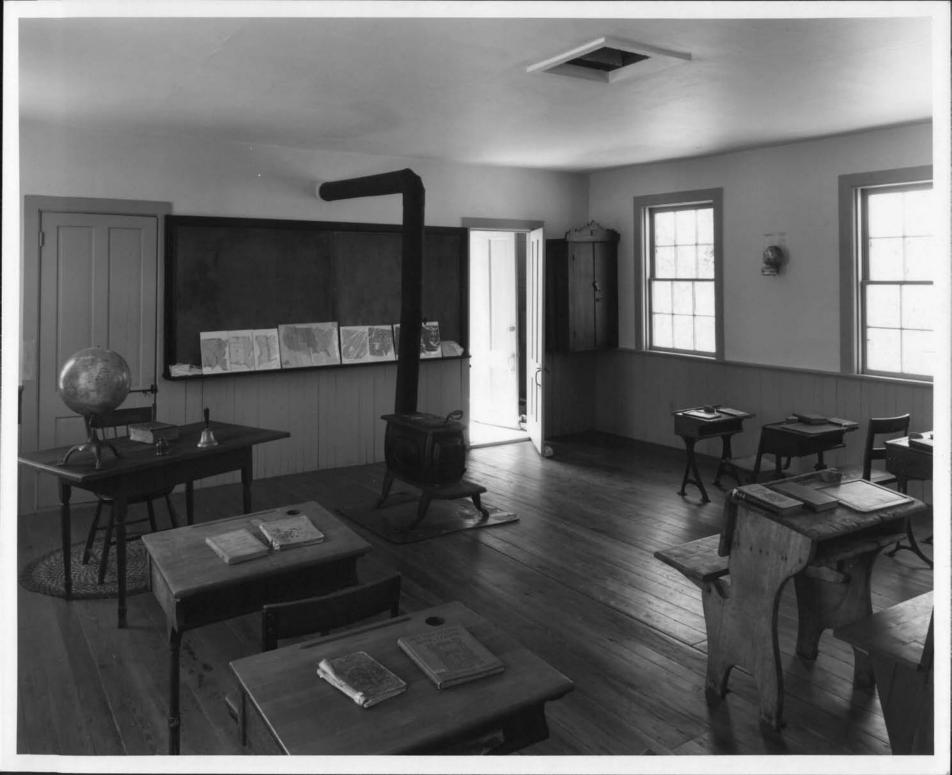
photograph #2

Interior from the northwest

On the interior there are two vestibules across the front, the smaller one for boys, and the larger (east) one with its window, for girls' use. The chimney projects from the rear wall of the larger vestibule, and both have wooden clothes-pegs on their walls. All remaining space is taken up by the nearly-square classroom. Here the original wide-board flooring remains, and door and window trim is as simple as that outside. A wainscot of narrow vertical boarding, believed to have been applied c. 1860-1870, runs around the room to window-sill height and is now painted its original blue, which was determined by scraping, as is all other woodwork. At the south end of the room it was found during restoration that an older wall exists behind the present one. The earlier wall has a red-stained wainscot of horizontal boards with plaster covered by two layers of early FHR-8-300A (11/78)

When paint was stripped from the north wall, marks were found showing the dimensions of the nineteenth-century benches built against it; these have been reproduced. Between the two doors to the vestibules the wall space is filled, above the wainscot and to the height of the doors, by a large blackboard. An iron wood-burning stove is set upon a large iron safety shield in a central location a few feet from the wall. Oil wall sconces have been hung, and there is a pendulum clock.
