National Register of Historic Places
Inventory—Nomination Form

historic Peleg Champlin House

Rodman Pond Lane
New Shoreham, Rhode Island

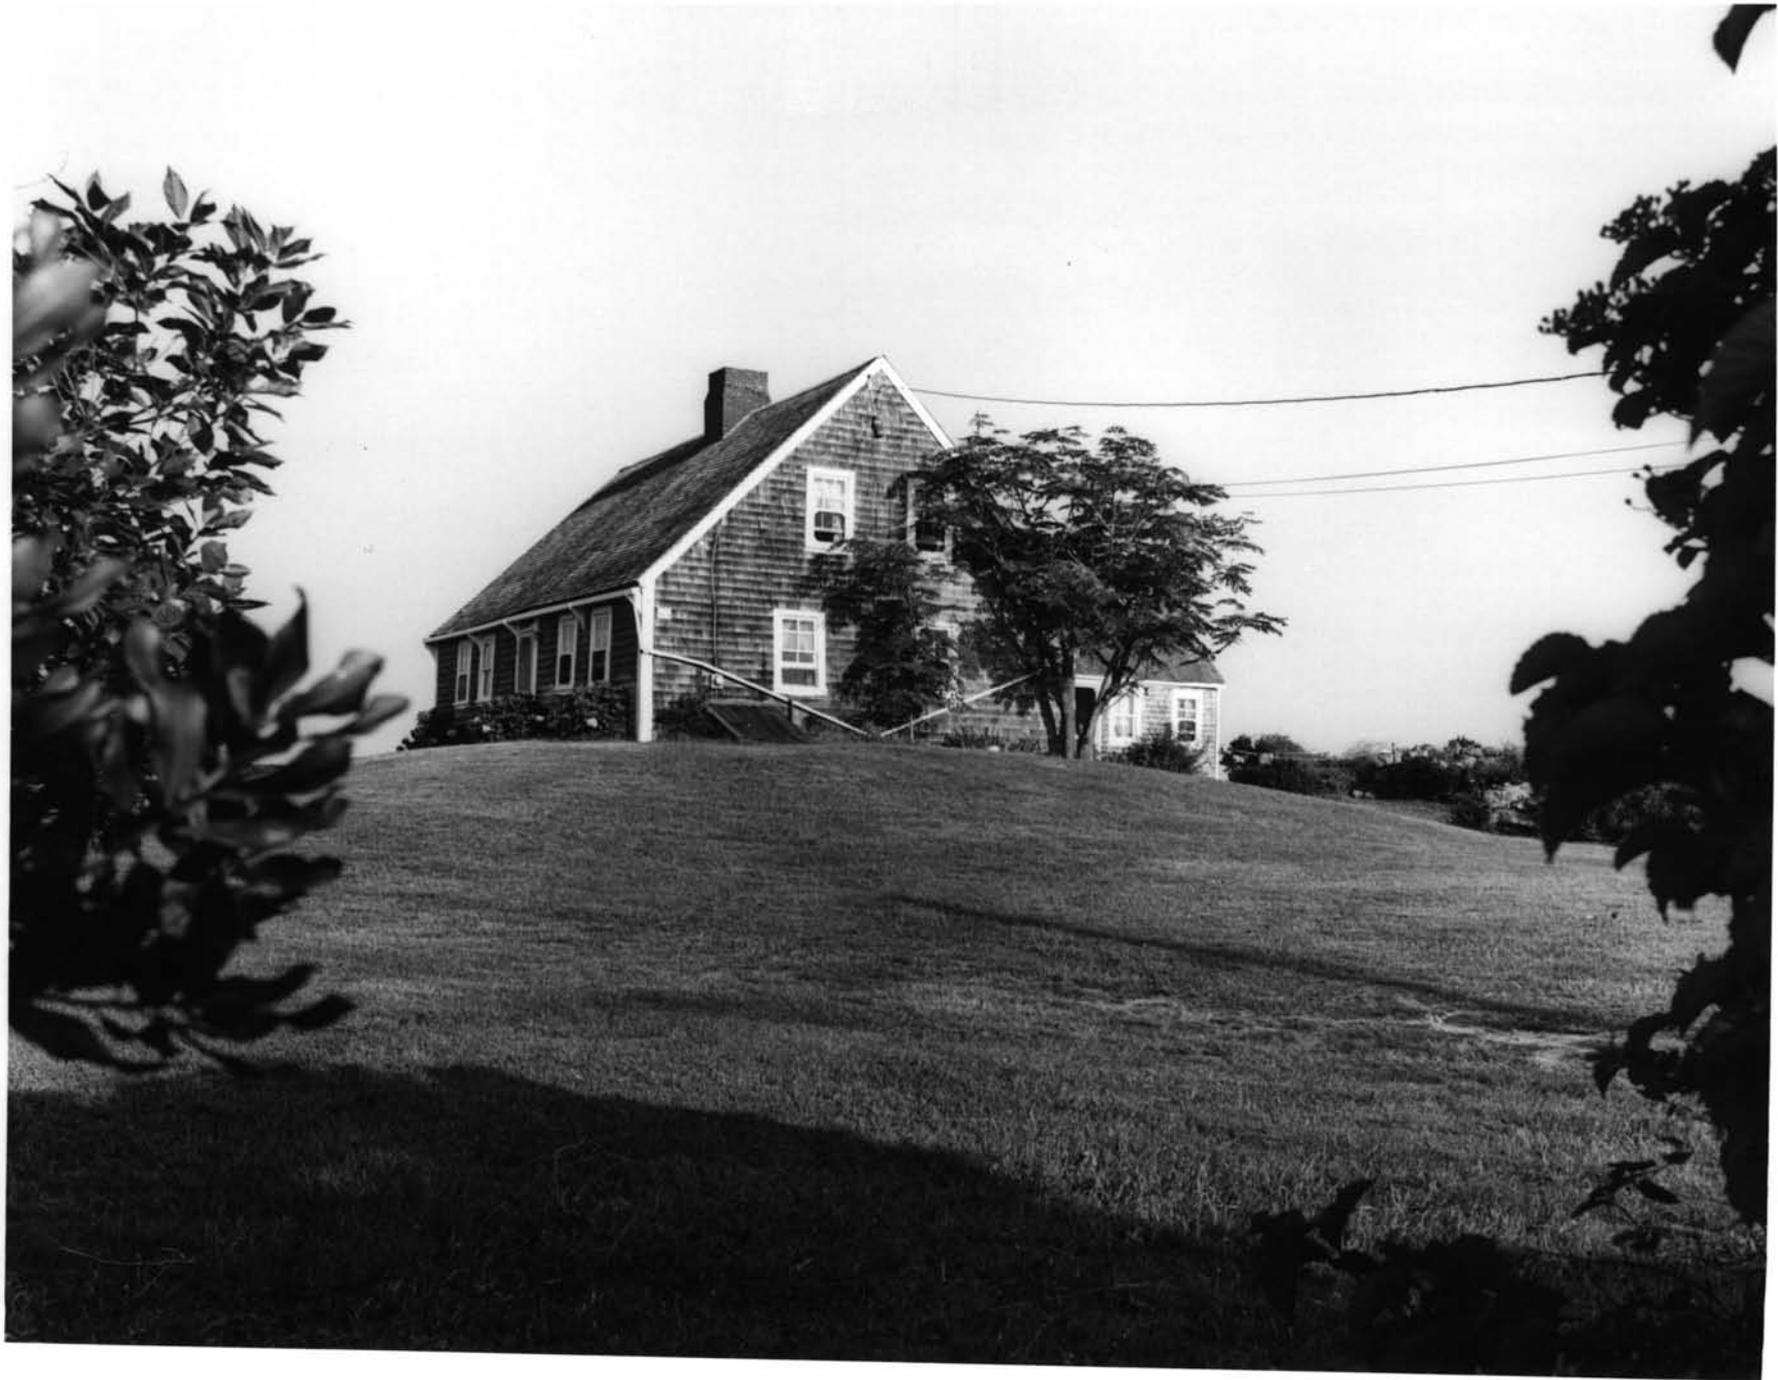
Photo #1

View of the south (front) facade and east gable end;
note transom above front door, "Y" of gutters on
gable end, and rear ell.

The south-facing facade has a central doorway flanked by two pairs of windows. Around the door there is a simply molded surround and, above it, a four-pane transom. The gable ends are two bays deep with a pair of windows on the upper and the lower stories. The original 6/6 double-hung sash windows have been replaced by 2/2 windows on the first story while they remain on the second story. There is a small 4/2 double-hung sash window in the kitchen pantry and a single four-pane sash lighting the garret in the west gable end.

An interesting feature of the house's exterior is the arrangement of the gutters. On the north and south eaves the wooden gutter troughs are canted so as to send their water into an underground cistern through a symmetrical Y of drain pipe on the east gable end. The cistern is not presently in use. The remains of another cistern under the ell indicate that these gutters formerly operated in the same manner.

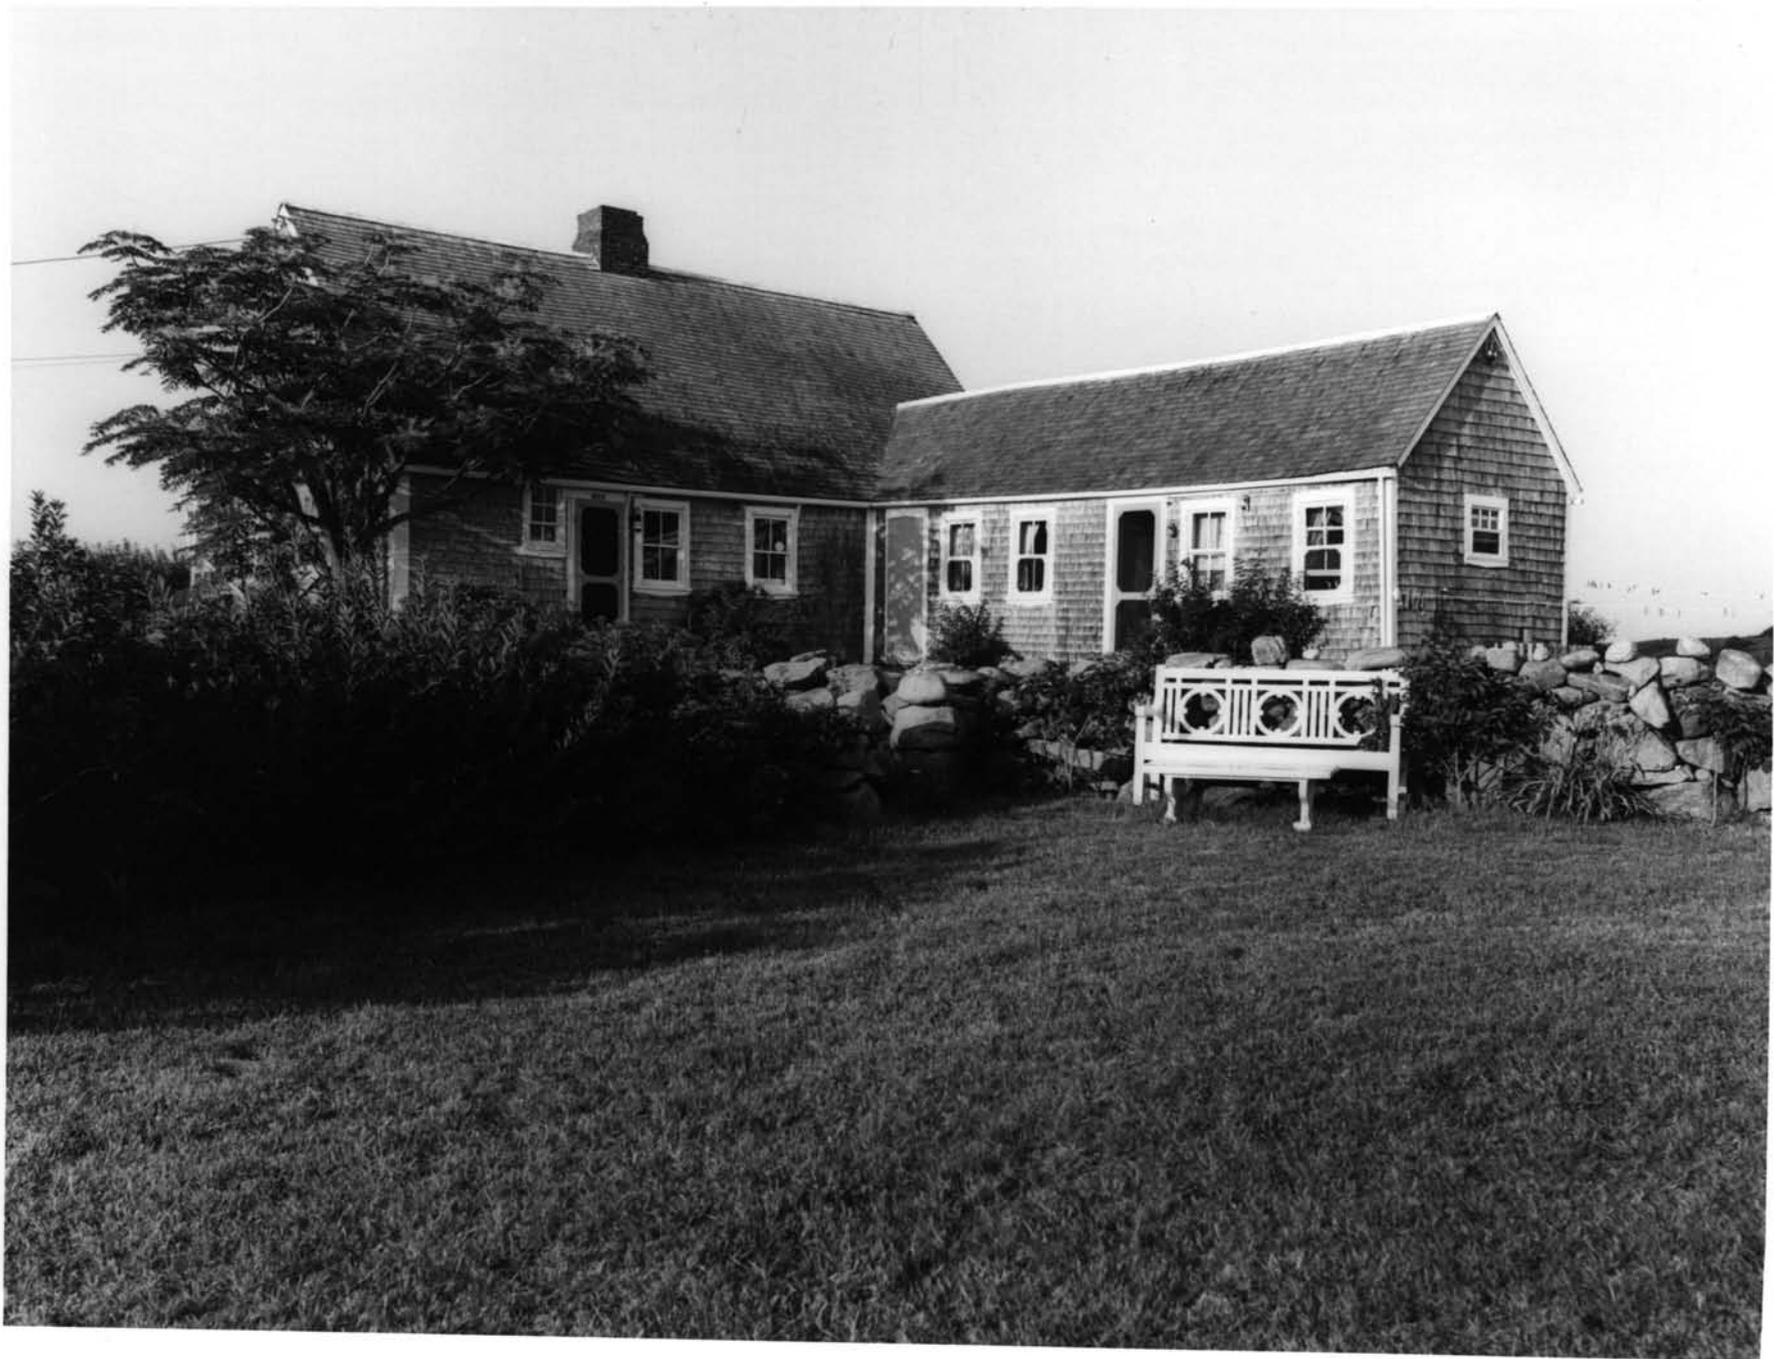
Photo #2

View of the north (rear) facade of the house from
the former barnyard.

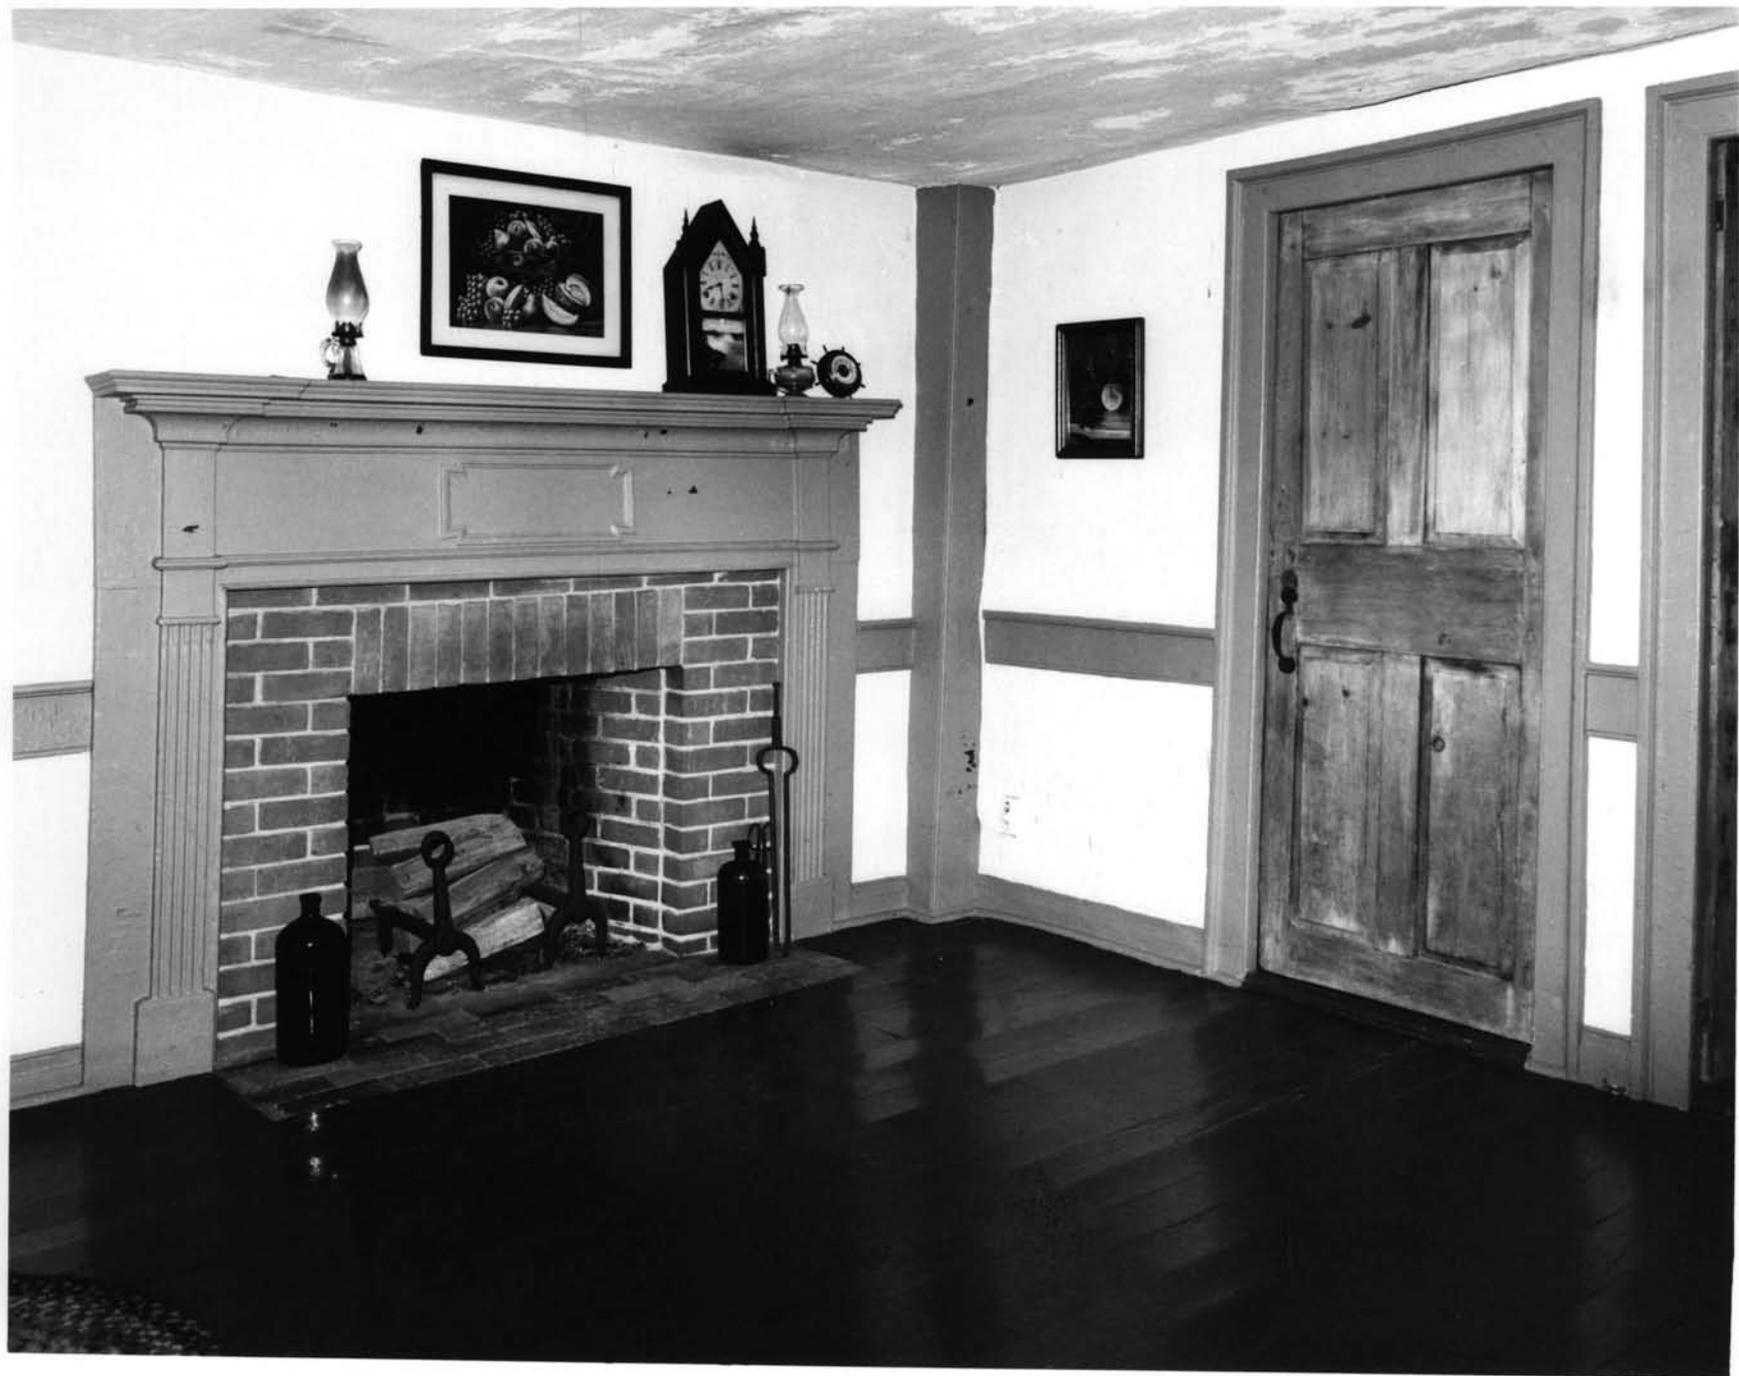
Photo #3

View of mantel in east parlor.

The interior of the house is finished with plastered walls and ceilings. Except in the kitchen, where there is vertical board wainscotting, there are molded chair rails and baseboards throughout the house (though the woodwork on the second floor seems to have been added later). The fireplaces in the two parlors are the most prominent decorative features. The wooden mantels are basically the same: tall, slender, pilasters, fluted in the east parlor and channeled in the west, support a broad frieze with a central panel and a projecting mantelpiece. The composition reflects the freer and more sophisticated use of classical elements during the Federal period while the execution displays the simple forthrightness of traditional carpentry. Two other apparently original features of note are a closet cupboard in the west parlor, located under the rear stairway, and a small cupboard with a glazed door built into the north wall of the east parlor. There are two other small closets in the house, one under the front stairway in the entry and the other in the wainscotting on the west wall of the kitchen, under the rear stairway. The doors in the front of the house are all four-panelled; those in the kitchen and on the rear facades are two-board, battened doors. In addition to the changes already noted there have been a few more alterations. The small chamber in the northwest corner of the first story has been converted into a bathroom, though its woodwork is largely undisturbed. Under the windows in the east parlor previous owners installed space heaters and in the west parlor they replaced the single window with a three-pane picture window bay. The present owners are now considering restoring both the windows and the chimneys to their original appearance.

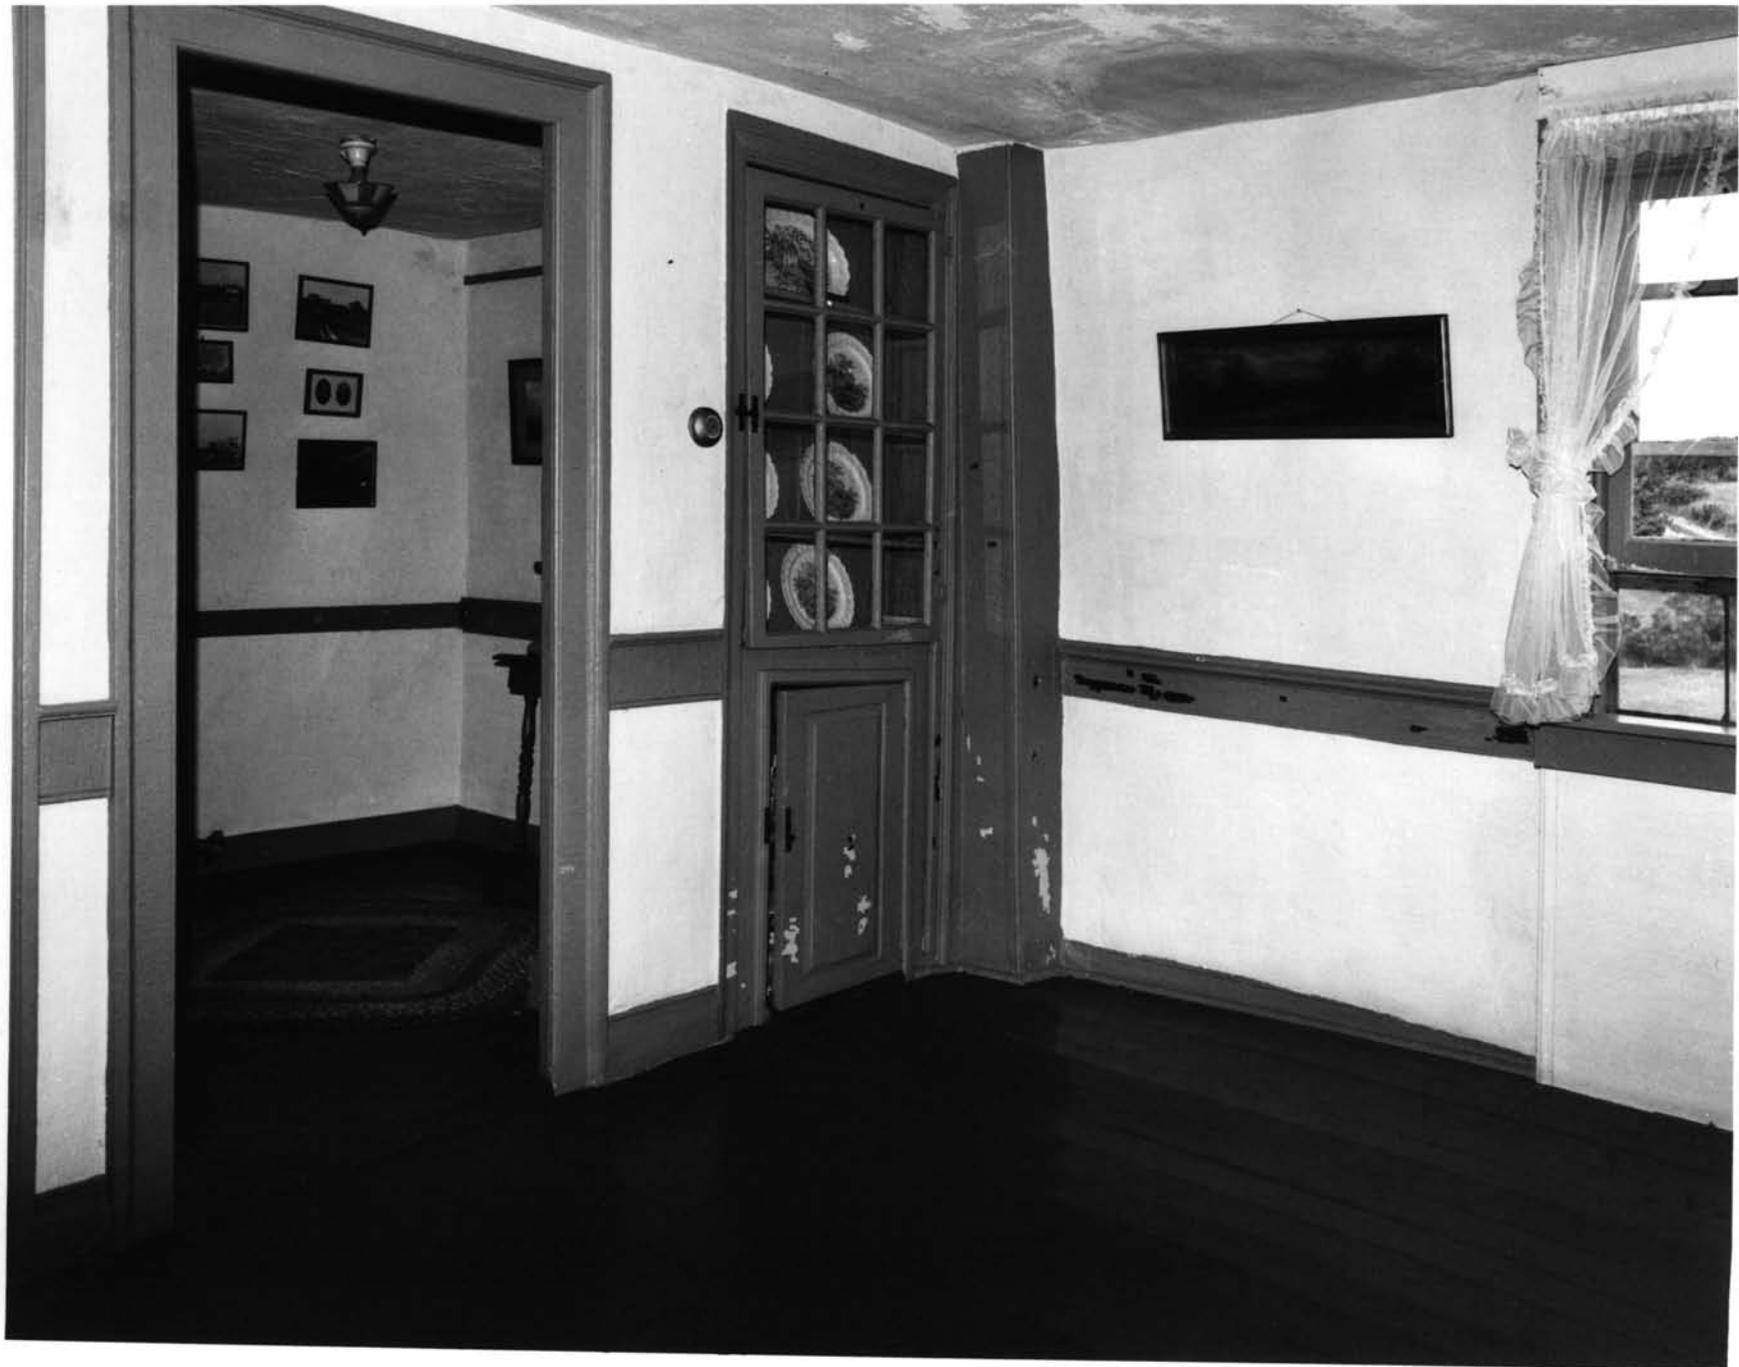
Photo #4

View of glazed china cupboard in east parlor and
small room opening off parlor.
