# National Register of Historic Places Registration Form

1. Name of Property			······		
historic name: <u>Mowry, T</u>					
other name/site number:				· · · · · · · · · · · · · · · · · · ·	_
2. Location				-	
street & number: <u>112 Sa</u>	yles Hill Roa	ıd			
				not for publication: <u>1</u>	N/A_
city/town: North Smit	<u>chfield</u>	vicinity: <u>N/A</u>			
state: <u>RI</u> county: <u>F</u>	Providence	_ code: <u>007</u>	zip code:	02896	
3. Classification					
Ownership of Property:	<u>Private</u>				
Category of Property:	Building				
Number of Resources within	Property:				ŧ
Contributing Non	contributing				
$\frac{1}{0}$					
	structures				
Number of contributing resol	urces previously liste	d in the National Re	gister: <u>0</u>		
Name of related multiple pro	perty listing: <u>N</u>	/A

Facing south on Sayles Hill Road, the Tyler Mowry House is a highly intact rectilinear center-hall-plan house with an integral kitchen ell to the east built at the same time as the house (ca. 1825). The interior of the main house is a typical Federal plan; with a central hall containing the stair to the second floor; two rooms to either side of the center hall at the first floor and the second f

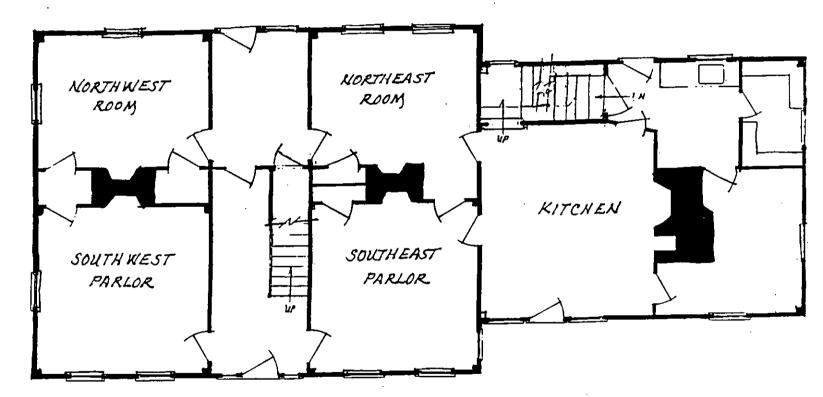
First floor sketch plan--not to scale

along the east wall, while the southwest parlor has only one door, other than the center hall door, that leads to the rear room. The two rear rooms are much plainer, with simple mantels and over cupboards with panelled doors. The northwest room also contains a shelved closet to the east of the chimney. These rooms have doors which lead back to the center hall which is now separated by a wall running east-west at the end of the stair run. The rear of the center hall contains a door to the exterior.

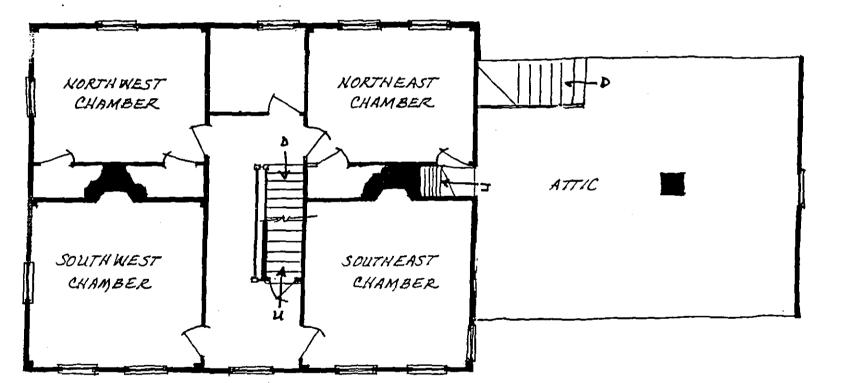
# Second floor sketch plan--not to scale

The second floor plan matches the first in room layout and dimension, except for the small room located at the head of the stair above the rear of the center hall. The second floor, like the first, has tall ceilings typical of the Federal period. The southeast and southwest chambers have pilastered mantels similar to, but smaller than the first floor mantels. These rooms are plastered and also have chairrails and beaded cased corner posts. Each room has only one door leading to the center hall. The rear rooms have no fireplaces, but have two closets each on either side of the chimney. The northeast room's east closet contains access to the ell attic as well as a ladder stair to the main attic. There is also a enclosed stairway to the main house attic above the main stair in the center hall. The west chimney remains intact and is offset from the mass below at the attic level so that it will fall centered on the ridge of the roof. The chimney mass at the attic has buttressed sides to provide extra support for the severe offset. The east chimney has been rebuilt from the attic floor up through the roof although it is apparent from the visible evidence that it originally matched the west chimney. The attic retains its original framing and is in good condition except at one rafter bay at the east end of the north slope where water damage developed and exacerbated a large hole.
