## United States Department of the Interior Heritage Conservation and Recreation Service

## National Register of Historic Places Inventory—Nomination Form

historic · Plain Farm House

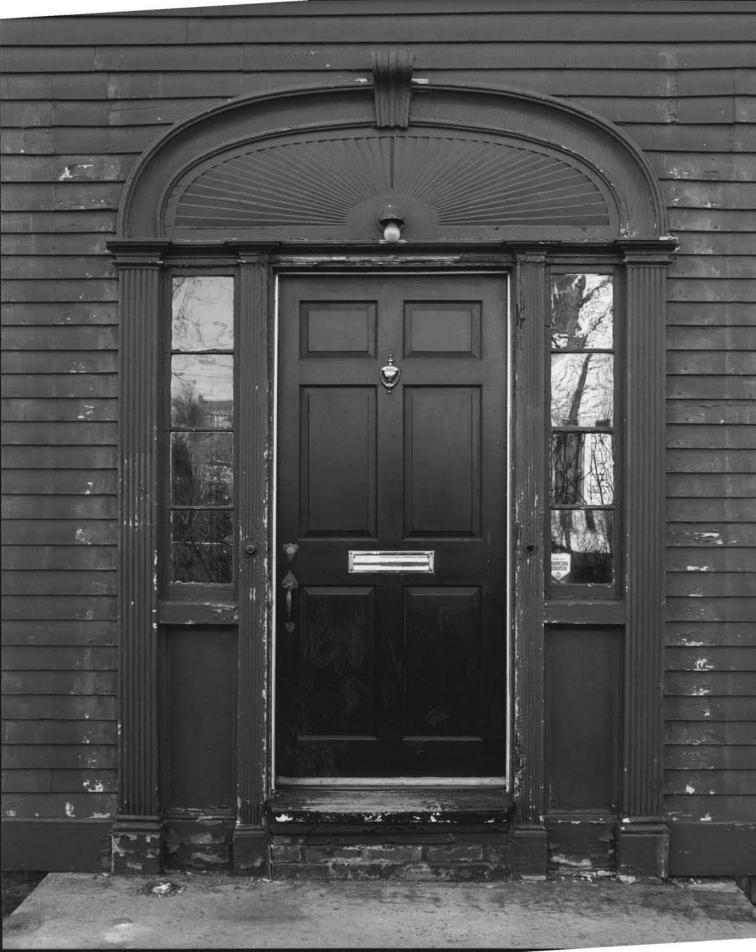
Plain Farm House, view from northeast

The Plain Farm House is a two-and-a-half-story, wood-frame, clapboardsheathed Federal farmhouse with a flank-gable roof and a two-story, gableroof ell more or less centered on the rear of the main block (Photograph 1). The house is typical for the period in both construction and plan.
