**NATIONAL REGISTER OF HISTORIC PLACES  
INVENTORY -- NOMINATION FORM**

Babcock House

Whistling Chimneys

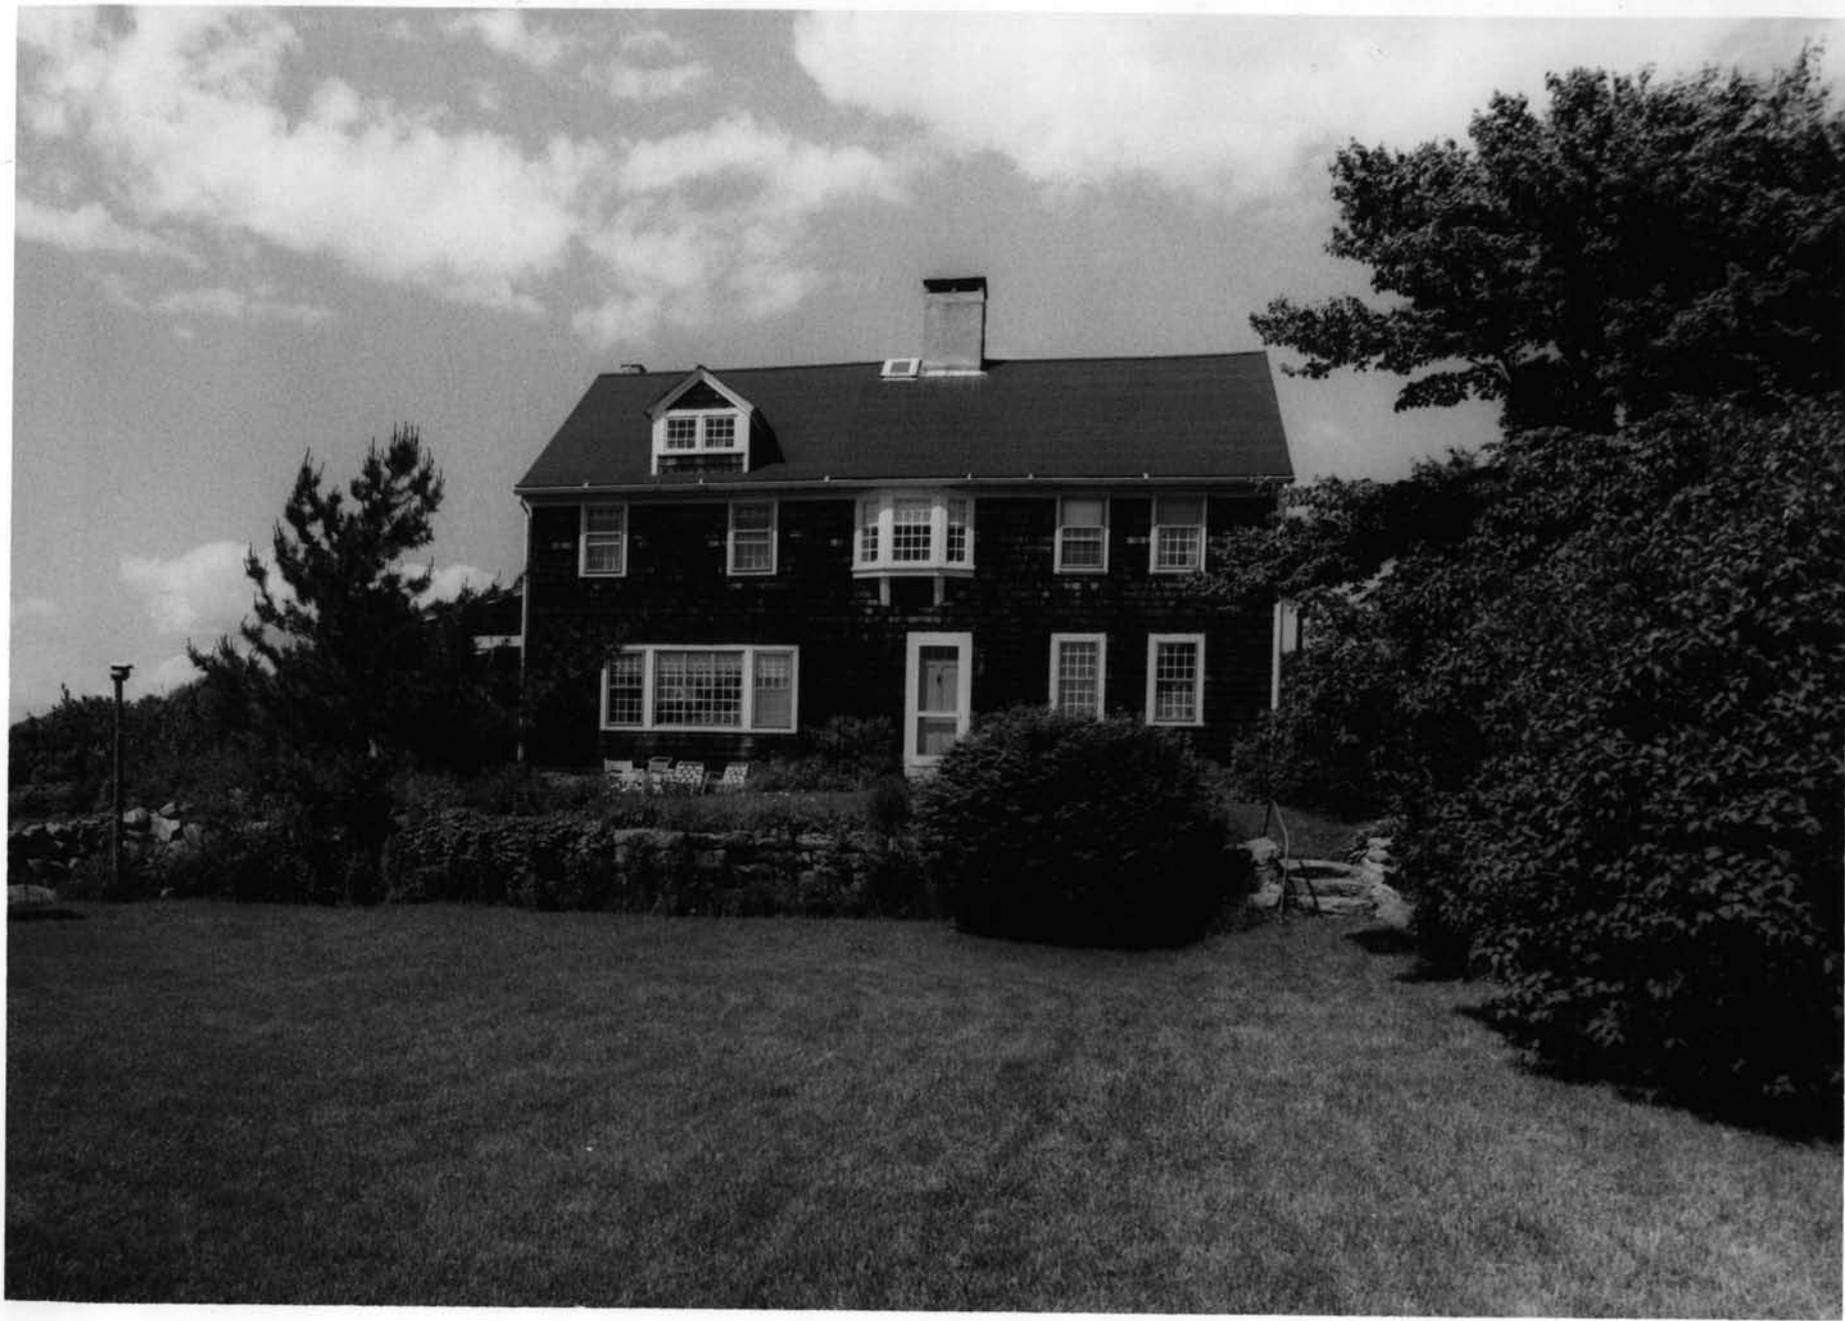
PHOTO NO. 1

View of south front facade.

The Babcock House, commonly called "Whistling Chimneys," is presently a two-and-a-half story, gable-roofed building of five bays with a framed center door and a large central stone and brick chimney. The structure is covered with naturally stained wooden shingles and white painted wooden trim. It faces south, with Quonochontaug Pond immediately to the west.

The present owner, Mrs. Harold Brown, placed a bay window above the front door, a horizontal group of three connected windows on the western half of the south facade, first floor, and added one double-window dormer on the south and two on the north in the early 1950's. In the early 19th century an entrance door was added on the east facade, replacing the lower right window there.

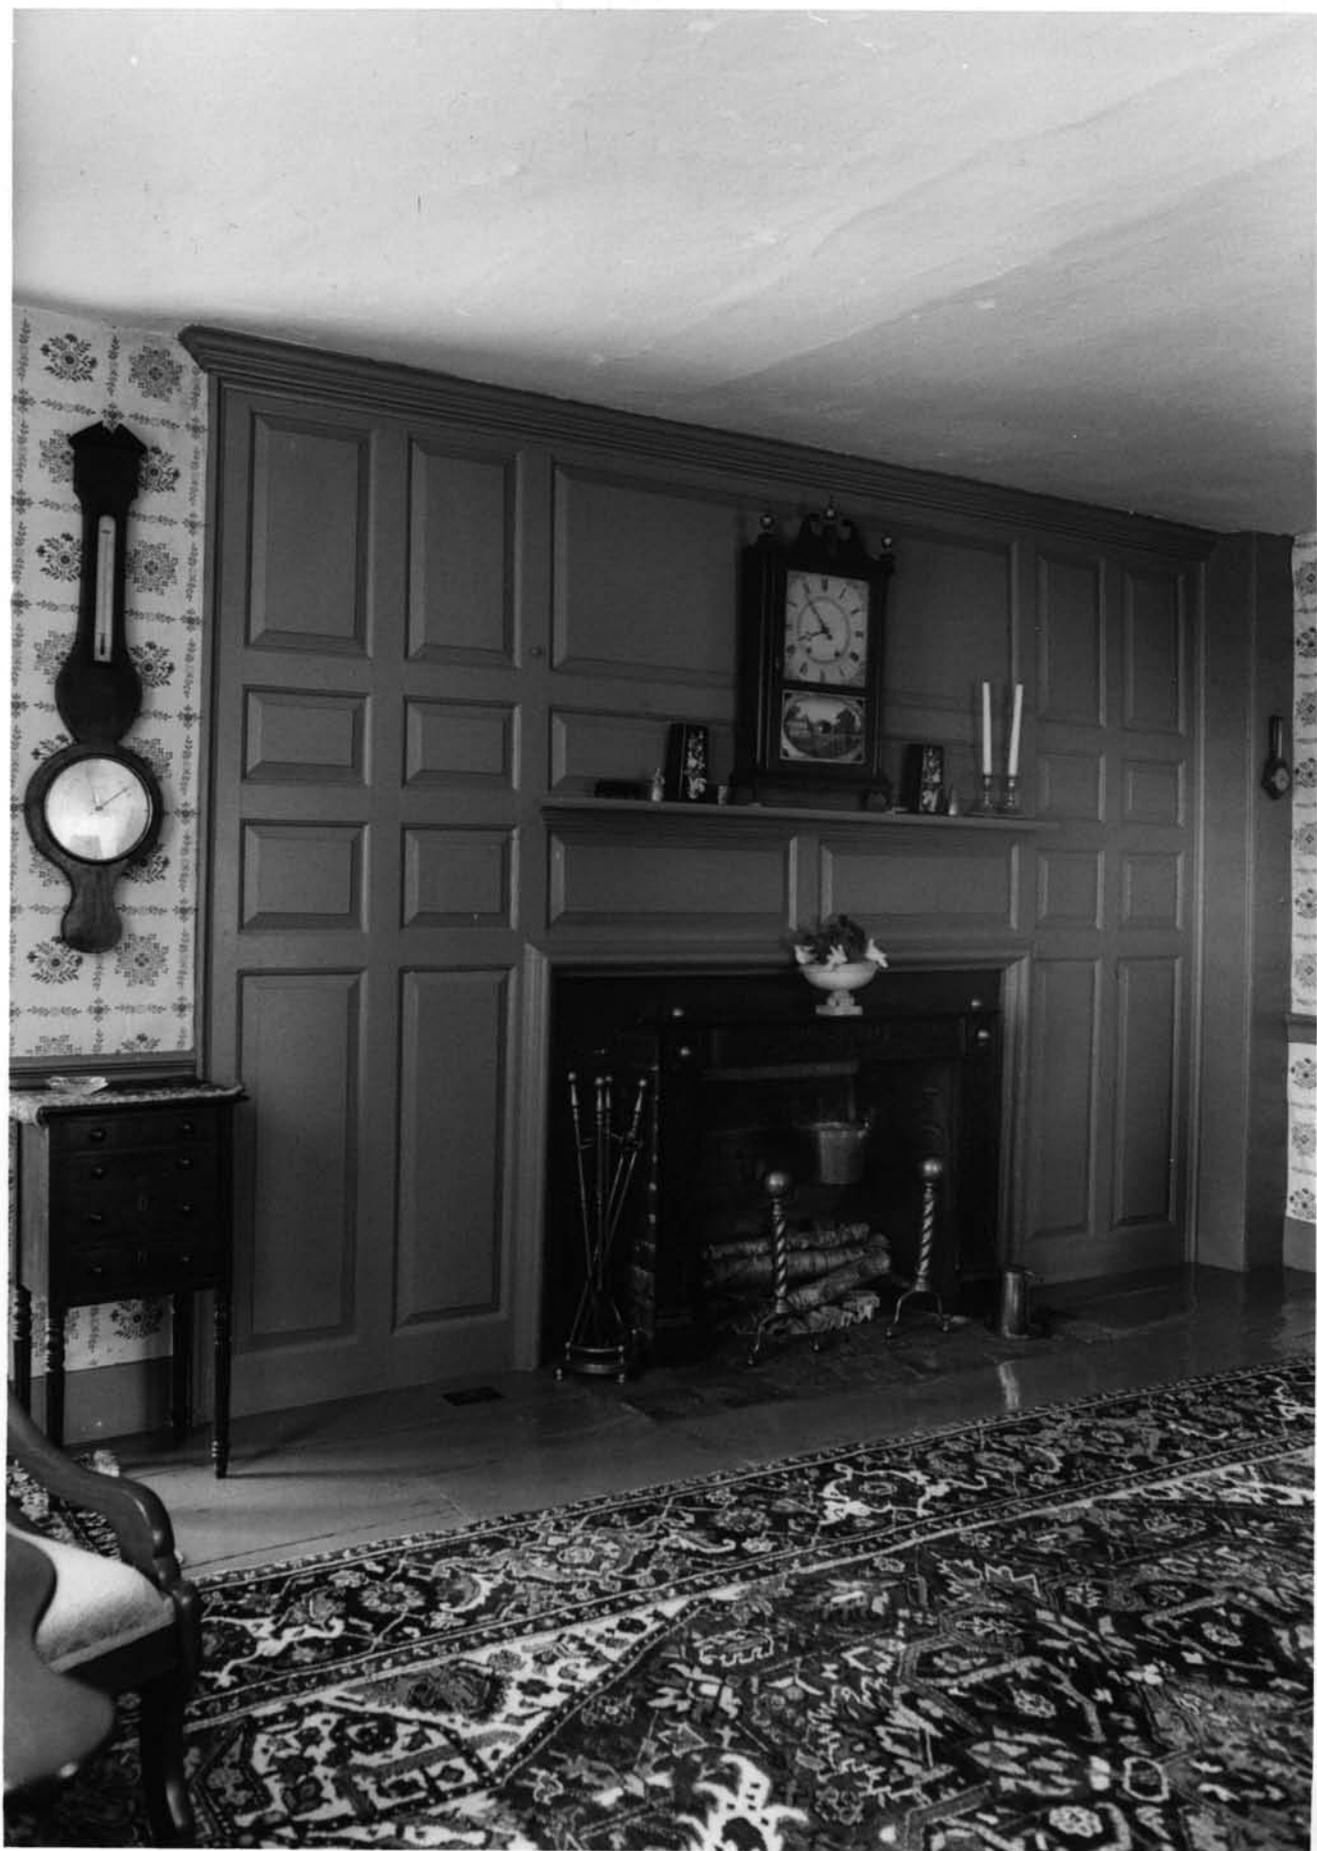
PHOTO NO.

Fireplace wall, Main Parlor

On the opposite side of the chimney from the keeping room is located the main parlor, distinguished by an elaborately panelled chimney wall. A 30"x 40" stone fireplace has been filled in by an early nineteenth century Franklin stove. The hearth is constructed of 7" square bricks, thought to have been imported as ballast due to their unusual shape. The fireplace opening is delineated by a bolection molding. An elaborate raised panel wall extends from floor to ceiling and 32" to the left and right of the bolection molding, thus abutting the northwest corner post in the room. Centered in the north wall of the room, a built-in-cupboard is flanked by two four-panel doors leading into the rear chambers. The upper half of the cupboard has a twelve-pane glazed door attached by original "HL" hinges. Below, there is a door of two vertical, raised panels. As throughout the house, the three parlor doors are raised four-panel units; wooden latches and latch strings have been restored in all rooms. The windows have been changed, but modern twelve-over-twelve sash has been installed by the present owner.

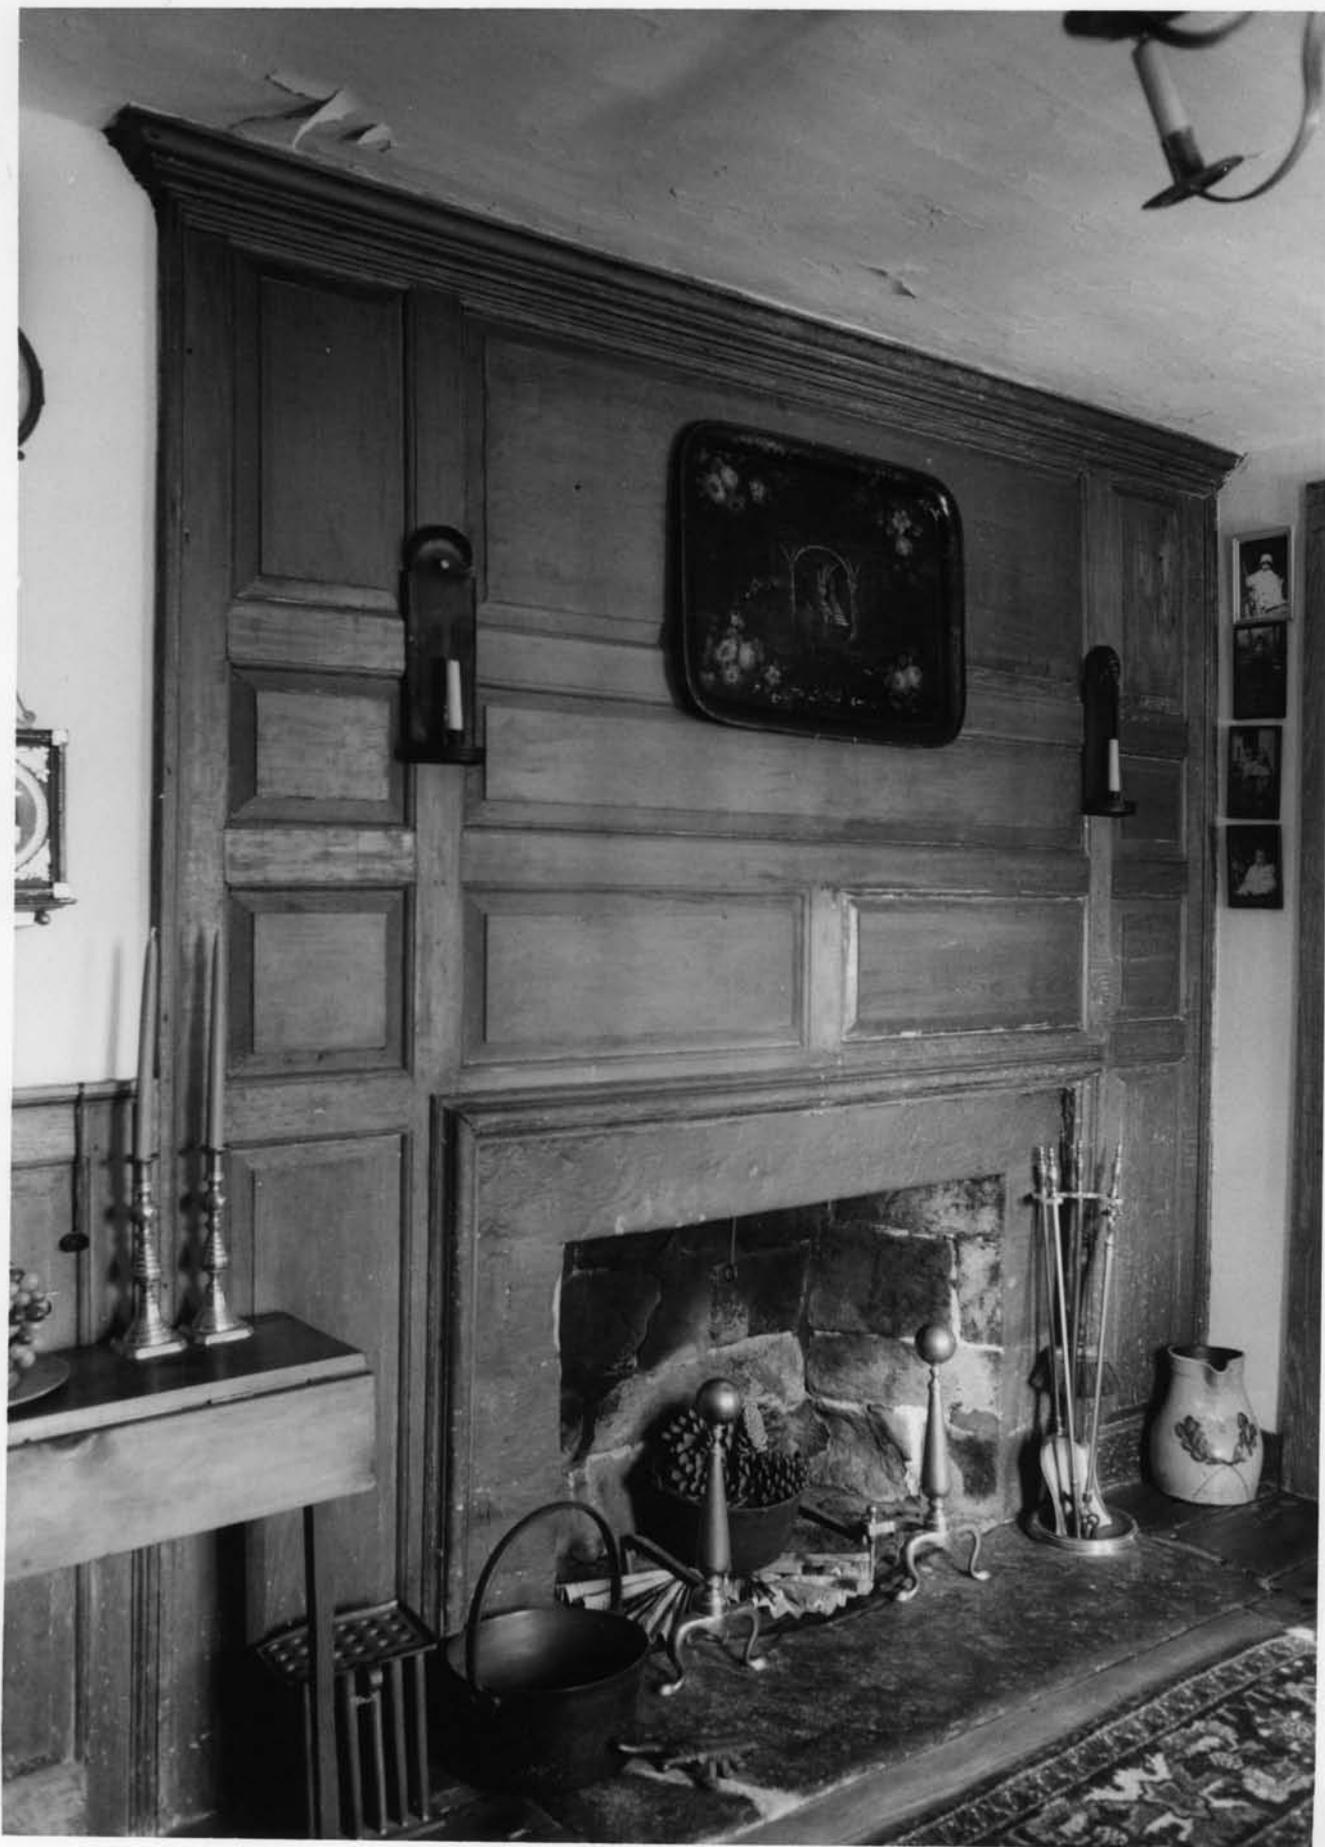
4

Fireplace, north bedroom, first floor

Two small rooms, presumably bed chambers, complete the ground floor of the original two-and-a-half story gable area of the house. The room in the northeast corner is the smaller and has been altered in character by the replacement of the room's east window by a major entrance door. The second bedroom, directly north of the chimney, is longer and is connected to the keeping room. On the exterior, the additional length of this room was accommodated by a leanto from the keeping room and attached to the original two-and-a-half story section. This northwest chamber is decorated by a chimney breast similar to that in the parlor but smaller in scale. A bolection molding around the fireplace and paneled wall is completed by a cornice of complex silhouette. All paint has been removed from this woodwork. A single raised panel of chair rail height to the left of the chimney breast paneling is unique to this room. The flooring here is of pine.

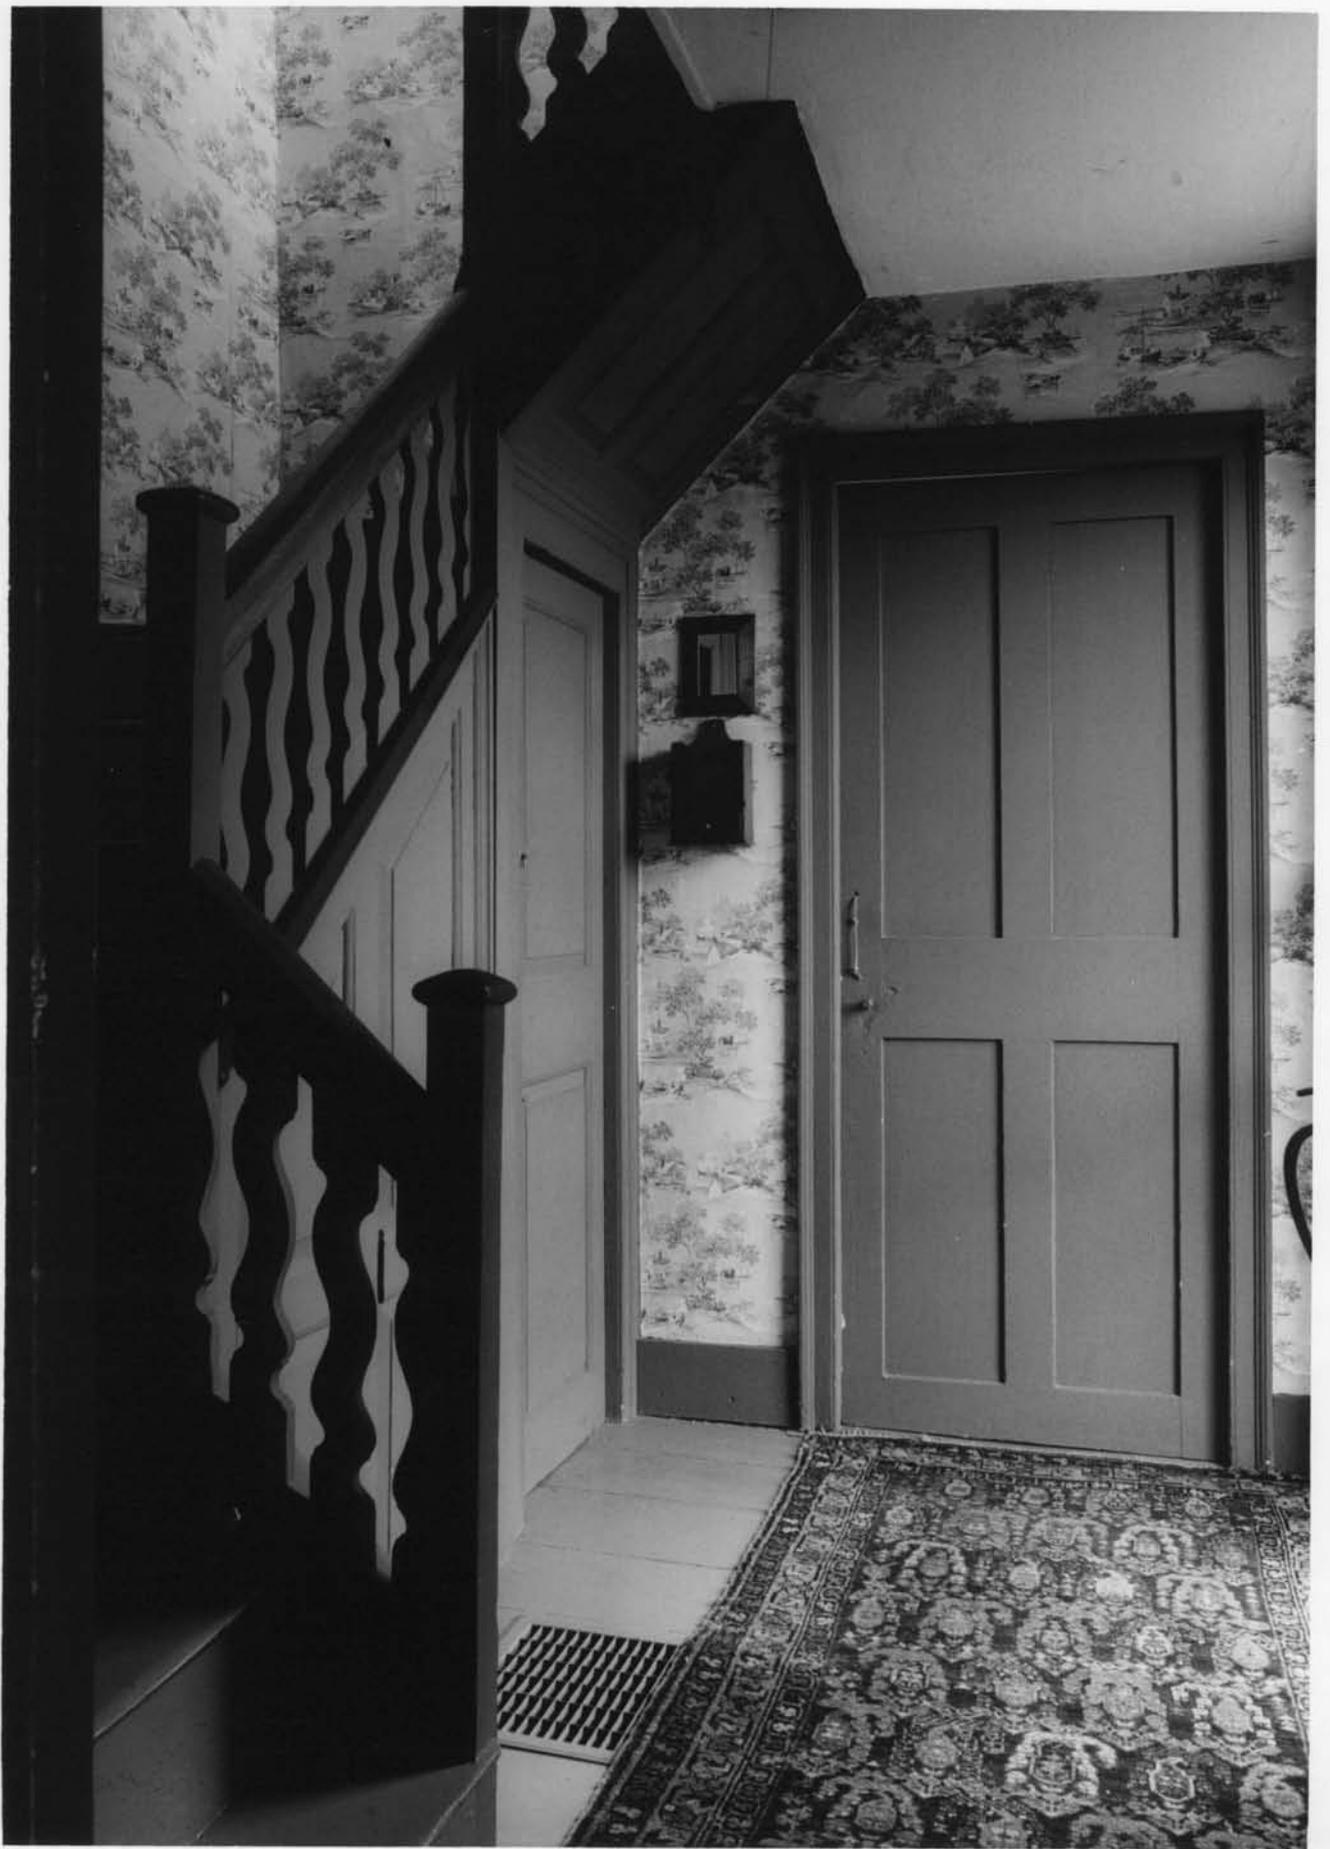
5

Entry stairwell

The entrance door, slightly off center on the south facade, is a framed four-panel door with a horizontal group of three transom lights at the top. Within, the entry includes a stairway which rises against the chimney in three runs. It has square posts and flat balusters sawn out in a modified "S" pattern. From the second to the third (garret) level, the balusters are straight. The string of the stairs is enclosed by fine raised paneling on the first level and simple vertical

sheathing above. A raised one-over-one panel door conceals the basement stairs immediately below. Peg molding and corner posts with a boldly beaded edge are also seen in the entry stairhall.

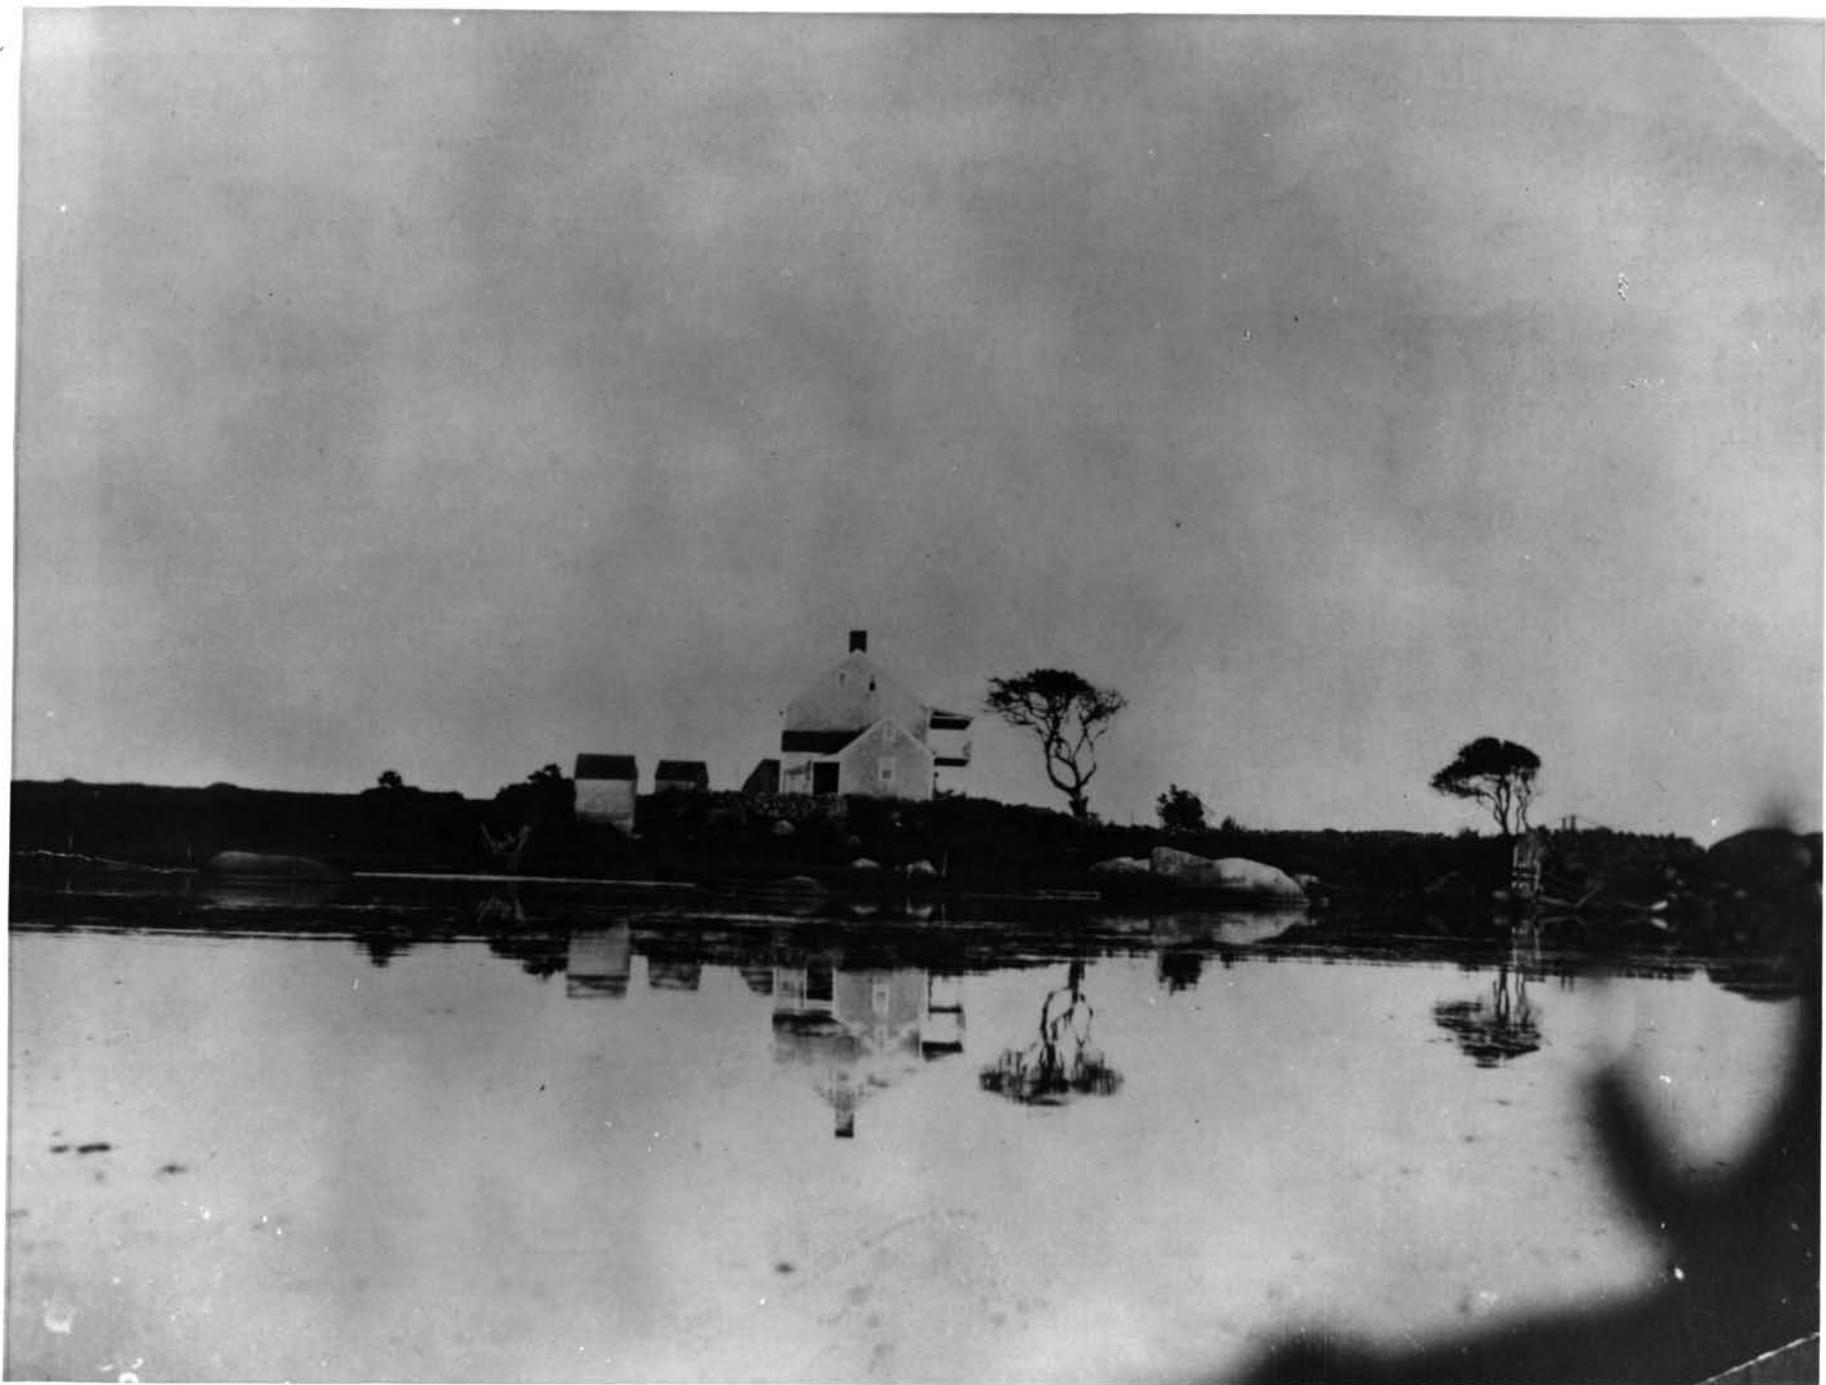
PHOTO NO 2

View of house from across Quonochontaug Pond, late nineteenth century

A nineteenth century photograph of the house shows an open leanto porch on the north side of the west ell and a two-story open porch across the front (south) of the house. In the early twentieth century the leanto was converted into a kitchen and the double level porch was removed. Subsequently, a glassed-in porch on the west end of the keeping room, and a utility room
