**National Register of Historic Places
Inventory—Nomination Form**

historic St. Joseph's Church Complex

street & number 1303-1317 Mendon Road

ST. JOSEPH'S CHURCH COMPLEX
Cumberland, Rhode Island

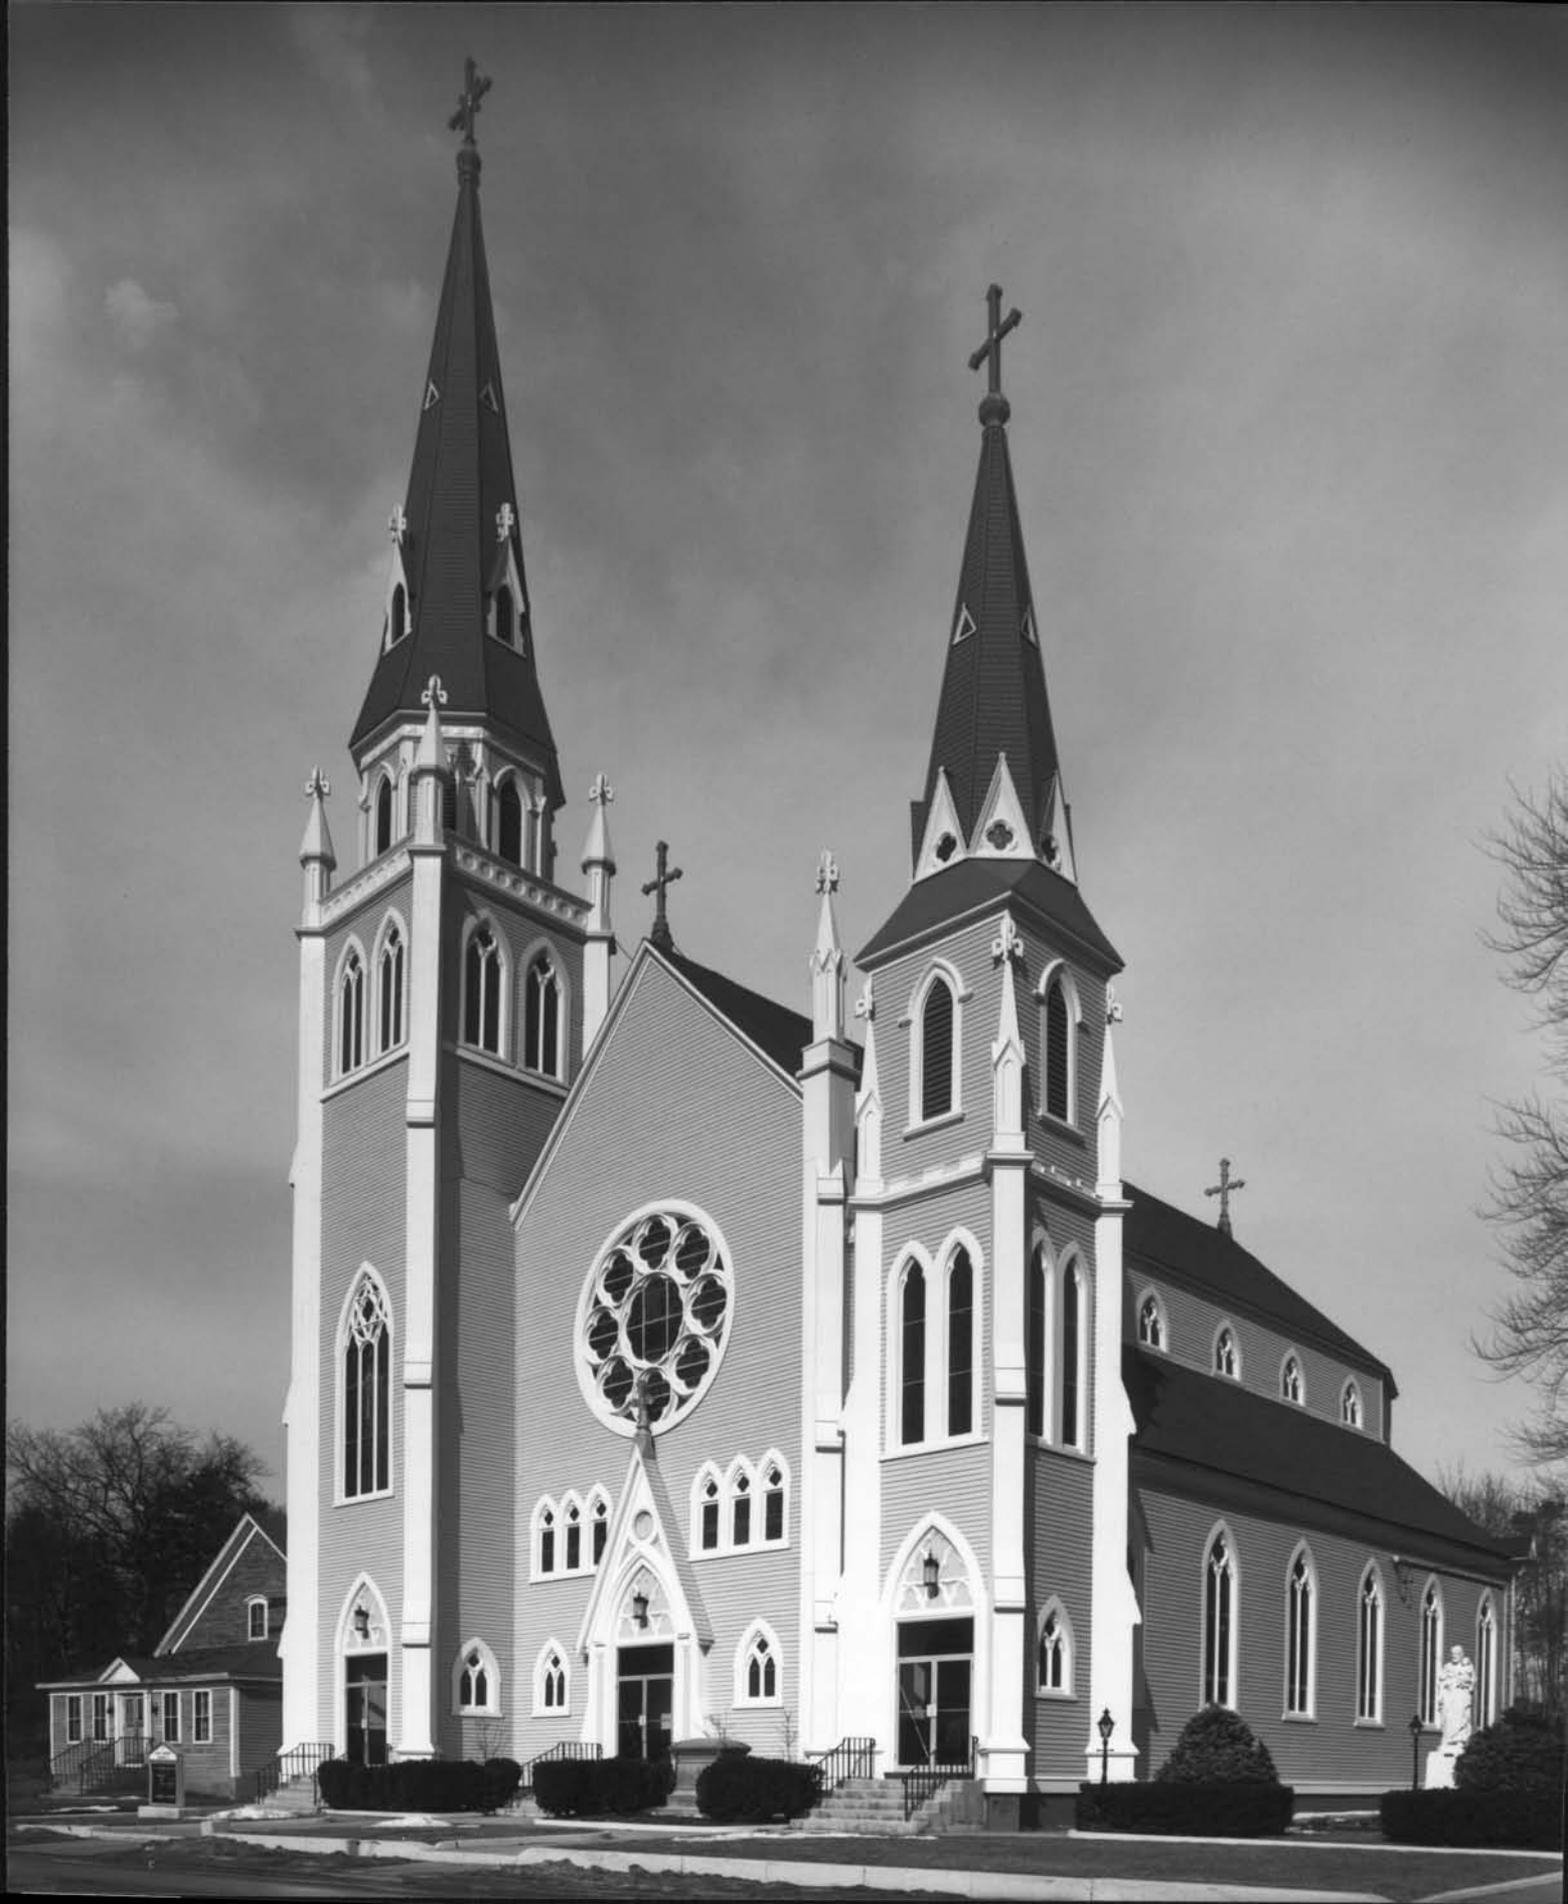
Photo #1.

Exterior view of church from the south, with parish
hall visible to the left.

The church, facing southwest, is a tall, end-gable-roof rectangular mass with a polygonal, hip-roof apse at the northeast end and one-story, shed-roof side aisles which continue around the apse as an ambulatory to connect with a projecting, rectangular chapel. Towers of unequal height are set at each corner of the facade. The shorter one, to the south, is three stories tall, with paired lancet windows at second-story level, a battlemented stringcourse between the second and third story, and louver-filled gothic arches with drip molds at third-story level. This tower is topped by a broach spire with steeply pitched gabled dormers around the base containing quatrefoil windows. The taller tower, to the north, is four stories tall and is surmounted by an octagonal belfry and spire. It has large traceried gothic windows at fourth-story level, a paneled parapet around the top of the square-plan base, louver-filled gothic arches with drip molds in the belfry, and steeply pitched gabled dormers in the spire containing gothic windows. Both towers have front entrances at the base with modern aluminum-frame plate-glass doors and transoms set within a larger gothic-arch frame with blind tracery filling the pointed upper section. The towers also have corner buttresses topped by pinnacles with overscaled fleur-de-lys finials. The shorter tower is set off slightly from the nave so that one corner of the nave also has this buttress-and-pinnacle detailing. The nave facade between the towers contains a central entrance identical to those in the towers, set in a slight projection with a steep gable roof. This

entrance gable is flanked on both sides by triads of small gothic windows and is surmounted by a large rose window. There are gothic windows to the sides and rear lighting the aisles and clerestory.

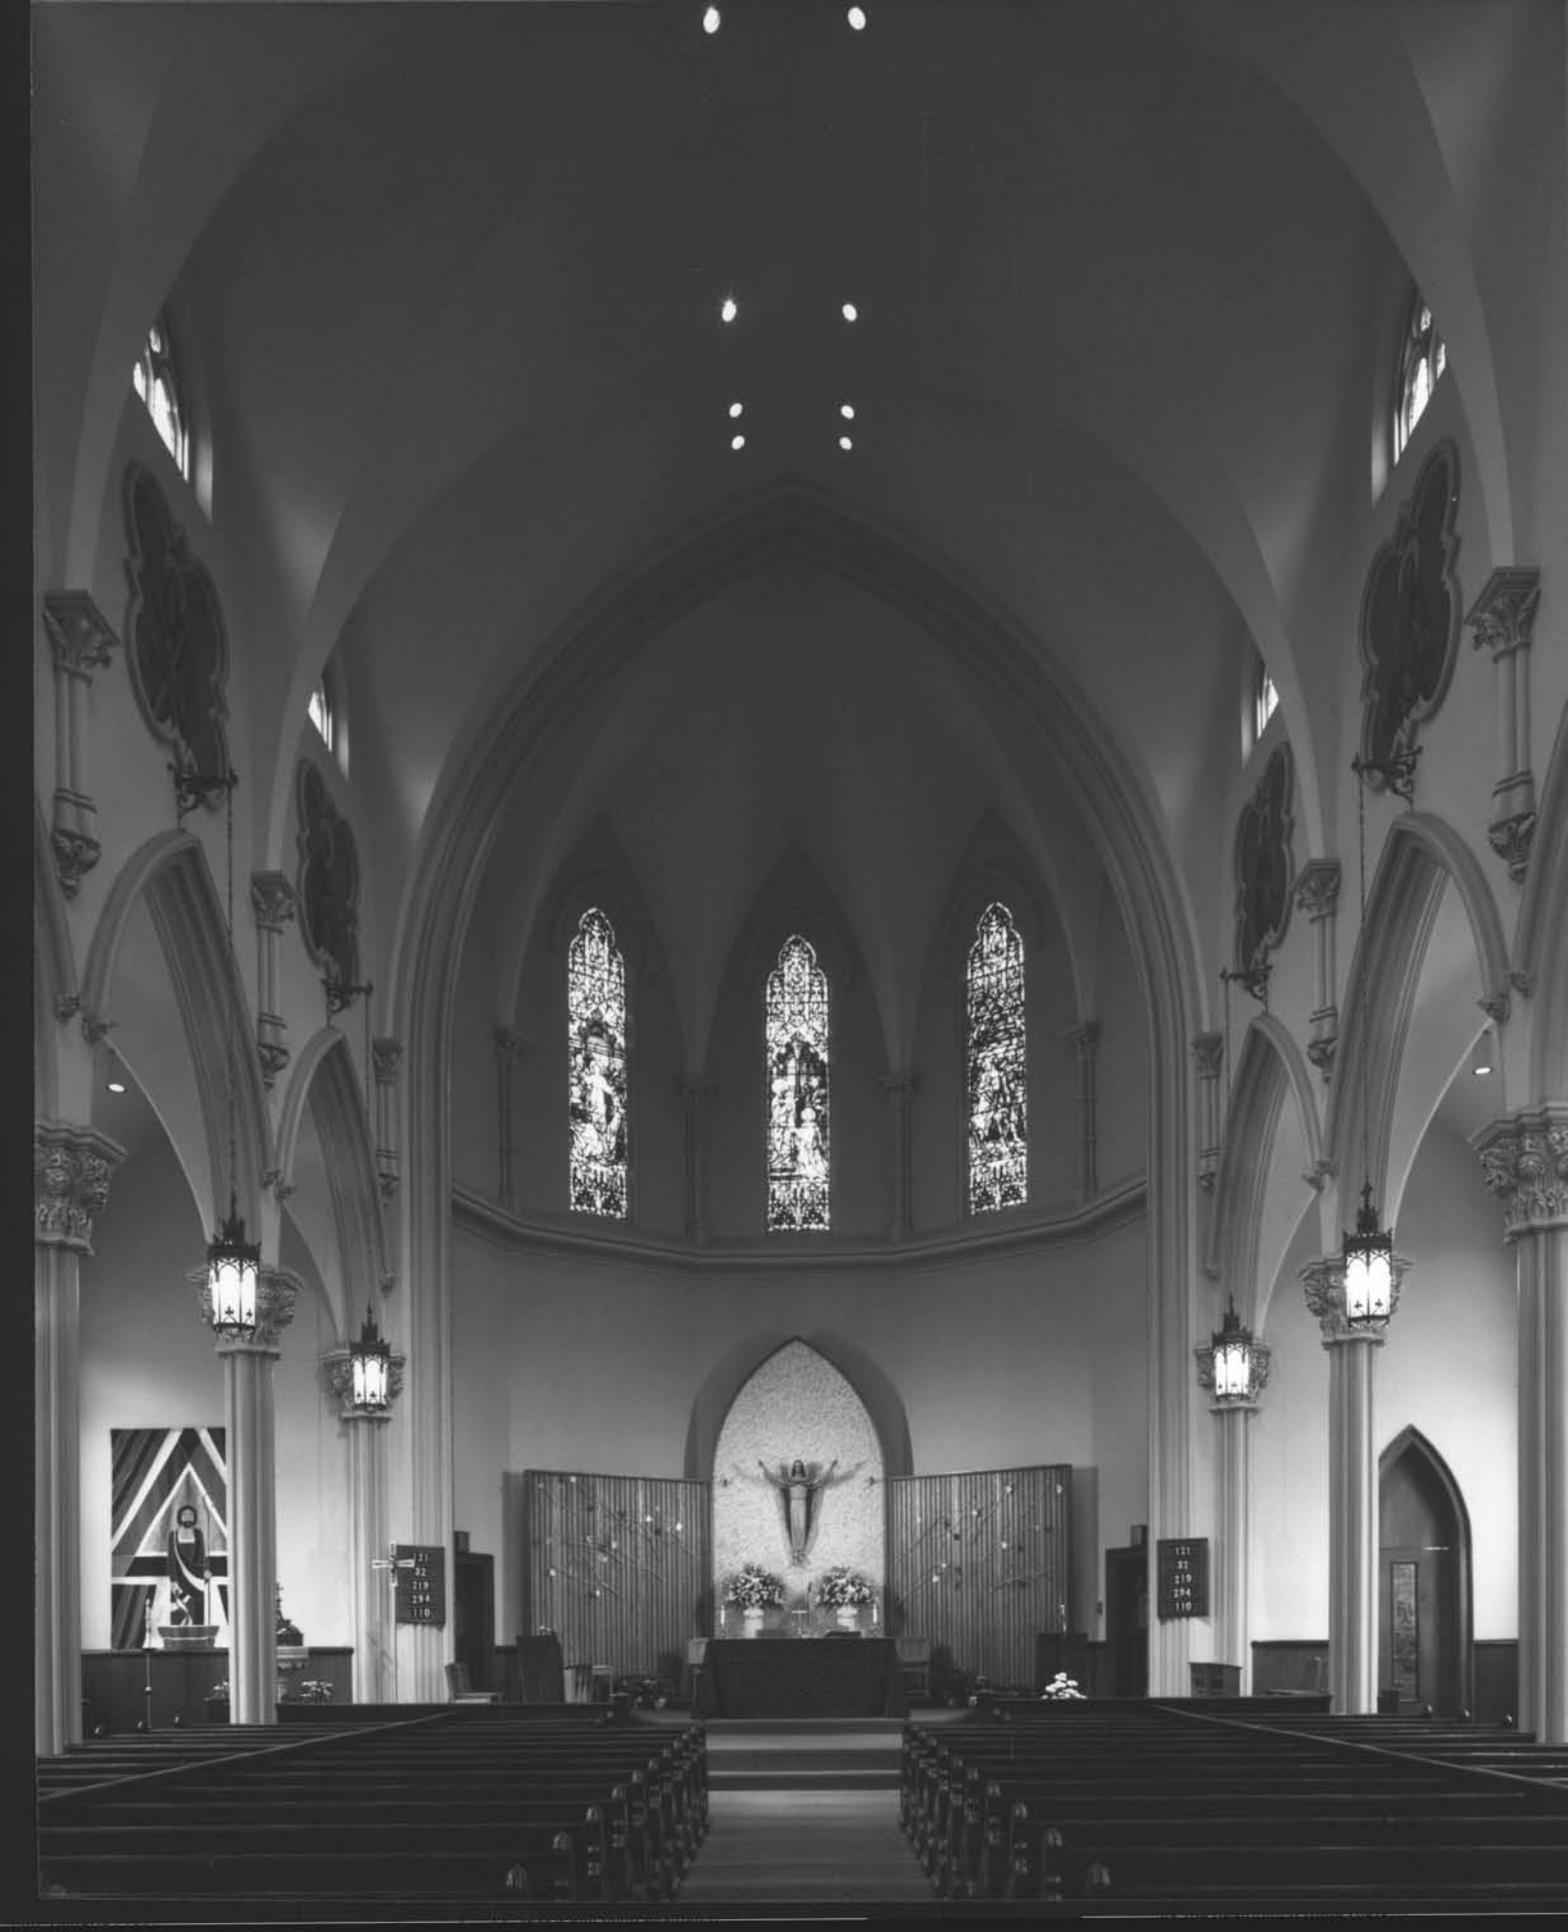
Photo #2.

Axial view of church nave, facing chancel.

The church interior is basilican in plan. A narrow vestibule across the front extends into the bases of the towers and contains an enclosed staircase in the north tower leading up to the organ loft. Six pairs of clustered columns with elaborately carved capitals support gothic arcades separating the clerestoried nave from the side aisles. The nave has sexpartite vaulting carried by clustered colonettes on corbels in the spandrels of the arcade, while the aisles have quadripartite vaulting springing from the arcade columns and corbels on the outer walls. An organ loft with a paneled gothic-arch-motif railing runs across the southwest (front) end of the nave and aisles, with small confessionals under each end. A polygonal chancel opens off the opposite end of the nave through a gothic arch, and has a heavily molded stringcourse supporting banded, clustered colonettes from which the chancel vaulting springs. There are three clerestory windows in the chancel, taller than those in the nave.

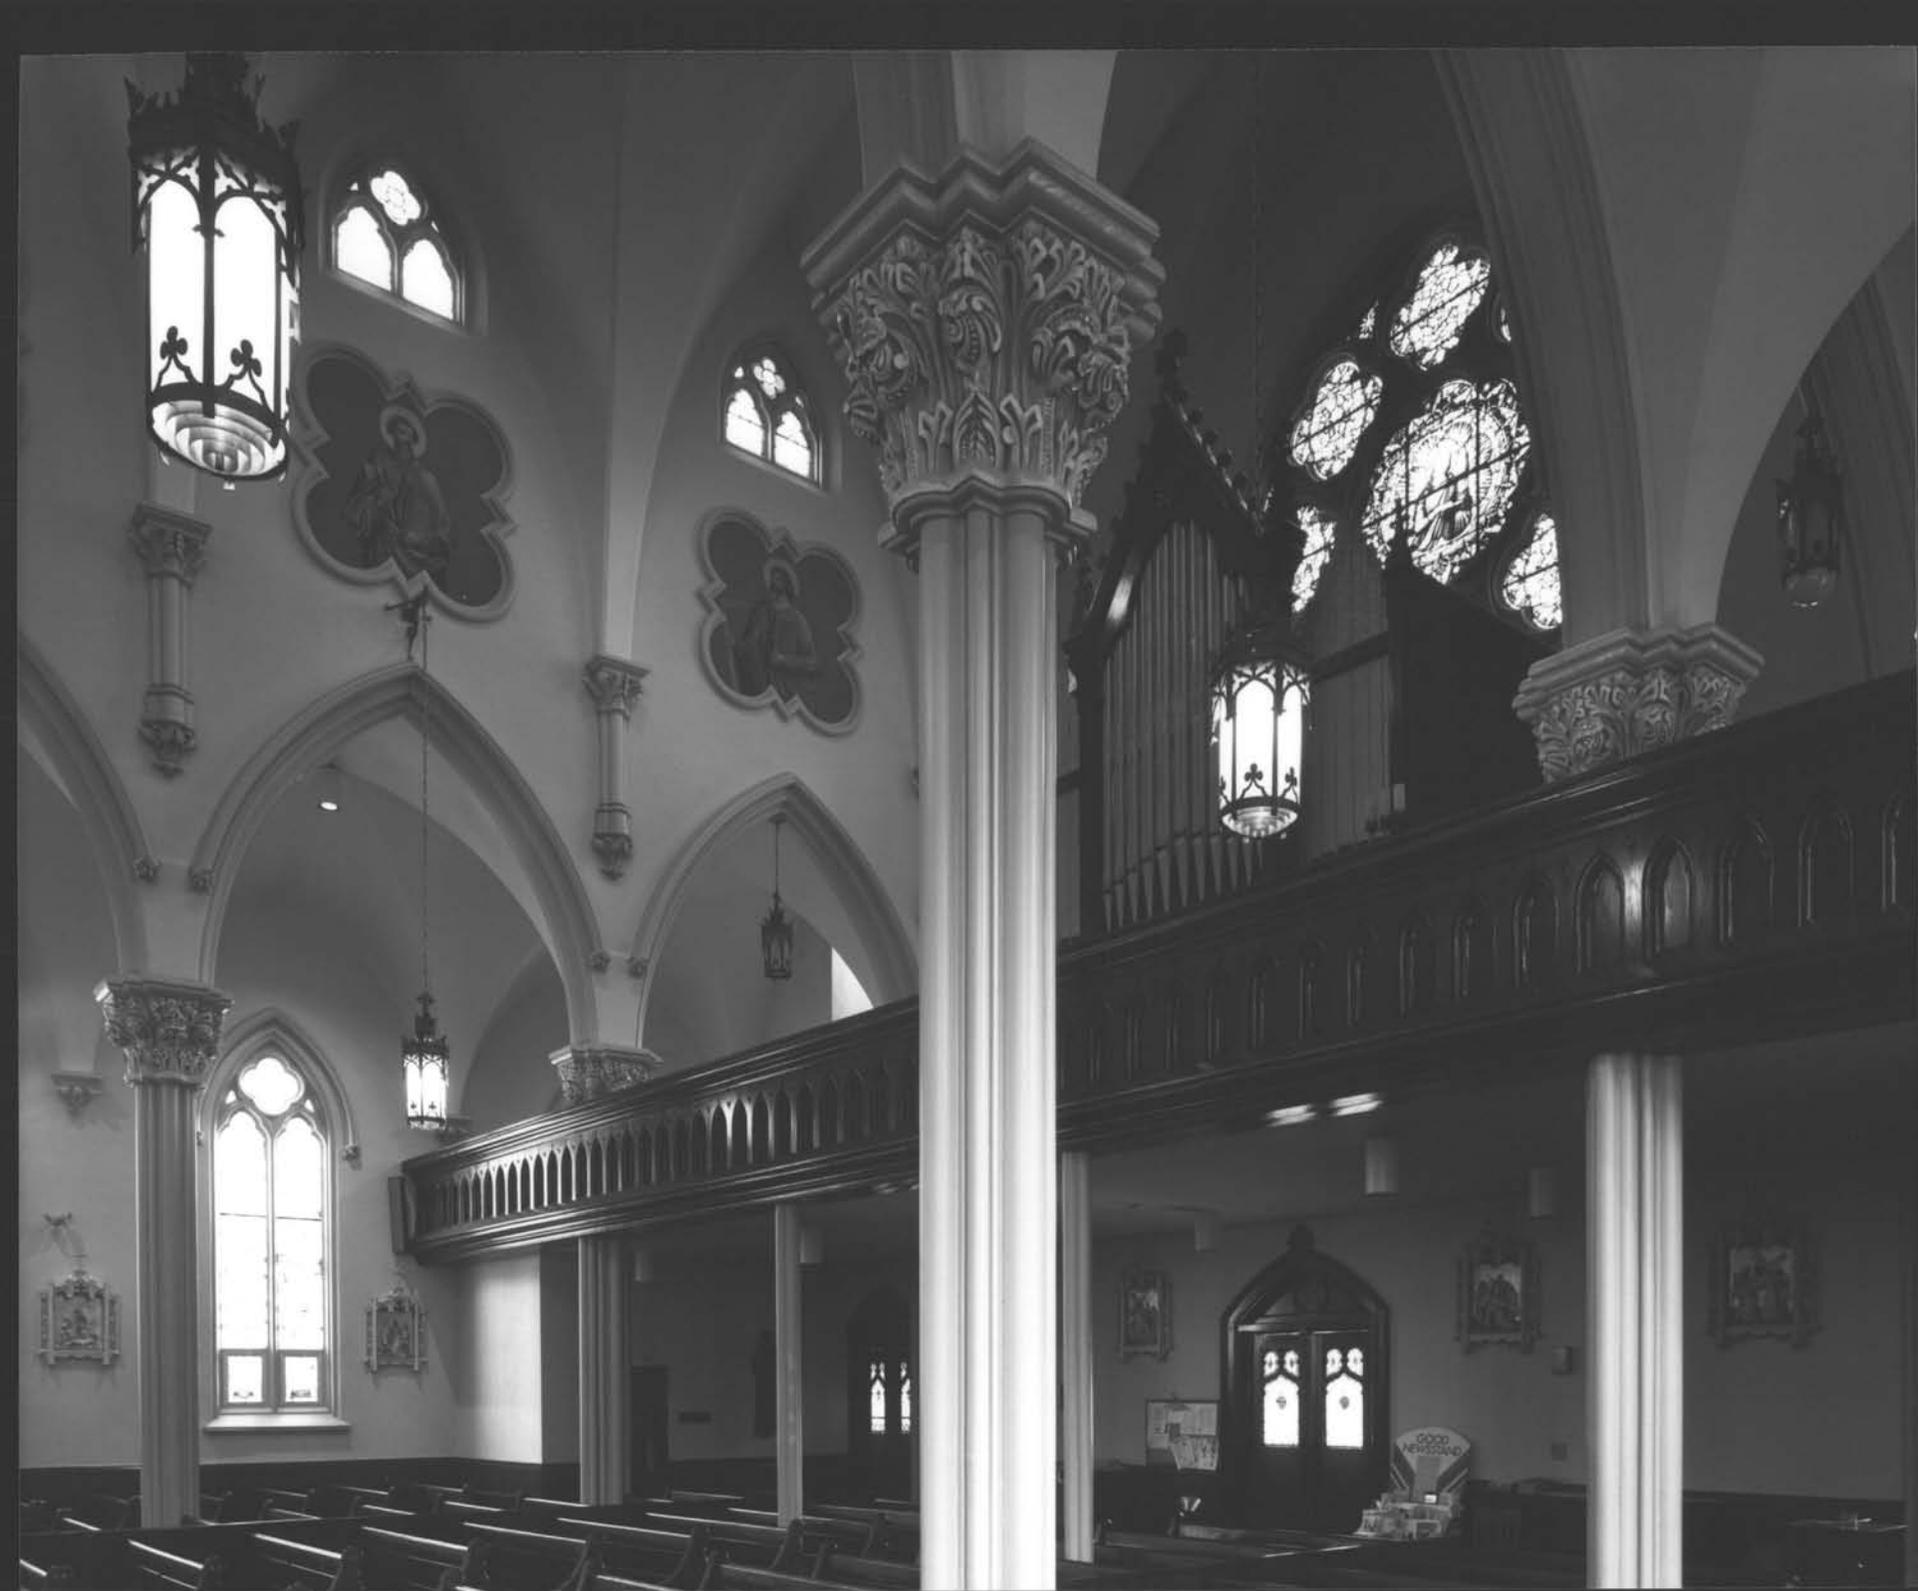
Photo #3.

Oblique view of church interior facing south from
north aisle, showing nave, choir loft, and south
aisle.

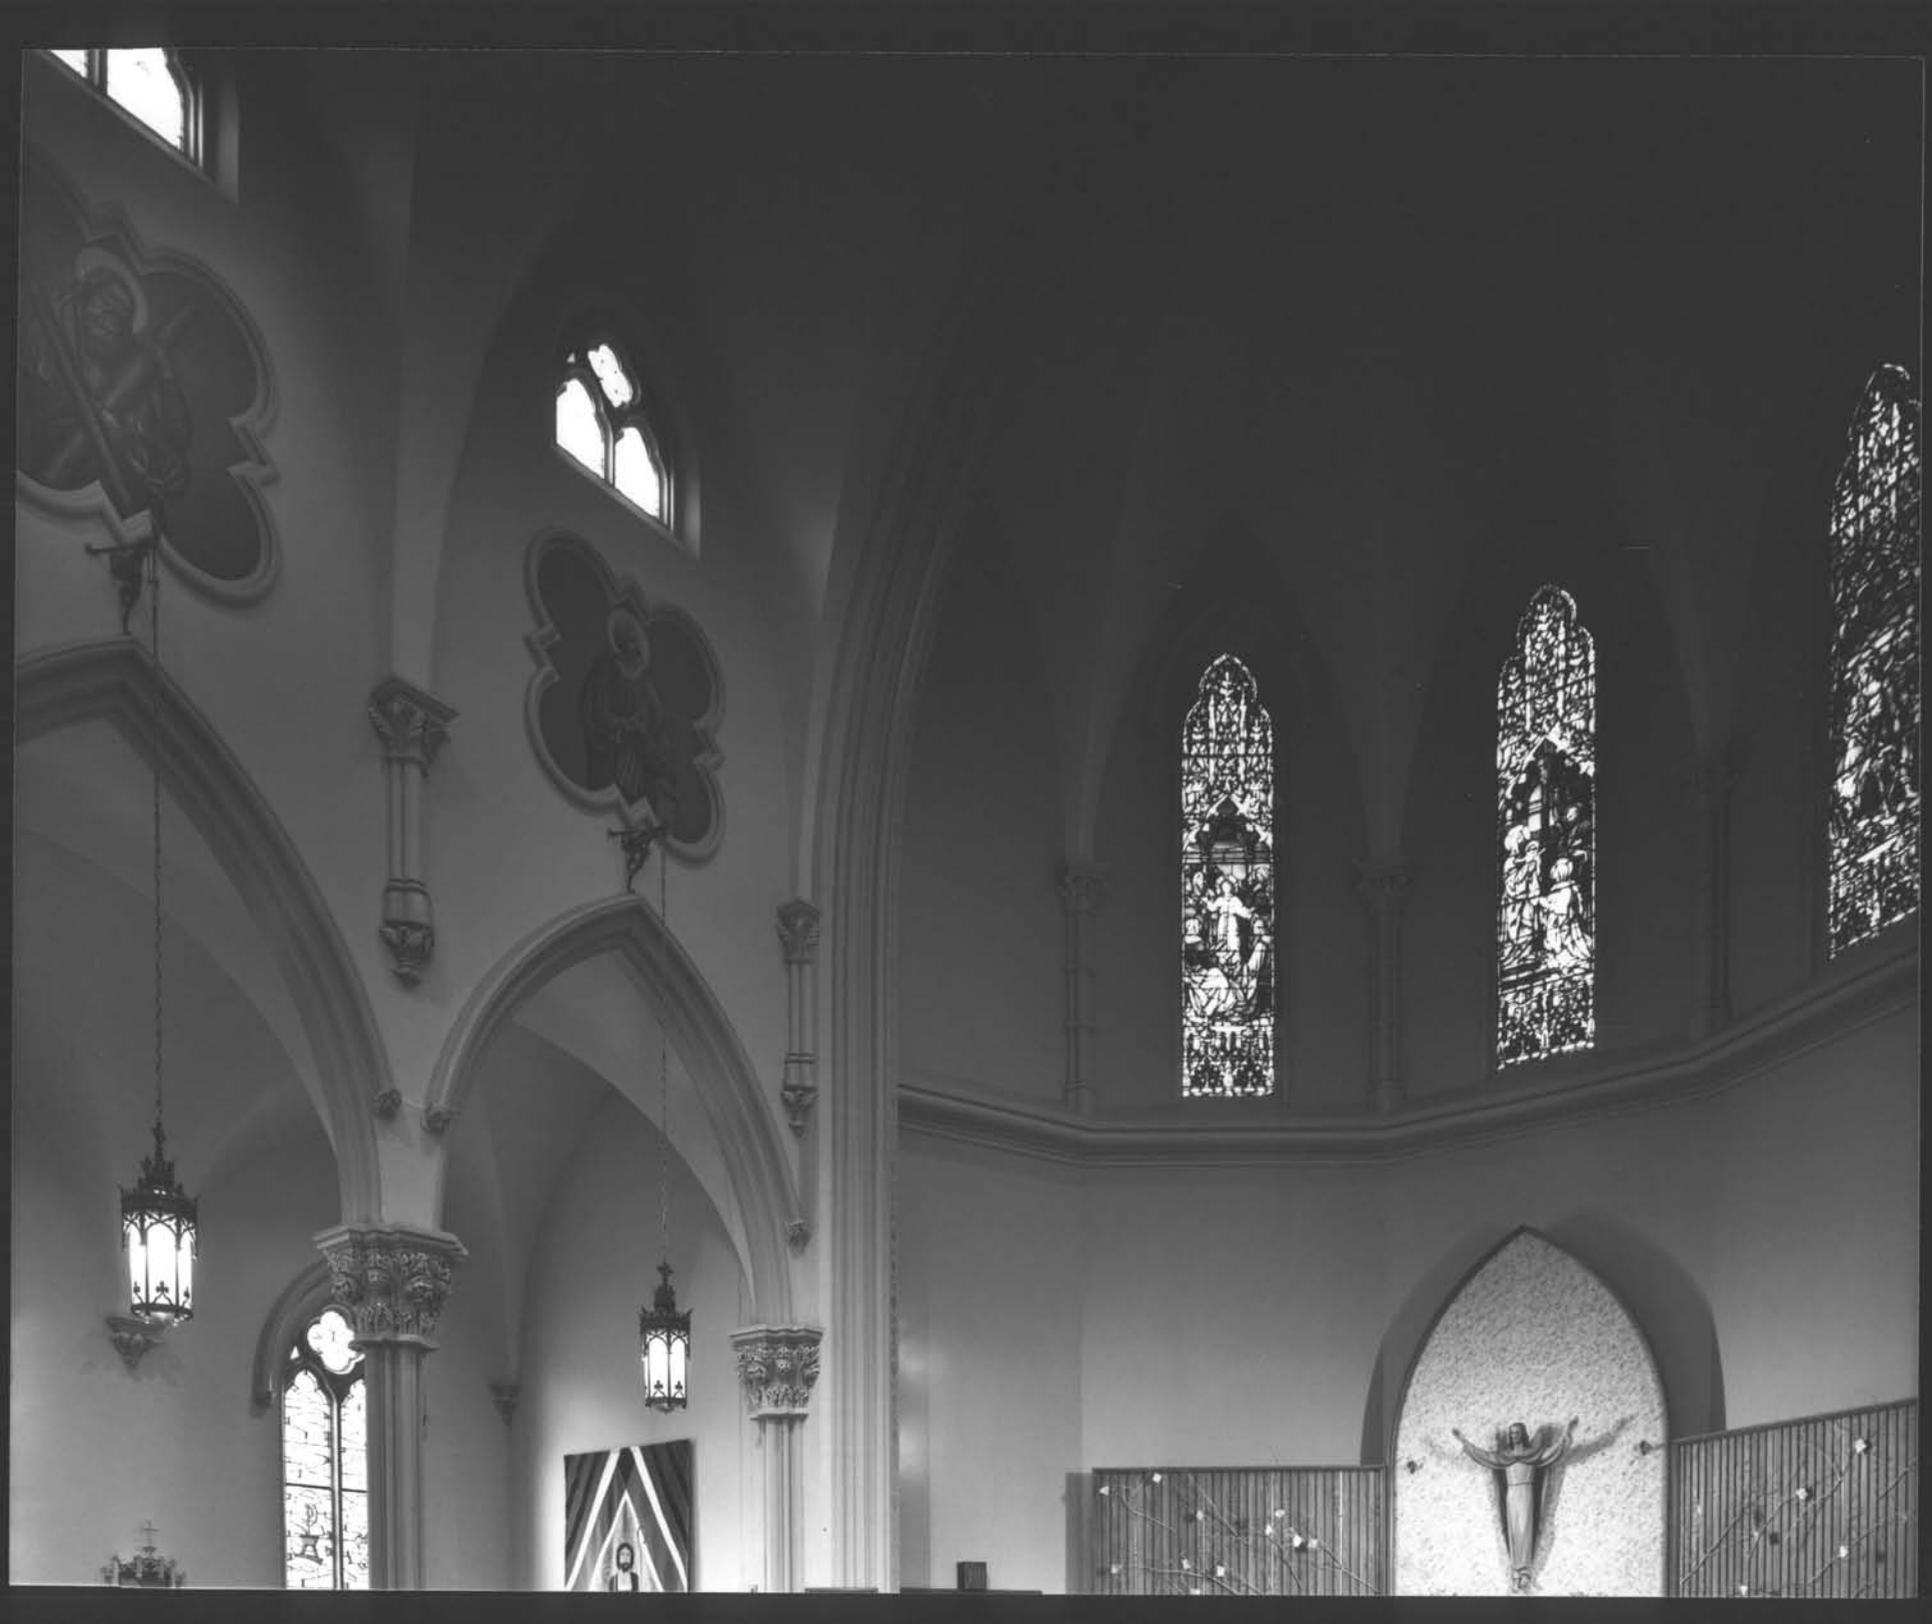
Photo #4.

Detail view of nave and chancel clerestory,
facing north.

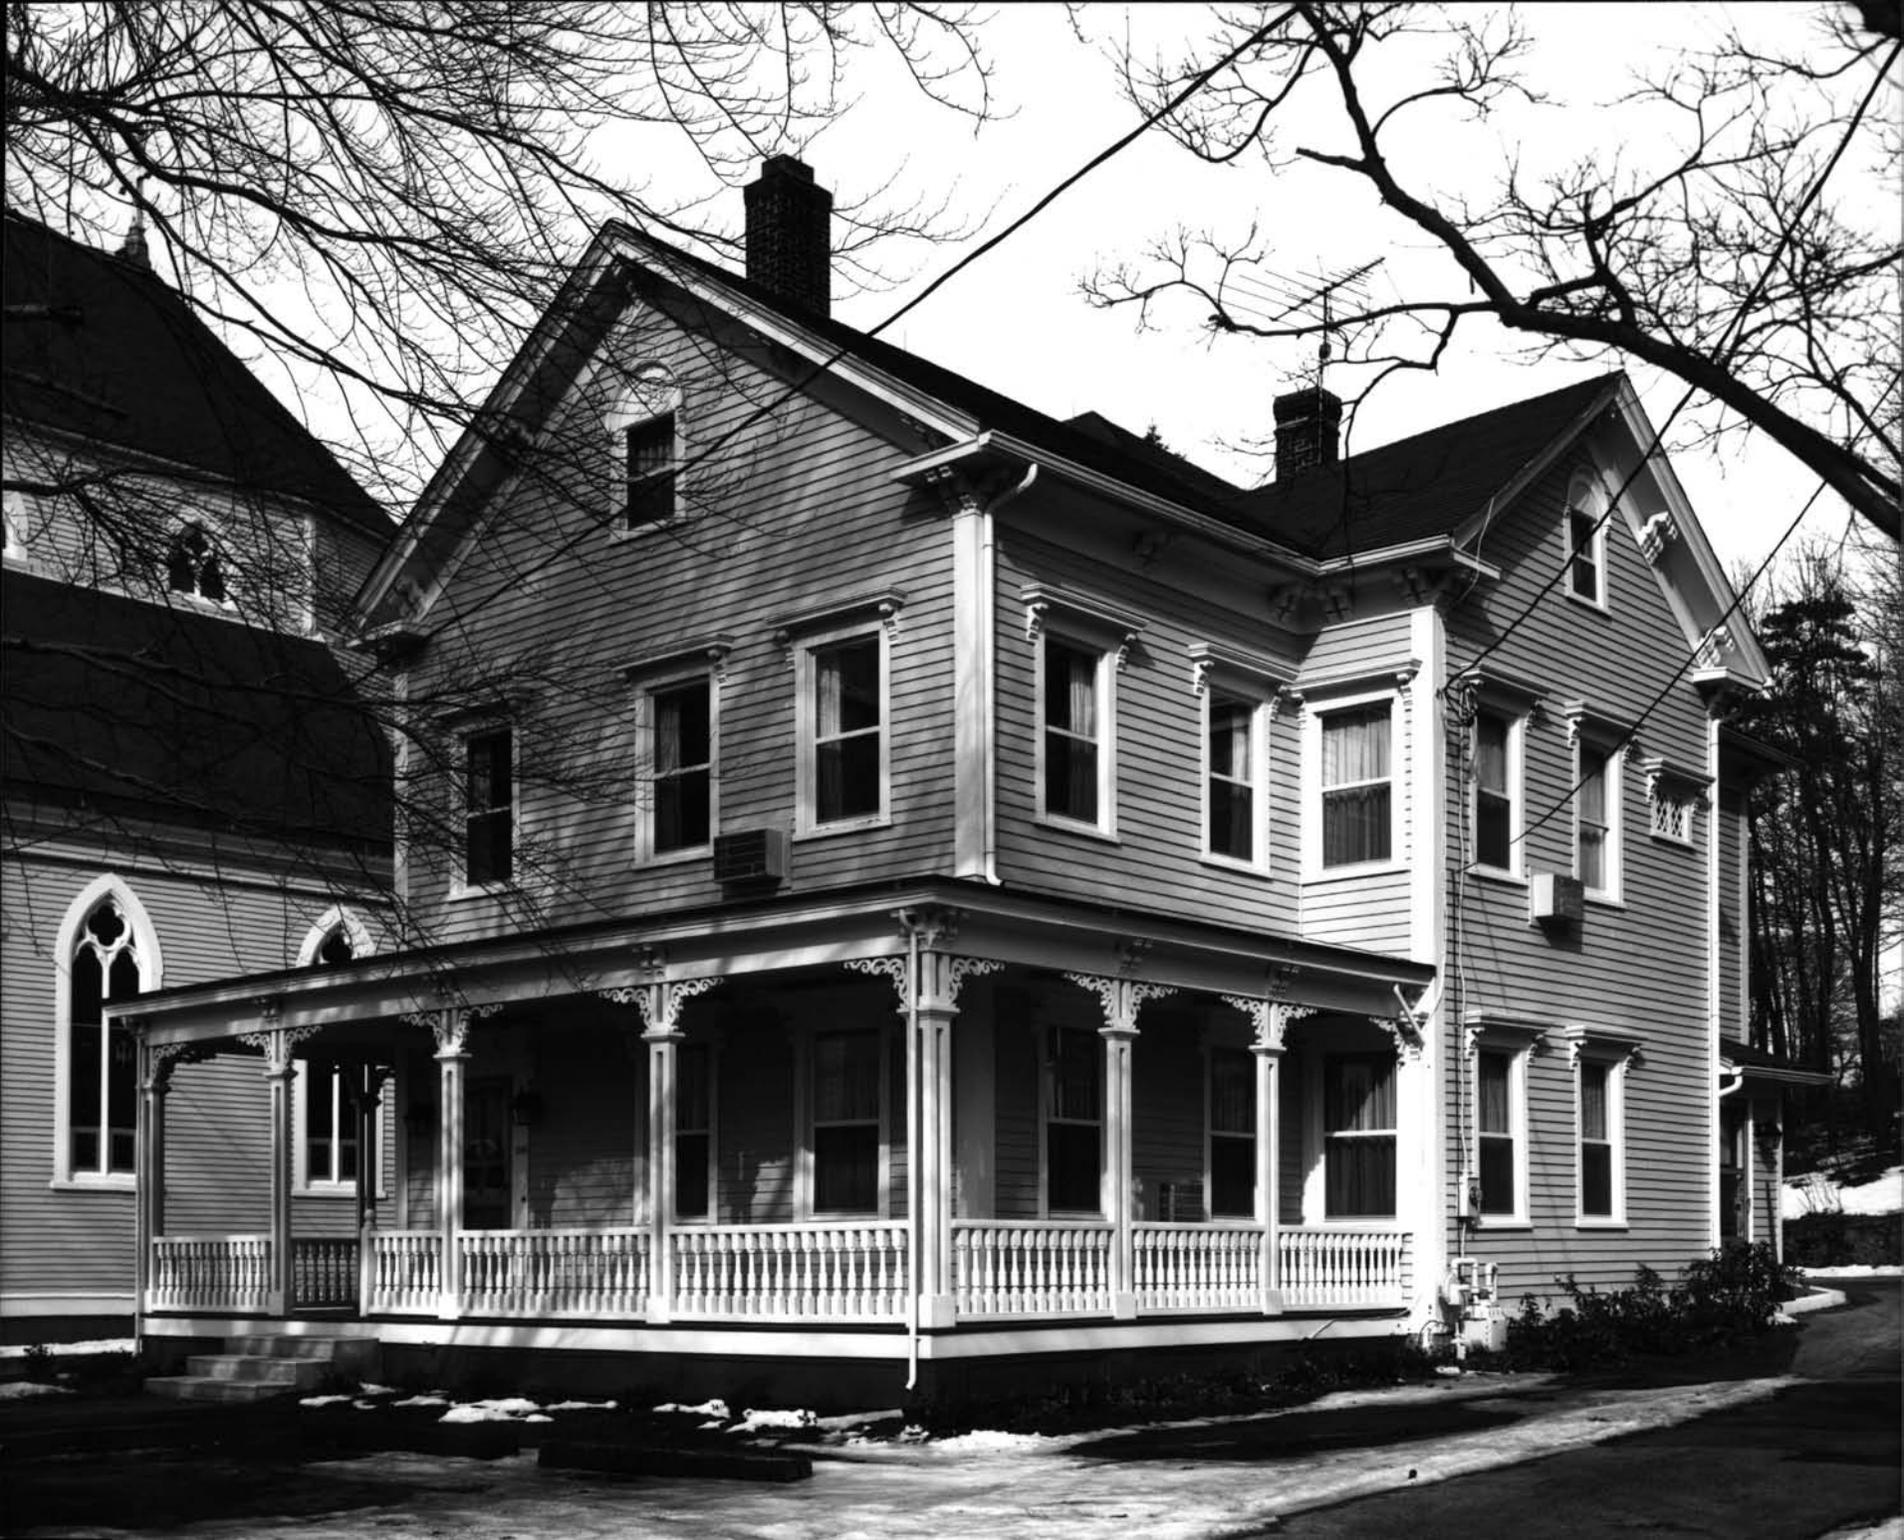
Photo #5.

Exterior view of Rectory facing north.

From the exterior, St. Joseph's Rectory is a well preserved example of Bracketed style domestic architecture. It is built on a modified cruciform plan, with the corner between the rear (northeast) and southeast

wings partly filled by a one-story vestibule and the corner between the rear and northwest wings completely filled by a two-story bay. The northwest wing is a full three stories tall and its gable roof forms a hip where it intersects the cross-gable roof covering the rest of the two-and-one-half-story house mass. A small one-story, gable-roof ell with a truncated end and a recessed entrance porch runs off the northwesterly corner of the house. Added in 1981, it has been carefully designed to be compatible with the original structure. The most conspicuous exterior feature of the rectory is a handsome veranda running around the three sides of the front (southwest) wing. It has flat, pilaster-like posts with voids cut out of their centers; a balustrade with turned balusters; elaborate scrollwork jigsaw braces connecting the veranda posts to the fascia above, and paired cornice brackets over the posts. The veranda shelters a side-hall entrance in the front wing. This entrance and all of the windows are surmounted by shelf-like molded hoods carried on small brackets. Other exterior embellishments include corner boards, wide overhanging eaves and gable returns ornamented with paired brackets, and arched windows in the gable ends with their semicircular upper sections now filled with solid panels. Cornice brackets have been applied to the modern northwesterly ell to help relate it to the original structure.

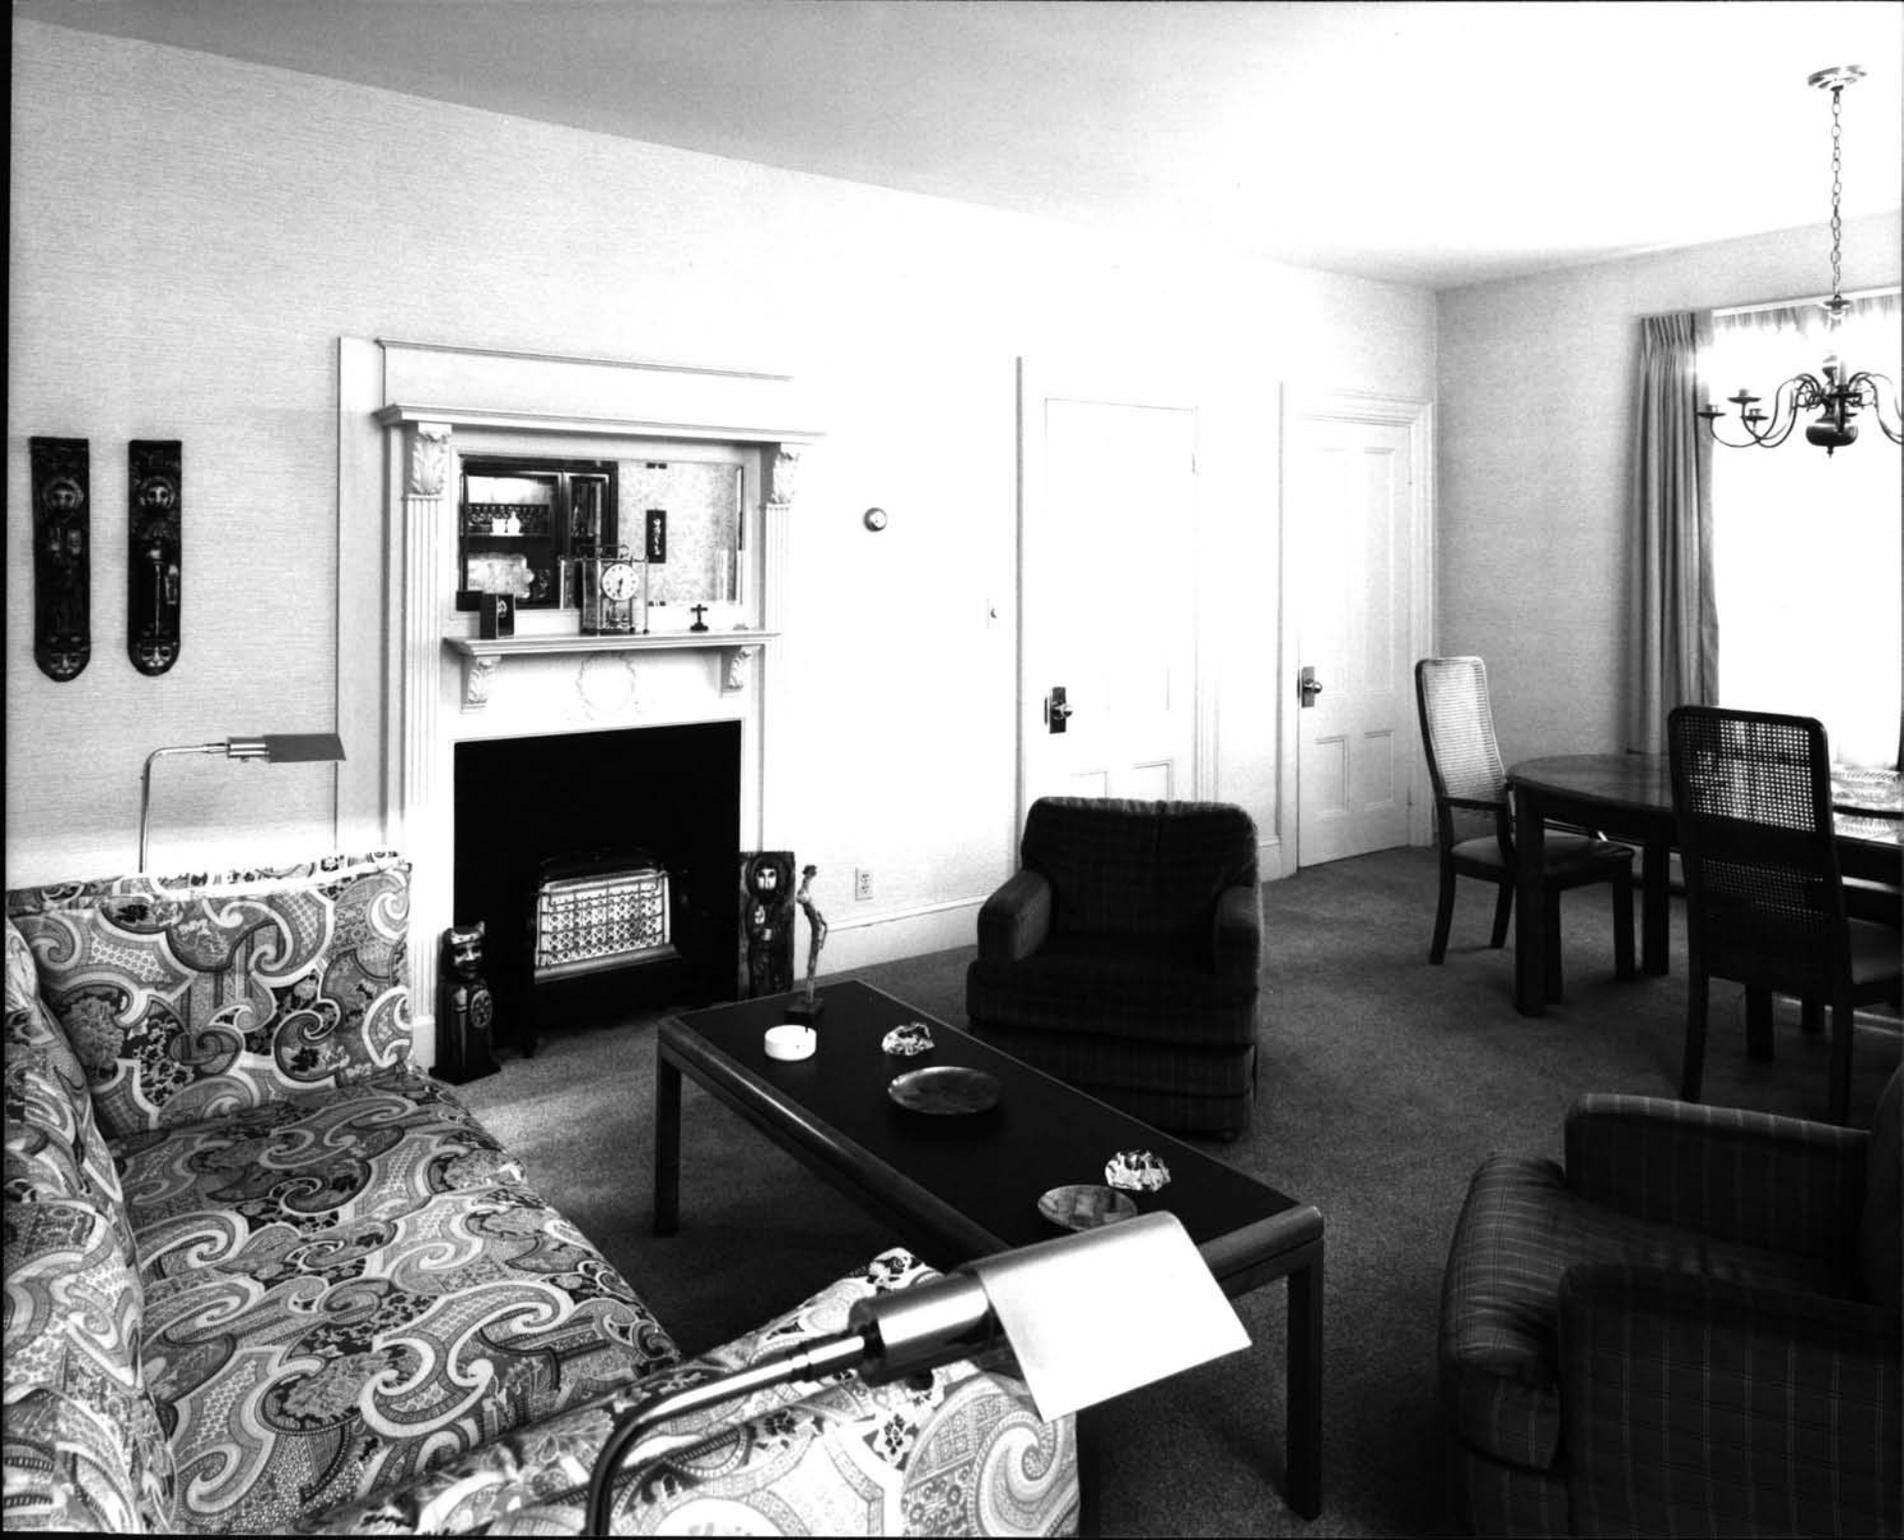
Photo #6.

View of living-dining room in the Rectory.

The interior of the rectory has been remodeled and redecorated during the past year (1981). On the first floor, the side-hall entrance and stair hall is flanked by a small front parlor or reception room, now used as a conference room, and a larger back parlor, now used as a combination living and dining room. The entrance-stair hall runs back to a kitchen at the rear. The original large kitchen, with space for both meal preparation and dining, was subdivided during the renovations into a galley kitchen and a separate informal dining area. There is a small office in the space behind the staircase and a laundry room behind the office, the latter opening off the kitchen dining area. The office and laundry room both open into the new ell, which contains offices and meeting rooms for parish functions. The second floor of the rectory contains a bedroom-sitting room-study alcove-bathroom suite for the pastor, a bedroom and bathroom for the part-time assistant priest, and a guest room with a private bathroom. Wall and floor coverings, hardware, and cabinetry throughout the rectory are all modern, but the staircase balustrade, interior doors, and molded door and window architraves are all original, and the fireplace mantels in the front parlor, living-dining room, and pastor's second-floor sitting room are sympathetic early additions, if not original features.

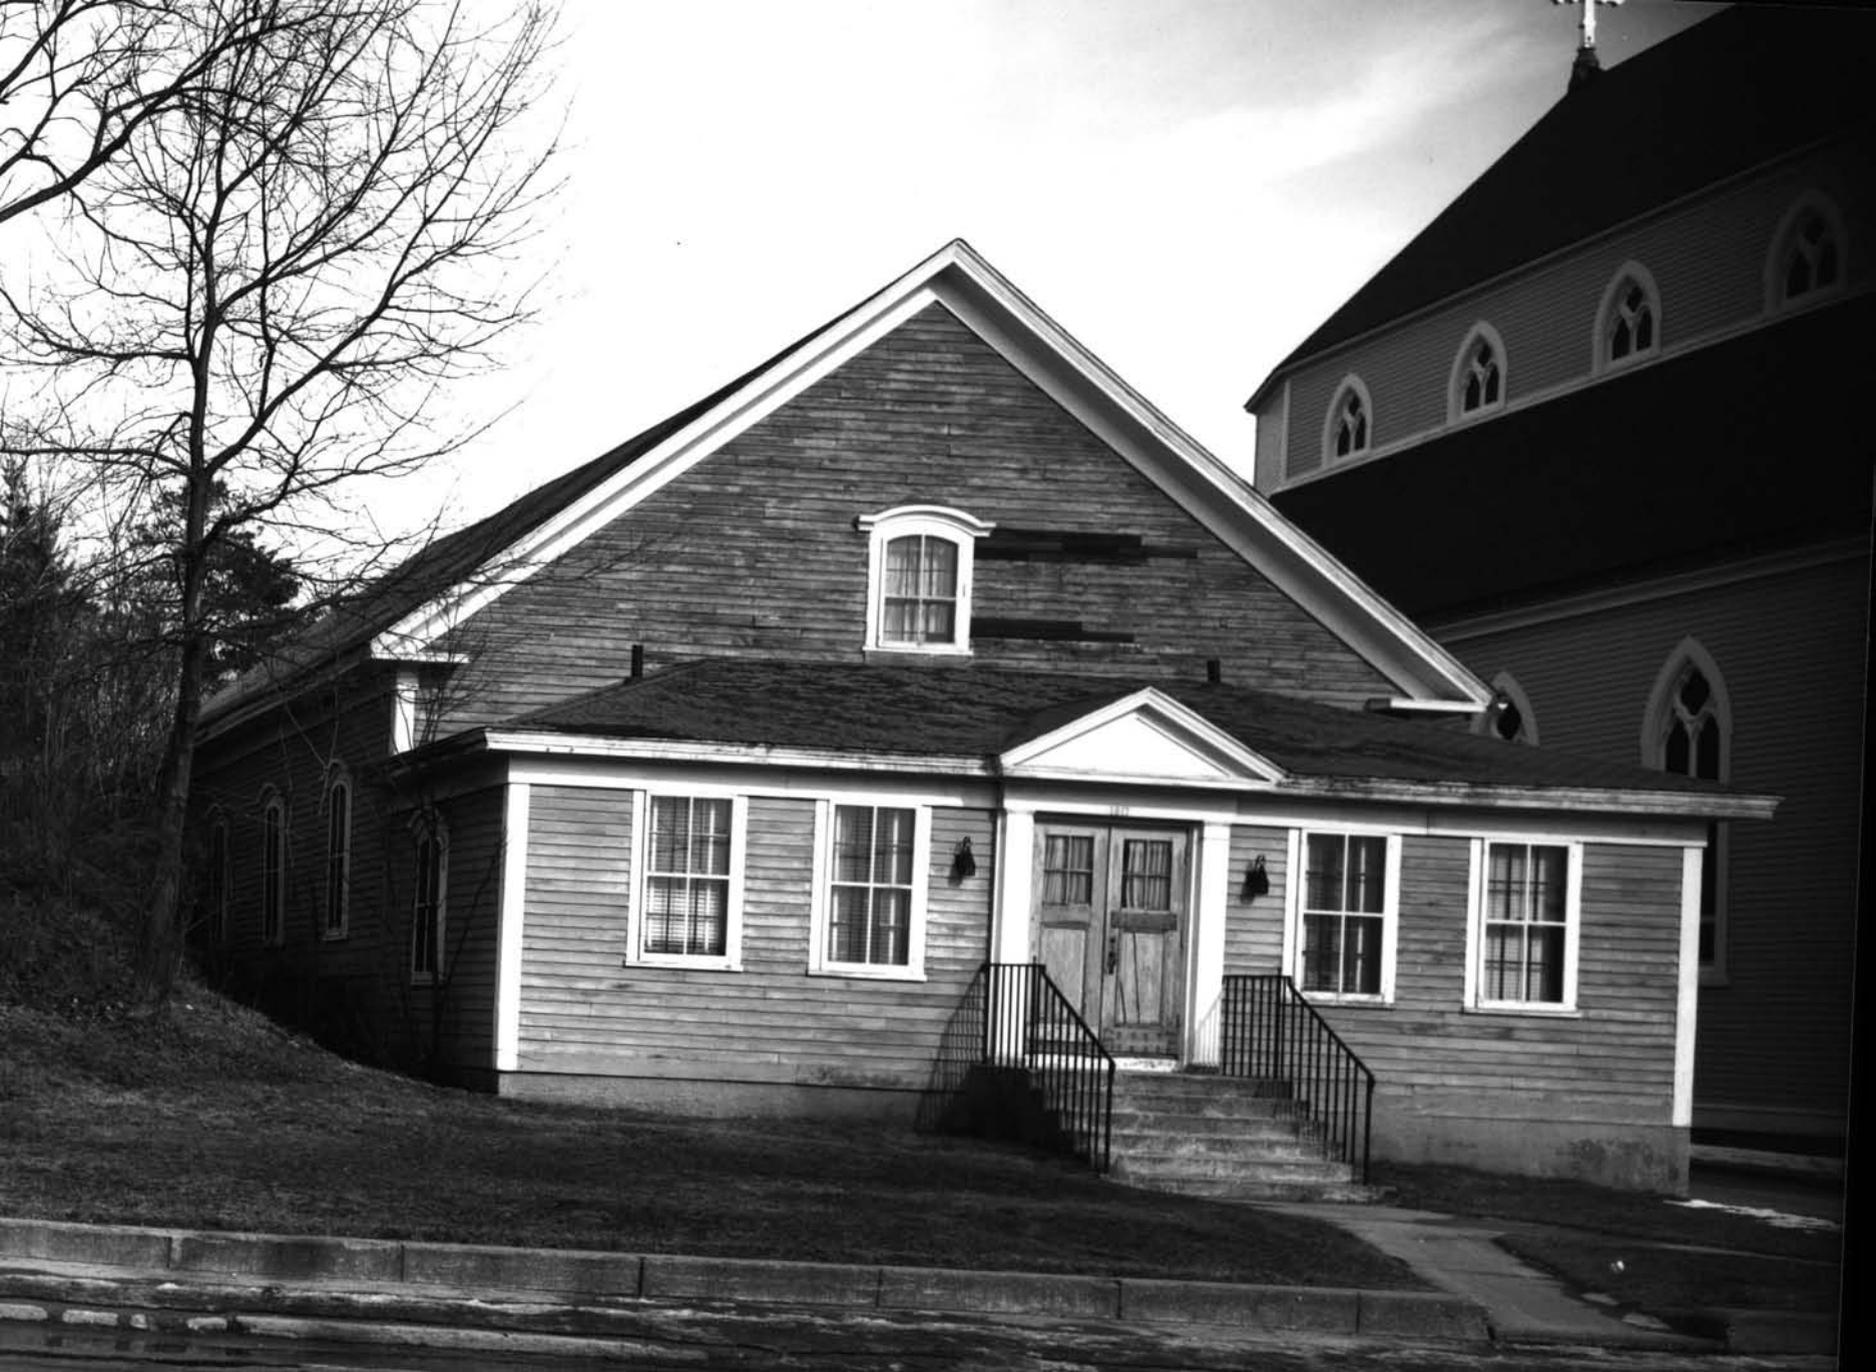
Photo #7.

Exterior of Parish Hall facing east.

The parish hall, in addition to its rather dilapidated condition, is rather nondescript in comparison to the church and rectory. The only

exterior decorative features besides the plain corner and cornice boards and deep eaves and gable returns are its segmental-arch windows with molded caps, vaguely Italianate in character, and the central front entrance with pilaster trim and a projecting gable pediment. On the interior, the front section--apparently a later addition--contains a central entrance lobby flanked by cloakrooms and toilet rooms. The remainder of building is taken up by a large open hall with a stage at the rear (northeast end). There is a kitchen beneath the stage with a pass-through cut into the front of the stage platform to facilitate food service. The hall has been subdivided with temporary low, fiberboard partitions into four classrooms. There is no notable interior finish. Current plans call for demolition of the present parish hall after construction of a new parish hall well to the rear of the older structure.
