National Register of Historic Places Inventory—Nomination Form

See instruction Type all entries	ns in How to Complete Na s—complete applicable se	tional Register Forms ections		T to MTS
1. Nam	ie			
historic U.S	. Weather Bureau	Station		
and/or common				·

2. Loca	ation			
street & number	Beach Avenue, F	ire Number 577	_	not for publication
	w Shoreham	N A vicinity of	#2 - Claudine	Schneider
state Rho	de Island code	44 county	Washington	code 009

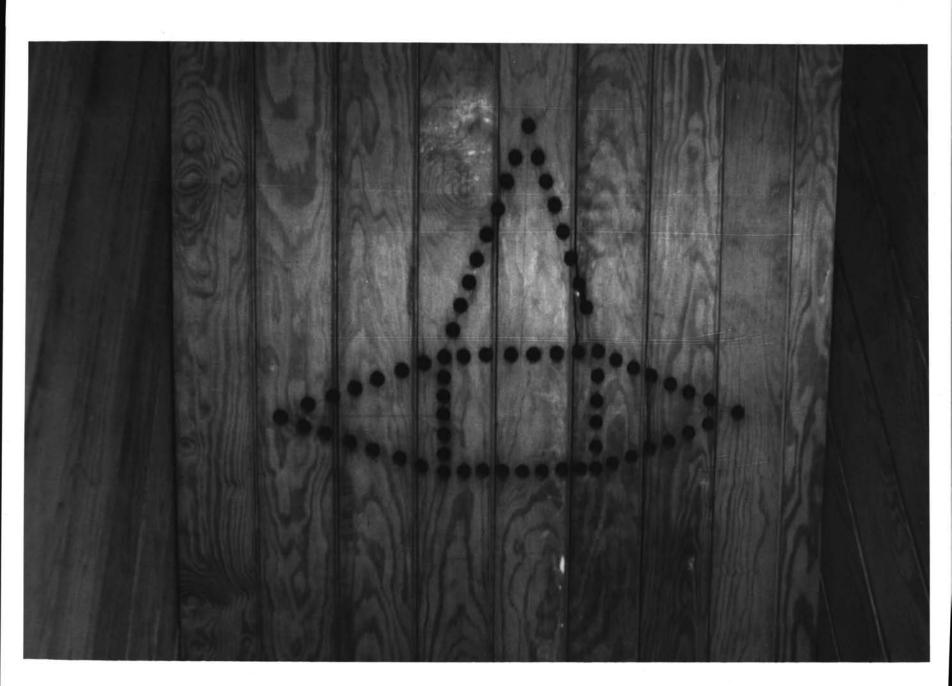
View: ventilating pattern, garret door, in the gangway.

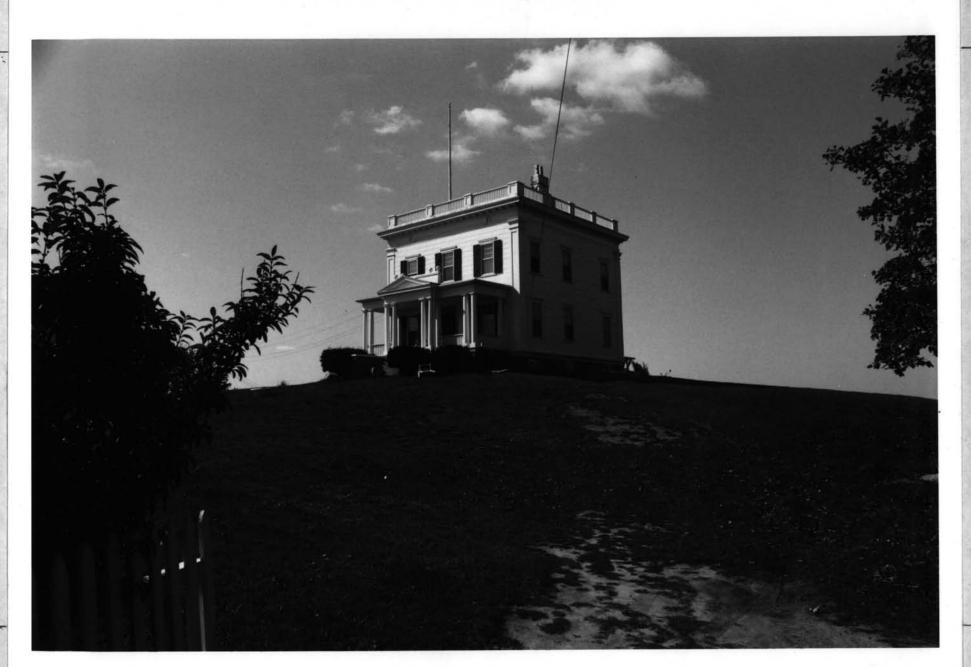
View: View of the station from the southeast: Front facade on the left, easterly elevation on right.

The building is two stories tall and three bays wide, with a flat roof and a high basement. It is a frame structure, originally clad with clapboards, which were replaced by asbestos shingles, painted white, in 1947. A single-story portico, supported by paired Doric columns, and a shallow, pedimented, central pavilion stretch across the southerly facade. The exterior is enriched with finely-drawn detailing, including channeled pilasters at the corners, a full entablature and an eared tablet, framed by scrolls, in the center of the frieze on the facade. The windows, capped by cornice moldings, have twelve-over-one double-hung sashes. The doorway in the center of the facade contains a paneled oak door with a large window. The transom over the door, originally housed a boxed glass sign, now kept inside the house; a single plexiglass pane is in its place.

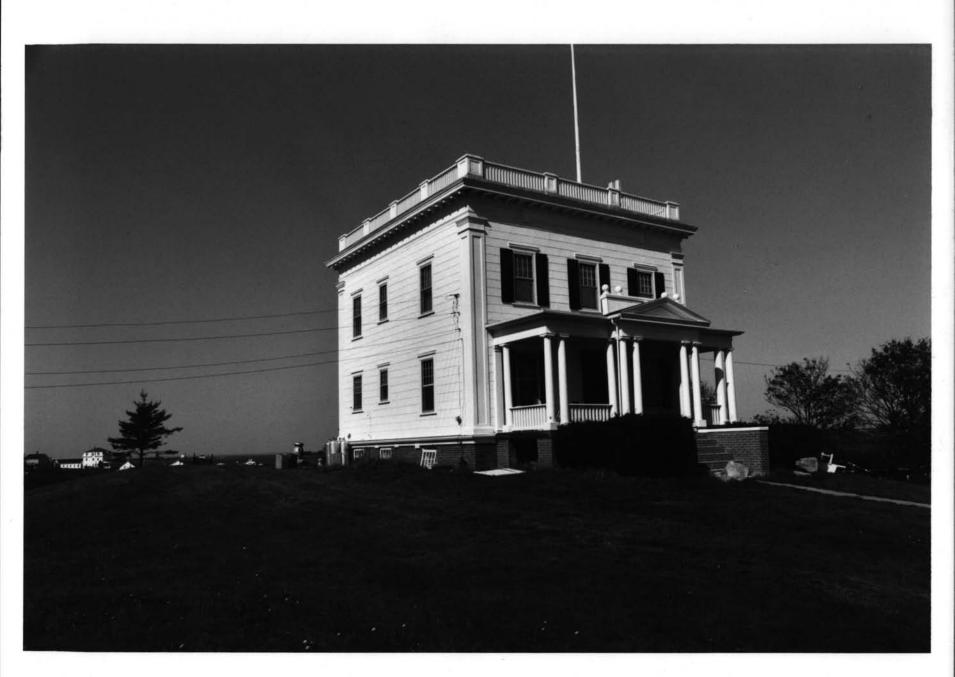
View: View of the station from the southwest.

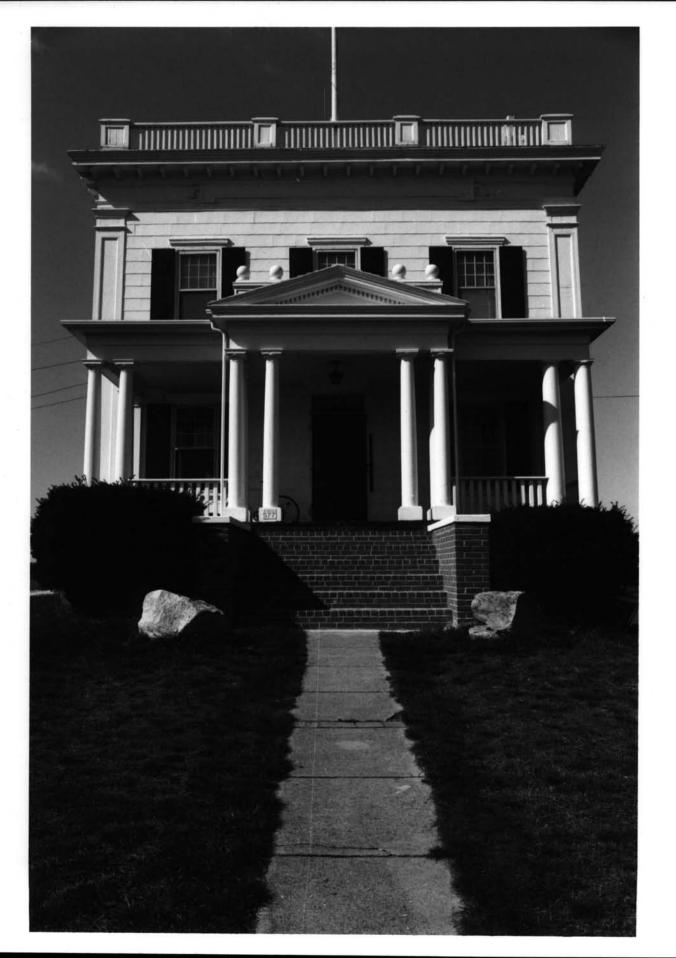
View: Front (southerly) facade.

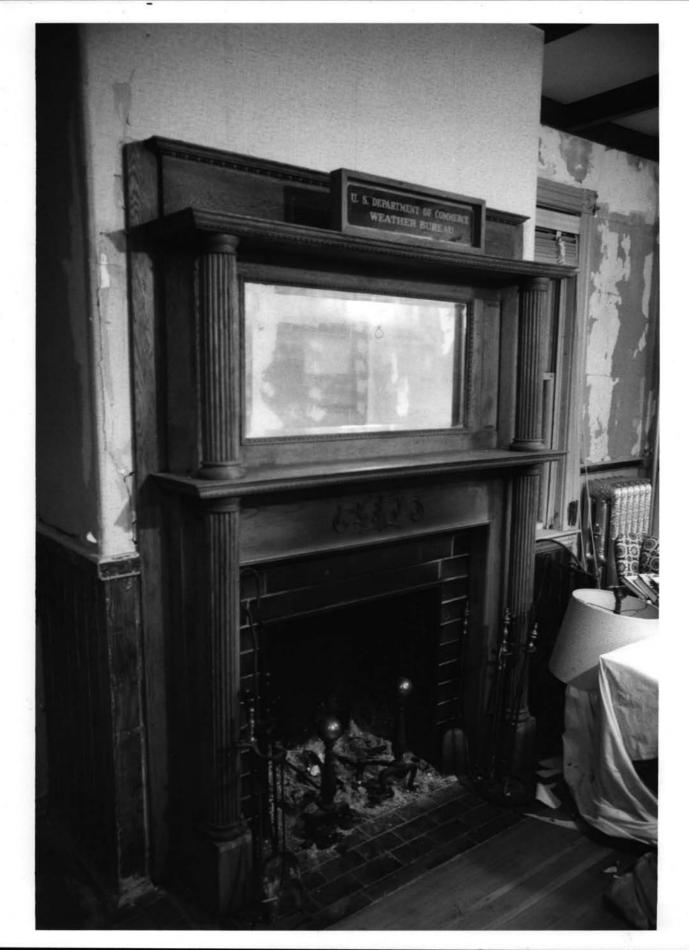
View: Mantelpiece, southeast parlor, first floor.

In the southeast parlor there is a two-story mantel with fluted Doric columns supporting mantel and overmantel shelves. A large beveled mirror occupies the center of the overmantel. The shelves have egg-and-dart bed molding; the same style of molding frames the mirror as well. The fire surround and the hearth are covered with green ceramic tiles; the cast-iron firebox is embossed with fleurs-delys. A similar mantel is in the southeast bedroom, though it is only one story high and its bed molding is fuller and more prominent. The tiles surrounding the opening are white, mottled with yellow, purple and green; the hearth tiles are green with borders of the mottled

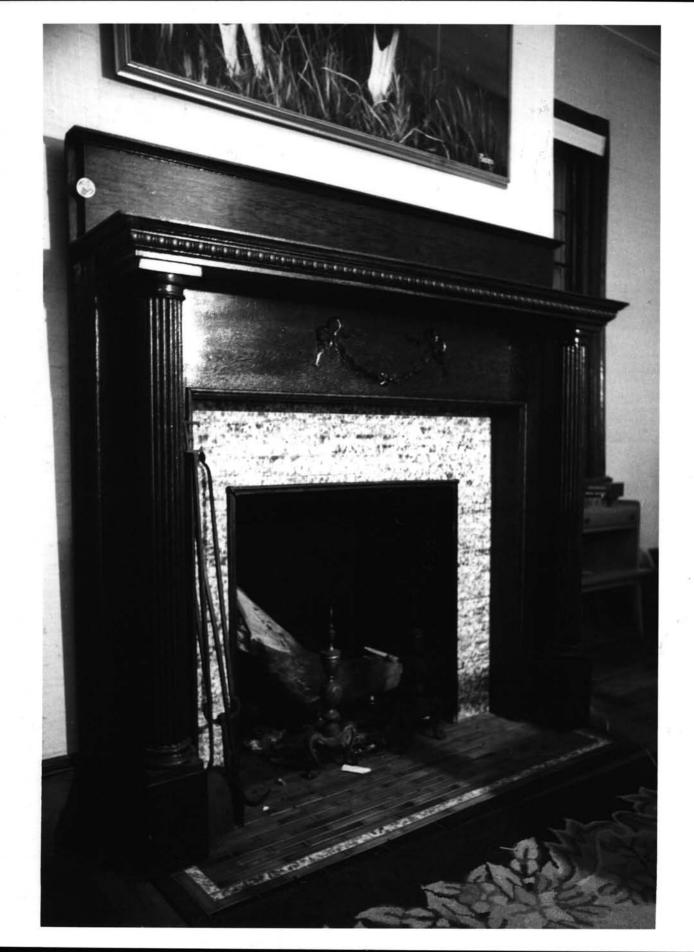
View: Mantelpiece, southeast bedroom, second floor.

white and plain black tiles. In both locations the chimneybreast projects into the room.

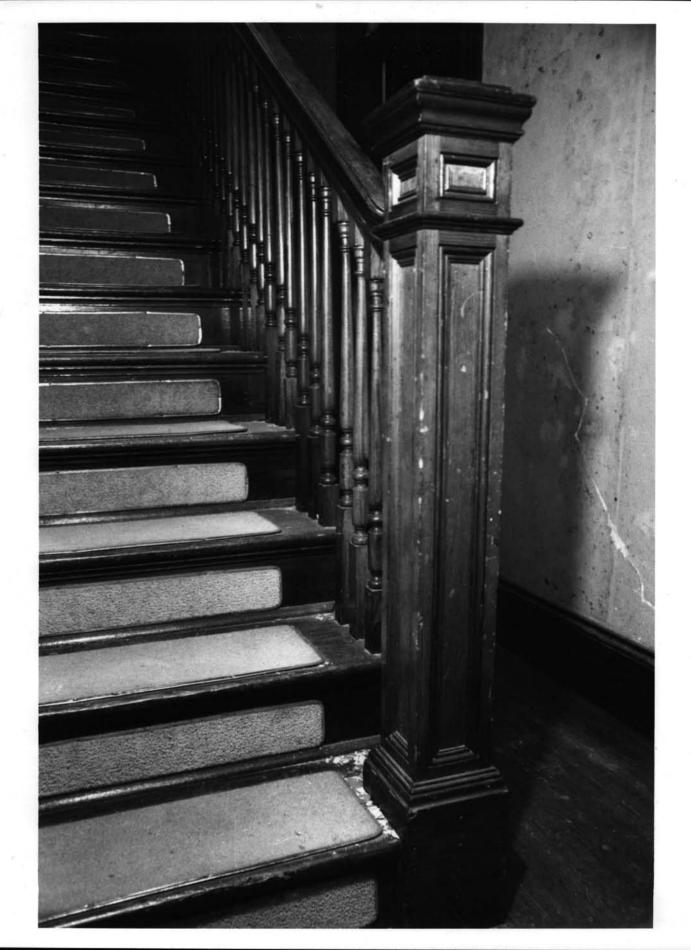
View: Newel post and railing, main stairway.

The interior is laid out on a center-hall plan with two rooms on a side, front and rear vestibules and a single-flight stairway with a turned-spindle railing at the north end of the hall. The two parlors on the easterly side served as the Bureau offices and on the westerly side of the hall there is a parlor/dining room and a pantry and kitchen. On the second floor there are four bedrooms and a bath. A narrow gangway, enclosed by paneled pine walls, leads to the roofdeck where the instrument tower was mounted and where there is still a flagpole. The rooms are finished with plaster walls, hardwood floors and oak and yellow pine trim. The parlors have vertical matchboard wainscoting; the other rooms have baseboard moldings. The doors have five horizontal panels and molded trim with corner blocks. There are tramsoms over the parlor and front bedroom doorways.

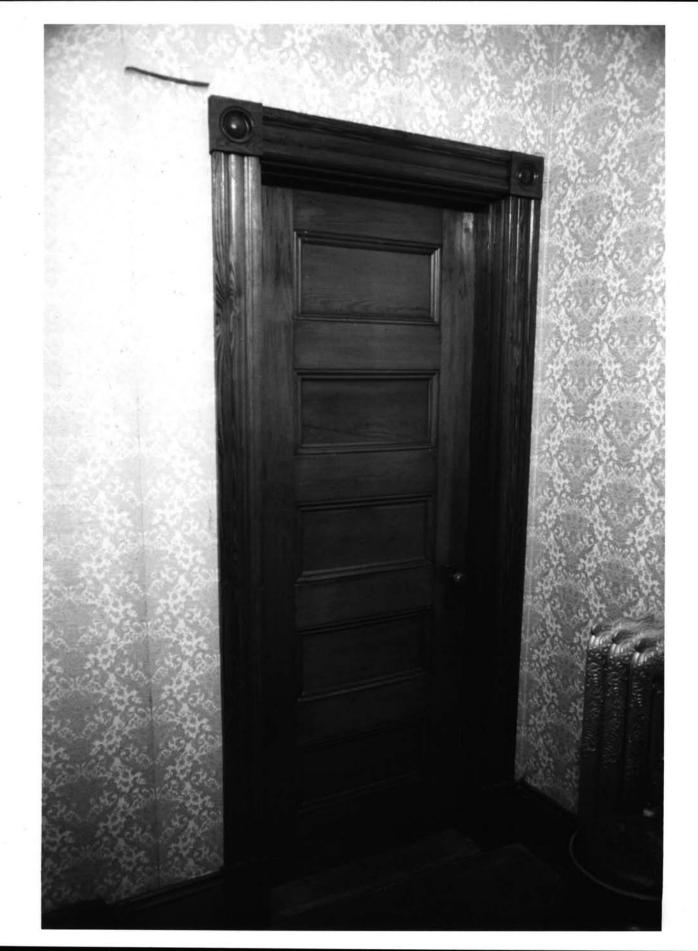
View: Doorway, northwest bedroom, second floor.

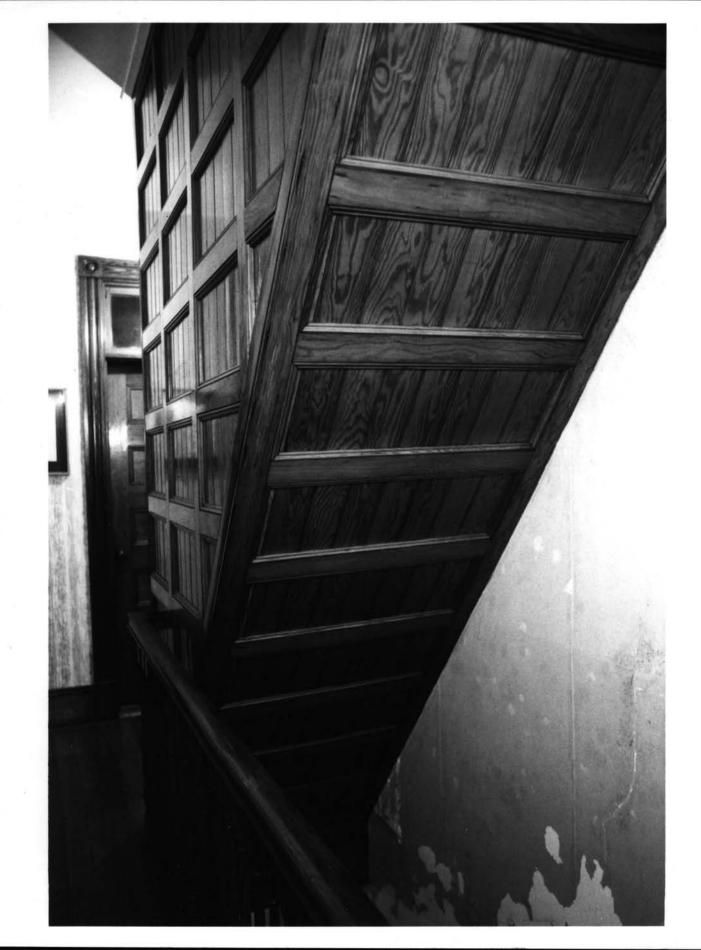
View: Paneled gangway walls, second floor.
