National Register of Historic Places Registration Form

historic name Woonsocket Rubber Company Mill
other names/site number _____

street & number 60-82 South Main Street n/a not for publication
city, town Woonsocket n/a vicinity
state Rhode Island code R.I. county Providence code 007 zip code 02895

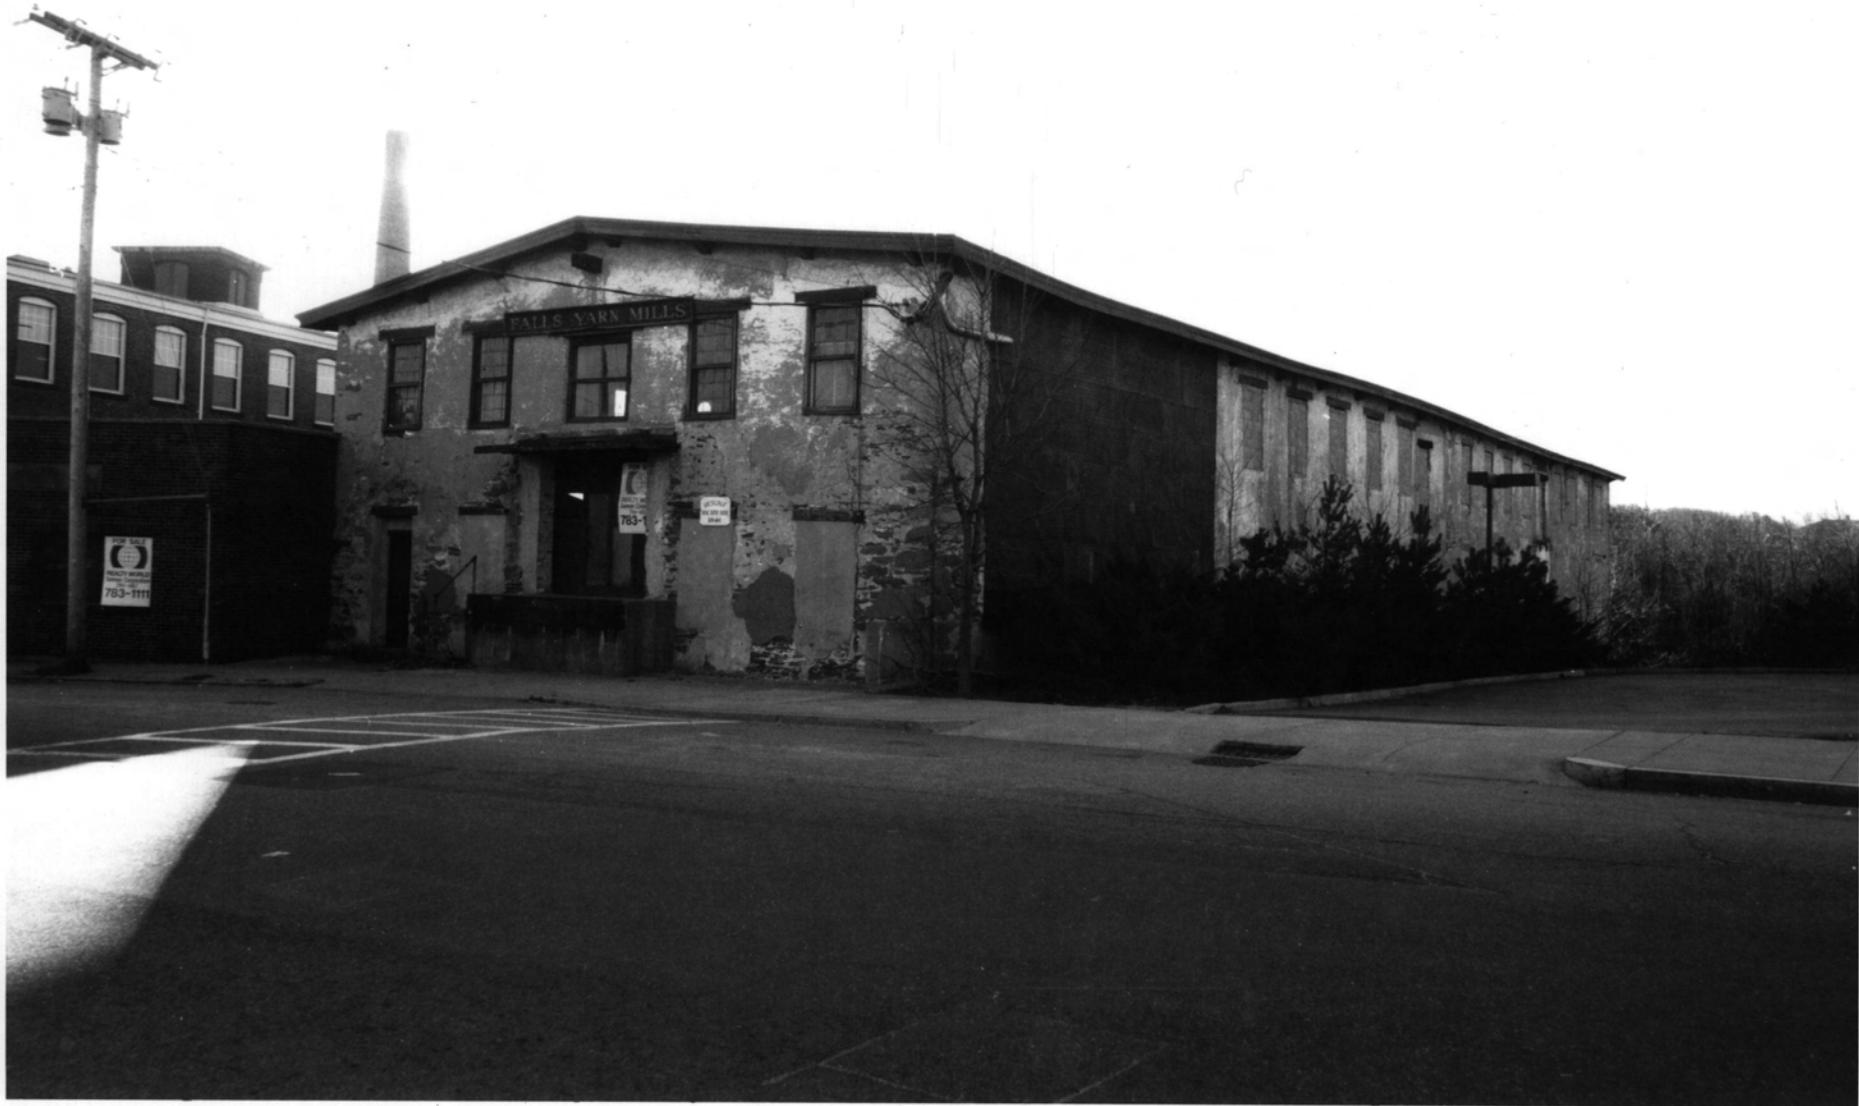
Photo # 1

View: North elevation of stone mill, looking
south from Market Square.

1. North Section (1857/69). The front (north), 10-bay-by-5-bay section of the stone building, abutting the south side of South Main Street, differs from the two rear sections in the use of wood window and door lintels and irregular gray, shale-like corner quoins. The symmetrical, 5-bay facade (north) retains original 12/12 double-hung window sash on the second (originally third) floor; three of the first (originally second) floor windows are infilled and the easternmost window was converted to a door in the early twentieth century. The original first floor windows, visible in the interior are now buried. A c. 1870 photograph indicates the lowest floor was never fully exposed along South Main Street. These windows most likely faced a light well. The wide central entrance is higher than it was originally and also dates from the early twentieth century when South Main Street was raised. Probably at the same time, the lower third of the central second-story freight opening was filled in, creating a 2/2 window. The wood hoist beam is original.

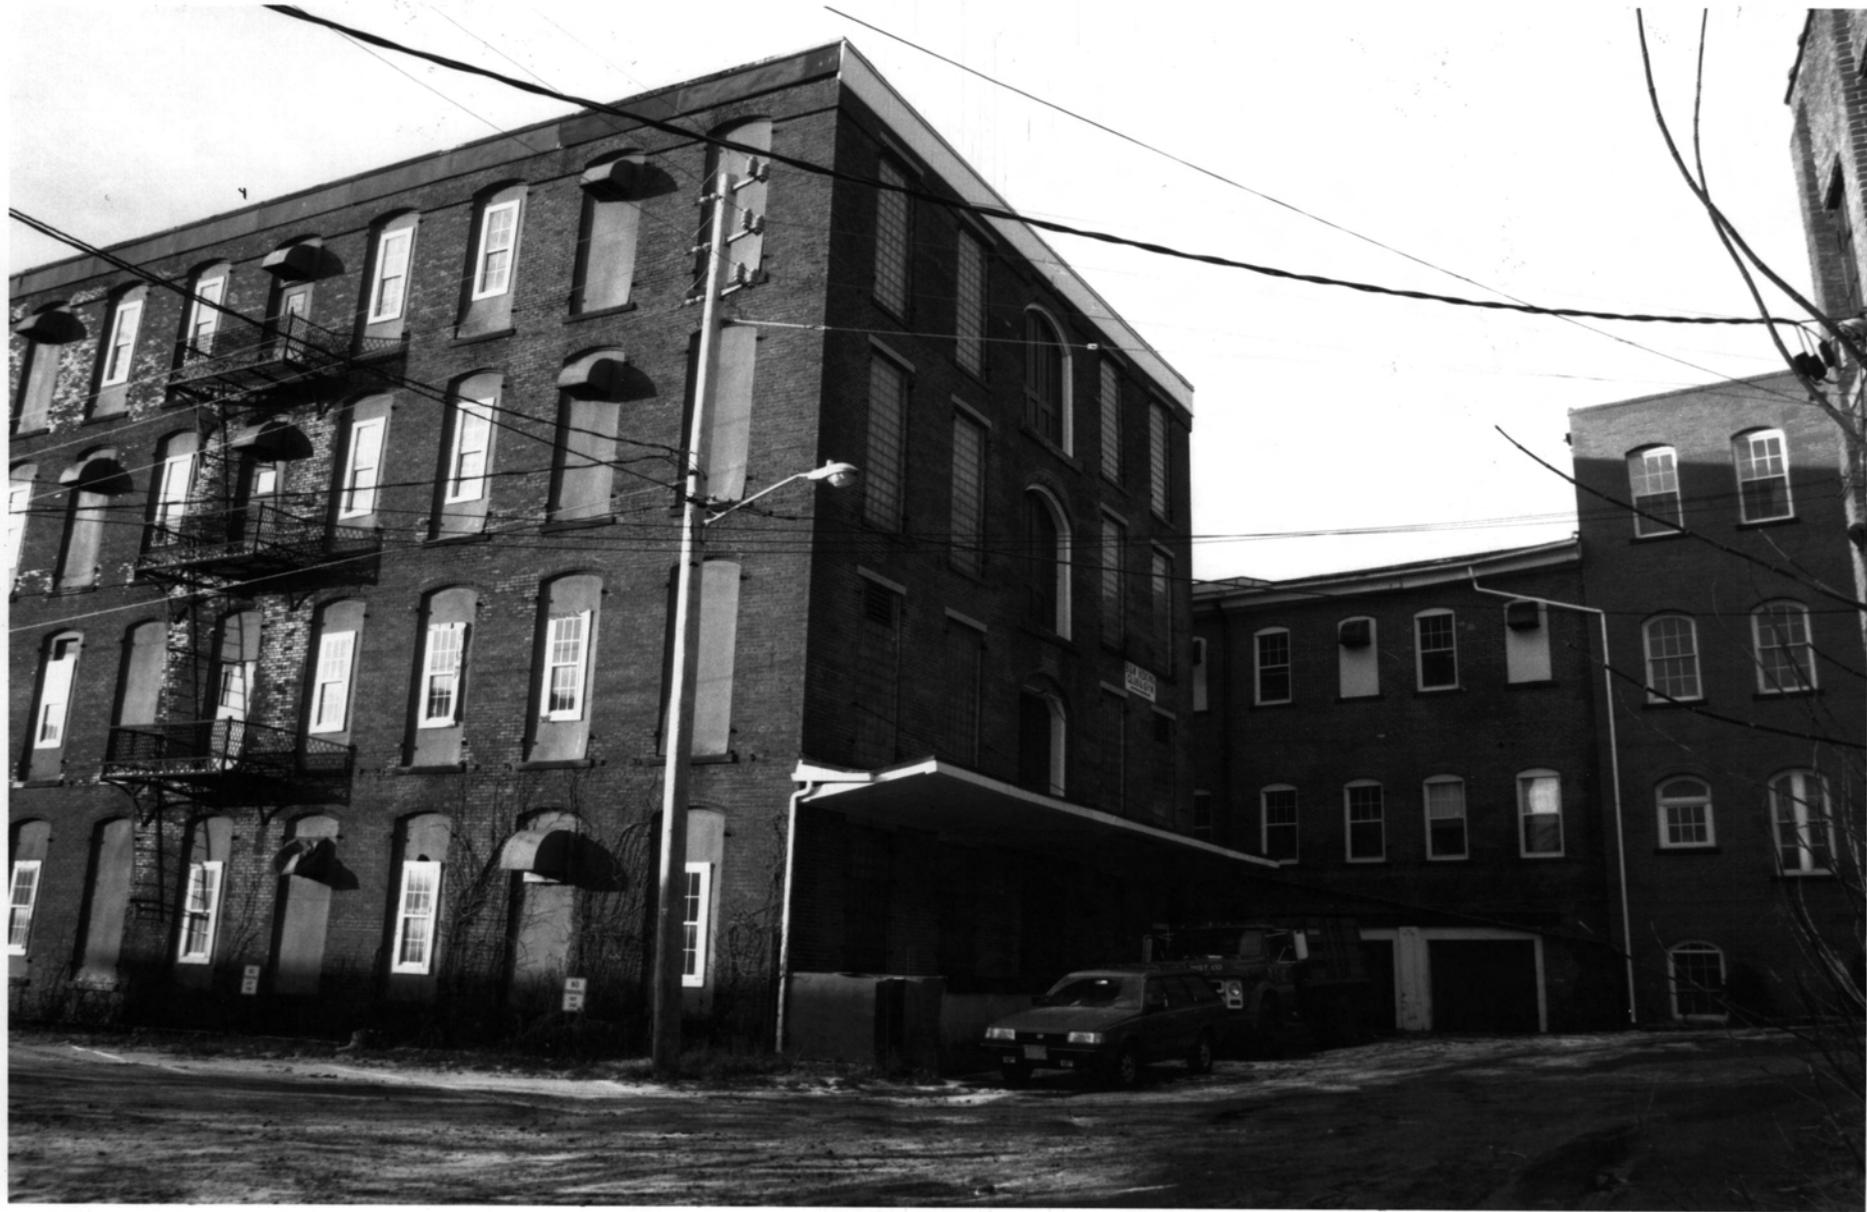
Photo #3

View: East and north elevations of rear brick
mill, looking west from Island Place.

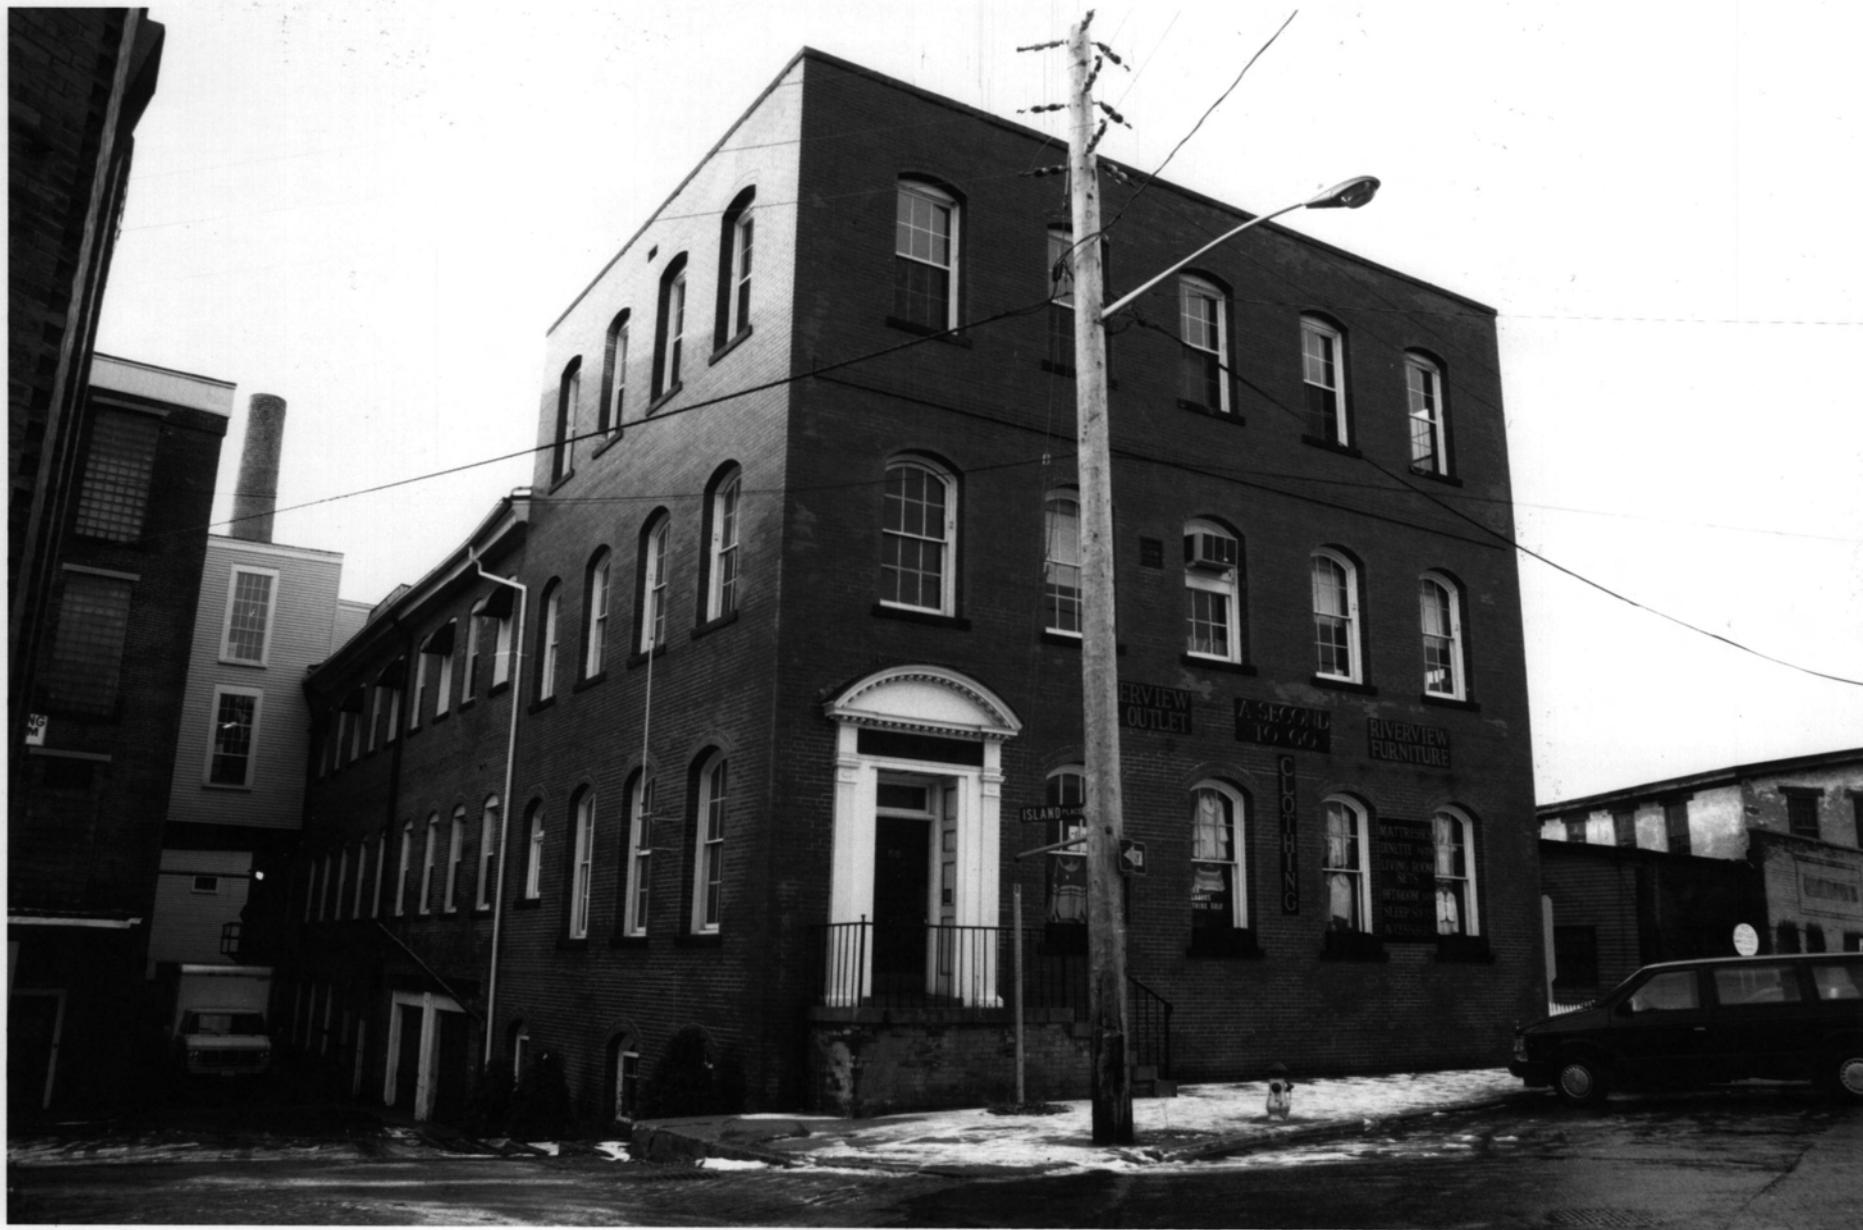
Photo #2

View: North elevation of brick mill, looking south
from Market Square.

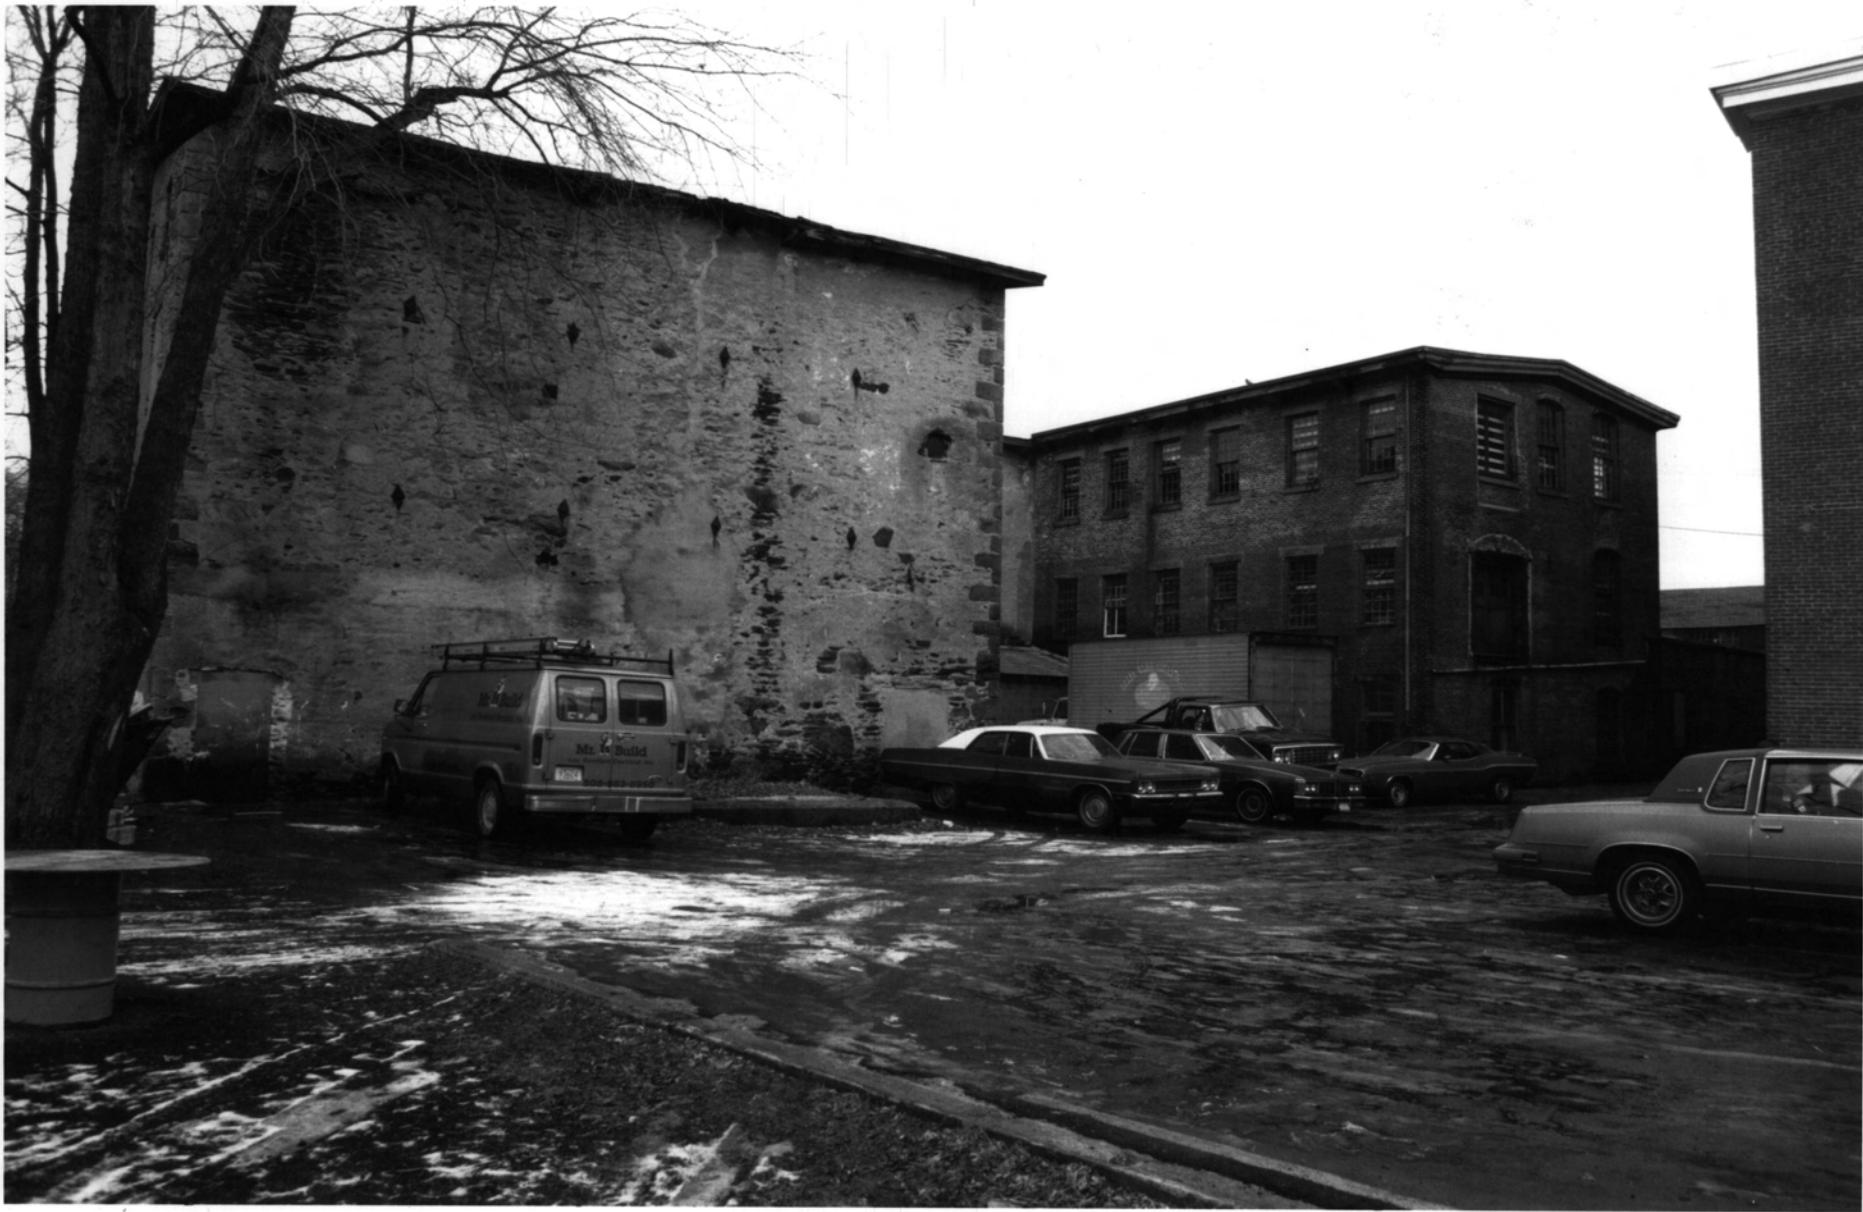
Photo #4

View: West elevation of front mill,
looking south from street

On the west elevation, abutting the now-filled Ballou mill tailrace, all windows are filled with concrete block. The

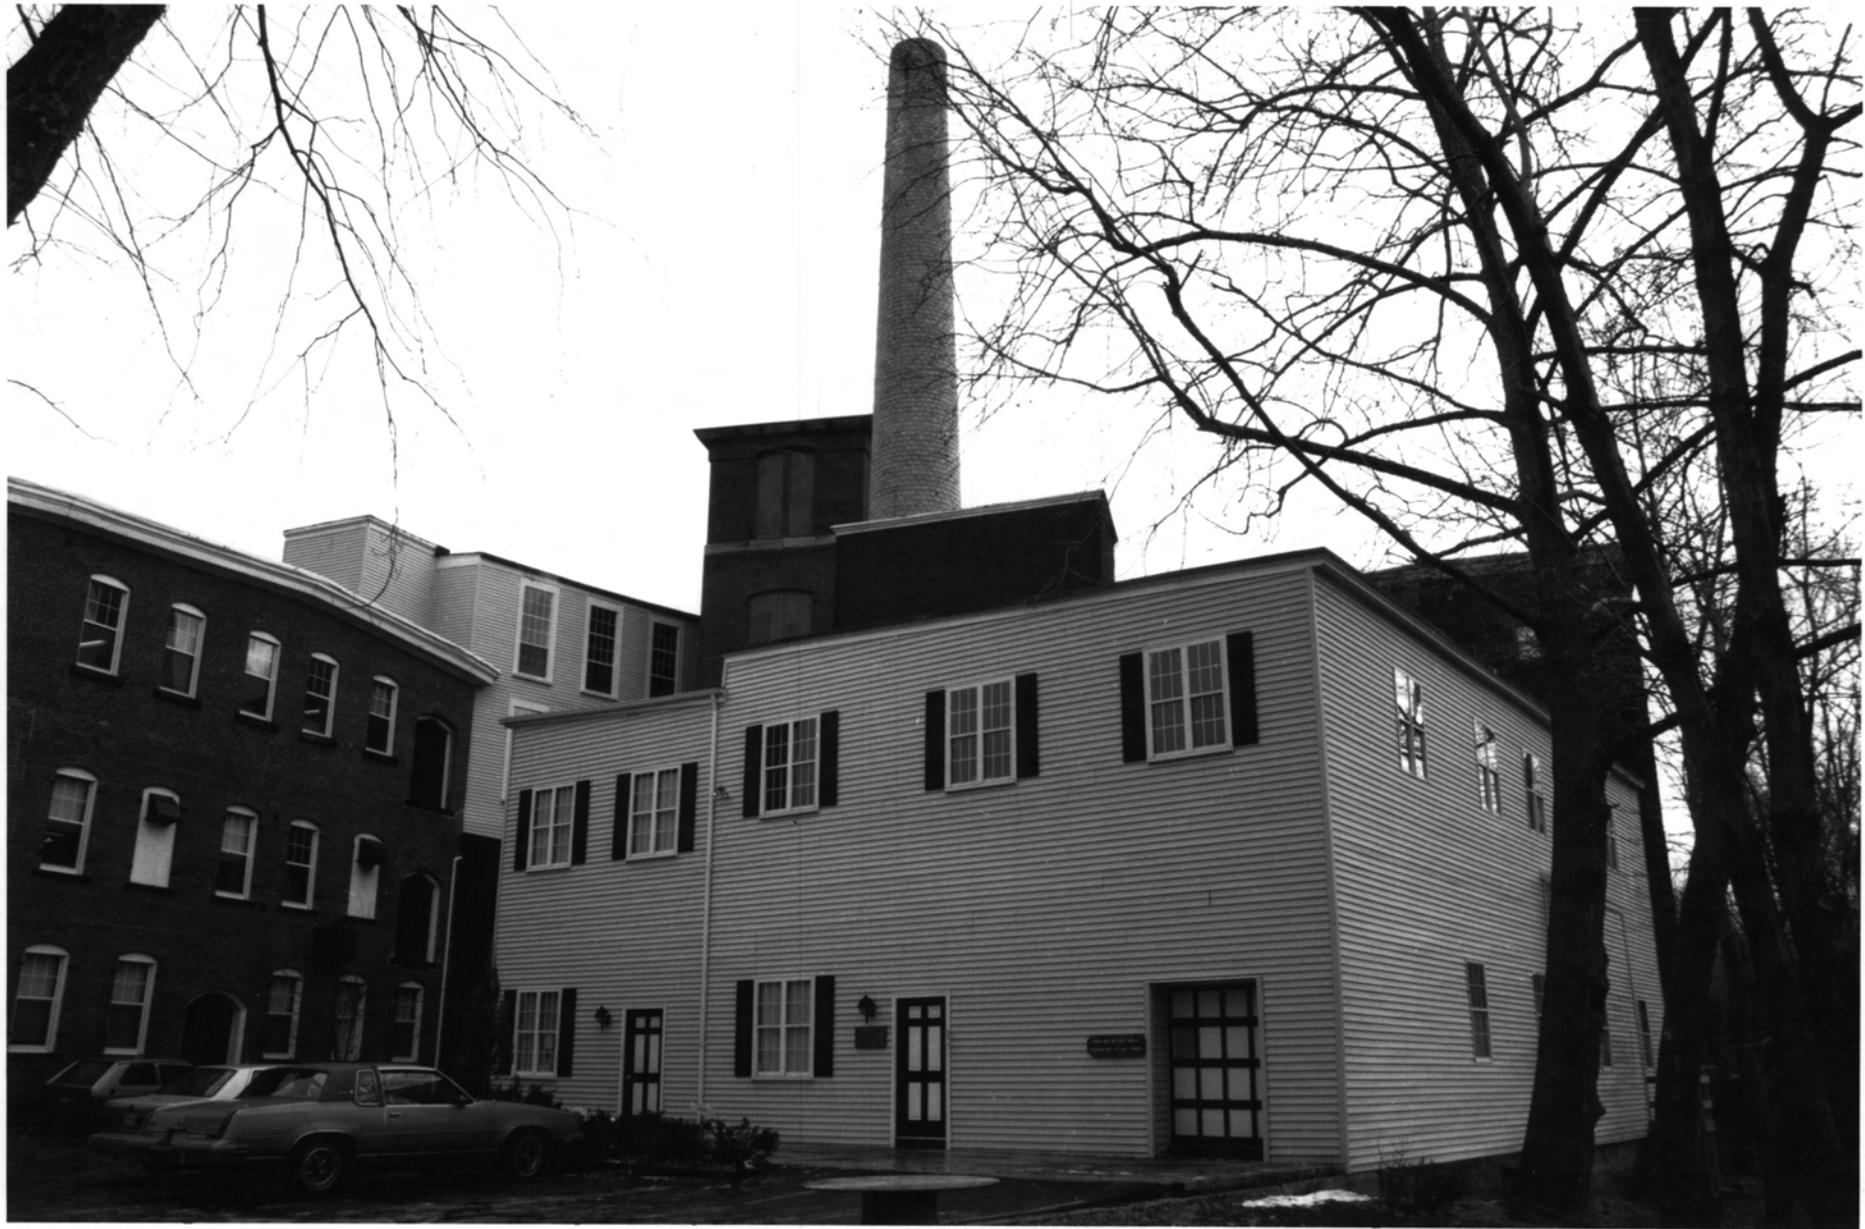
Photo # 5

View: Rear elevation of brick mills, looking
northeast from rear of property.

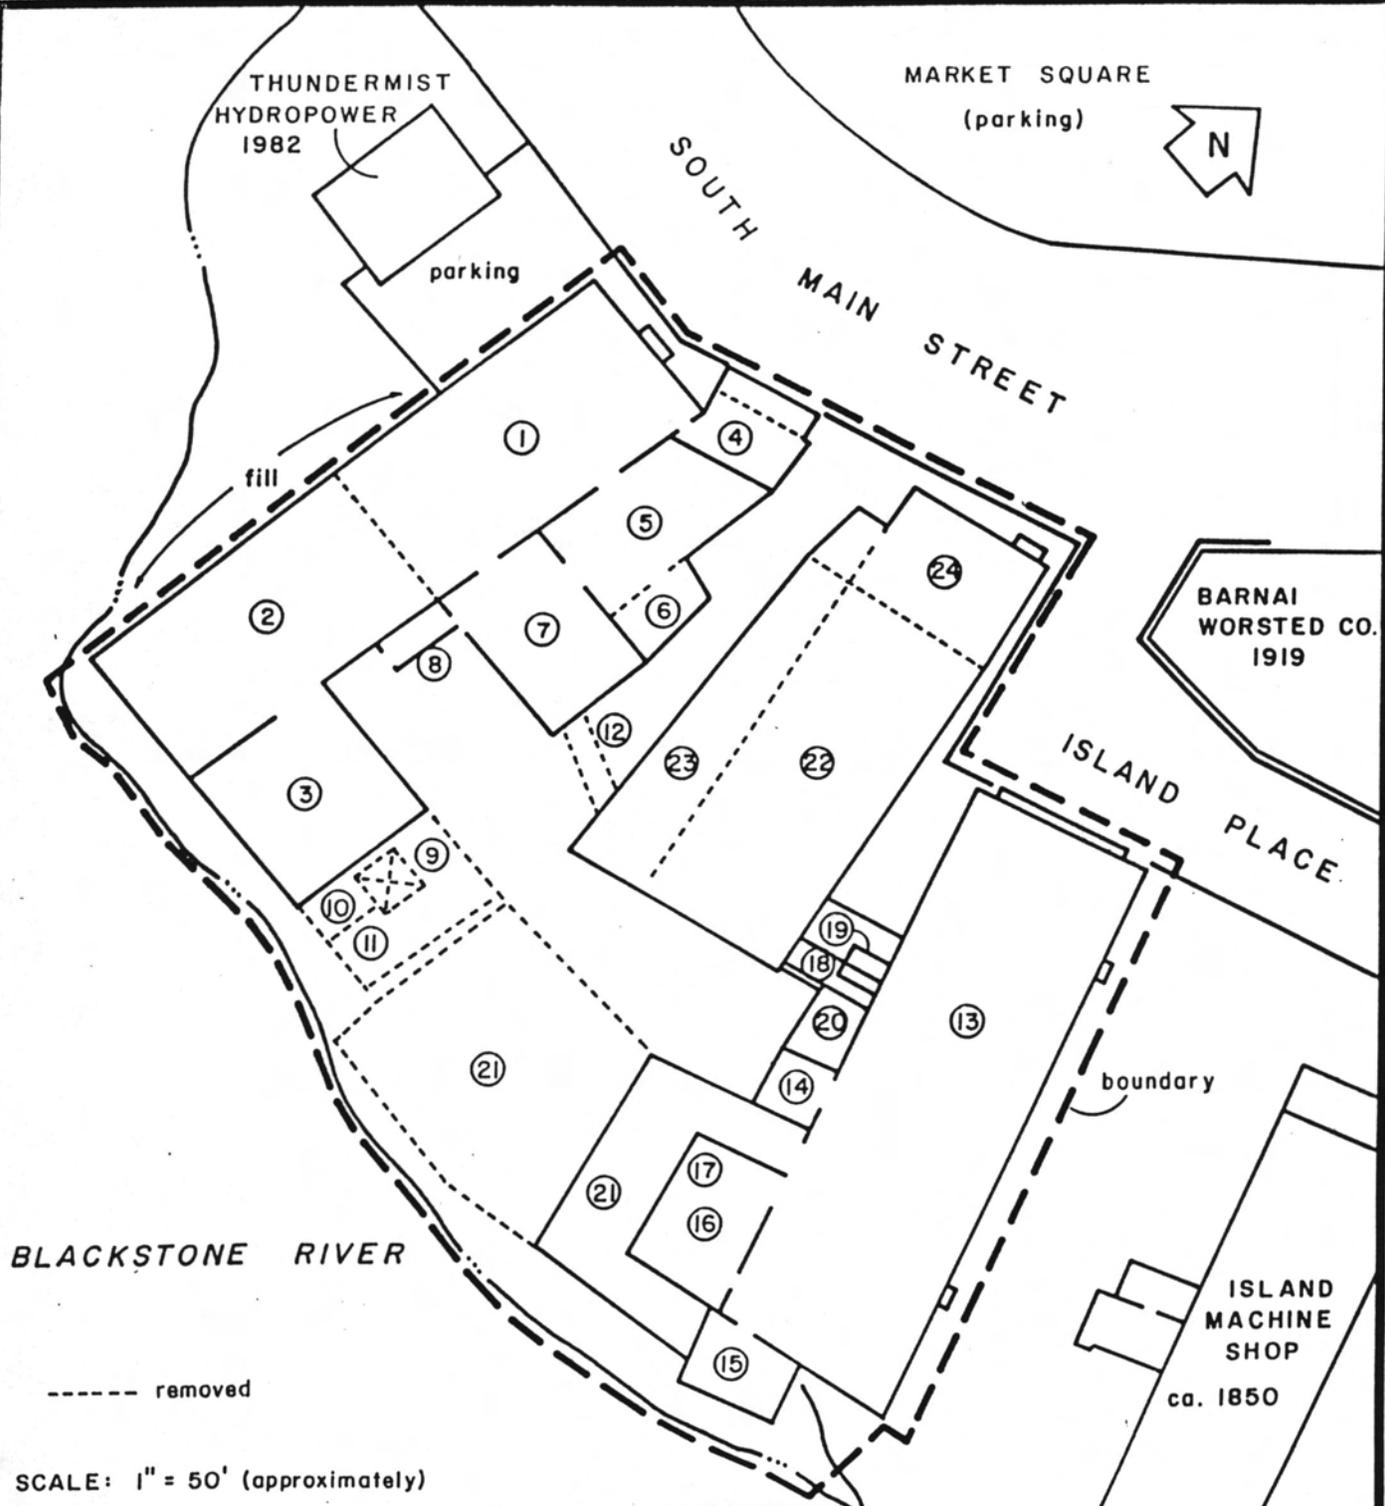
WOONSOCKET RUBBER COMPANY COMPLEX
 1988
 NATIONAL REGISTER NOMINATION MAP
 SOUTH MAIN STREET
 WOONSOCKET (PROVIDENCE COUNTY), RHODE ISLAND

SCALE: 1" = 50' (approximately)

The following description of the Woonsocket Rubber Company complex structures is keyed to the accompanying map. Numbers are assigned for ease of identification only, and the two halves of the complex on separate lots are described separately.
