**National Register of Historic Places
Registration Form**

historic name: Angell-Ballou House

street & number: 49 Ridge Road

The Angell-Ballou House (c. 1800) is a well-preserved 2½-story Federal farmhouse. It faces east and is located in a semi-rural setting on Ridge Road in Smithfield, Rhode Island. The house has a center hall plan; there is a rear kitchen ell. The house is located on a narrow road and is fronted by a wooden picket fence, granite walkways, and large maples. Dry-laid stone walls mark the boundaries of the 4-acre lot, which declines in grade at the rear of the house; a 2-car garage is located just north of the house.

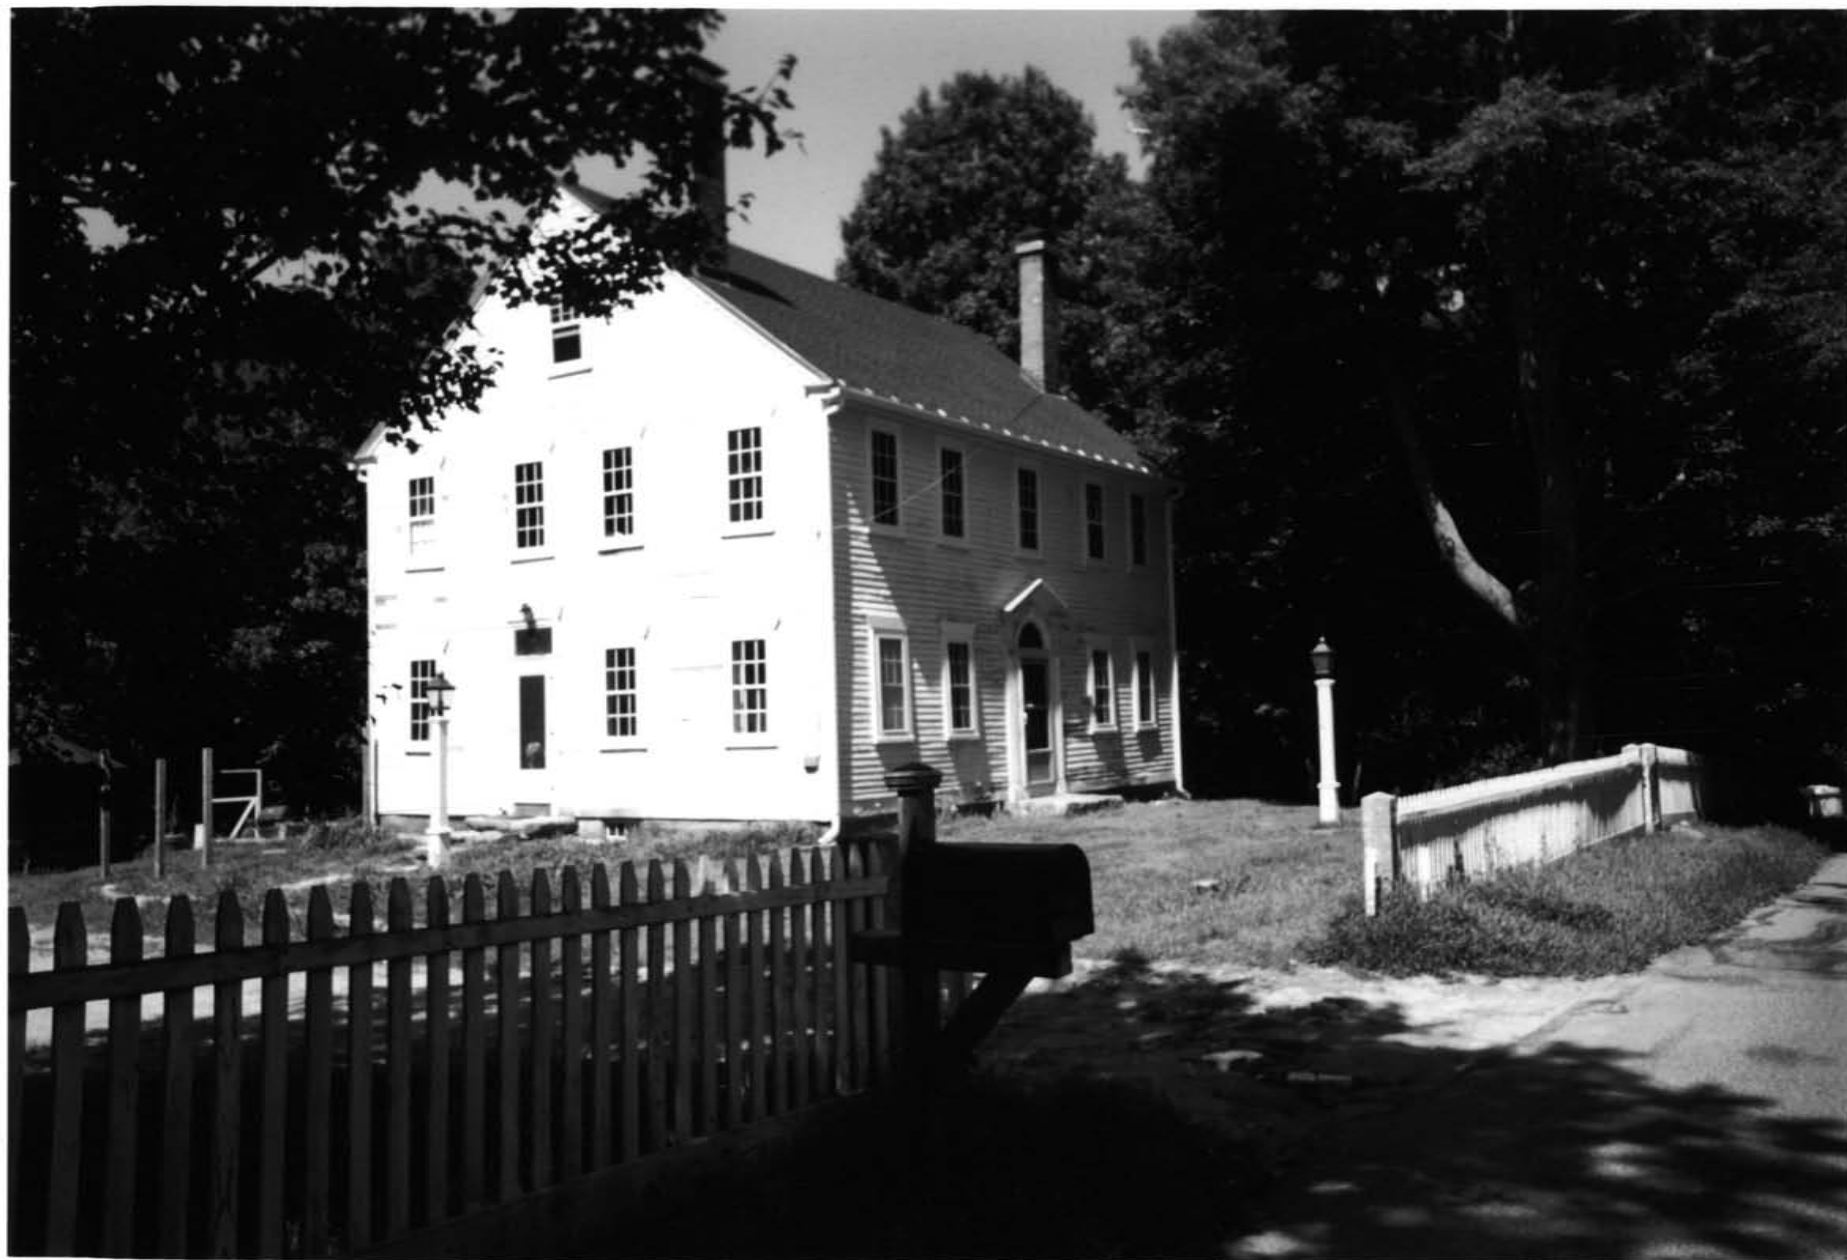
Angell-Ballou House
Providence County, Smithfield, RI
Photo # 1 of 10

The main block of the house is 36 feet wide by 28 feet deep, with a flank-gable roof and a dentil cornice. The façade of the house is 5 bays wide with a center entrance. Two end chimneys (on the north and south sides) are set forward of the ridgeline and well inset from the end wall planes. They provide fireboxes for the two front rooms on both first and second floor. The south gable end elevation is articulated into 4 bays, the north gable end elevation into 3. There is a secondary entrance on the south side and a door into the kitchen ell as well. The walls are clapboarded. All (except one) of the windows have original plank frames with later (but old) six-over-six sash. One original twelve-over-twelve sash remains on the west wall. The windows, the side entrance, and the ell entrance have splayed lintels.

Photo #1
View: East and south elevations, looking northwest.

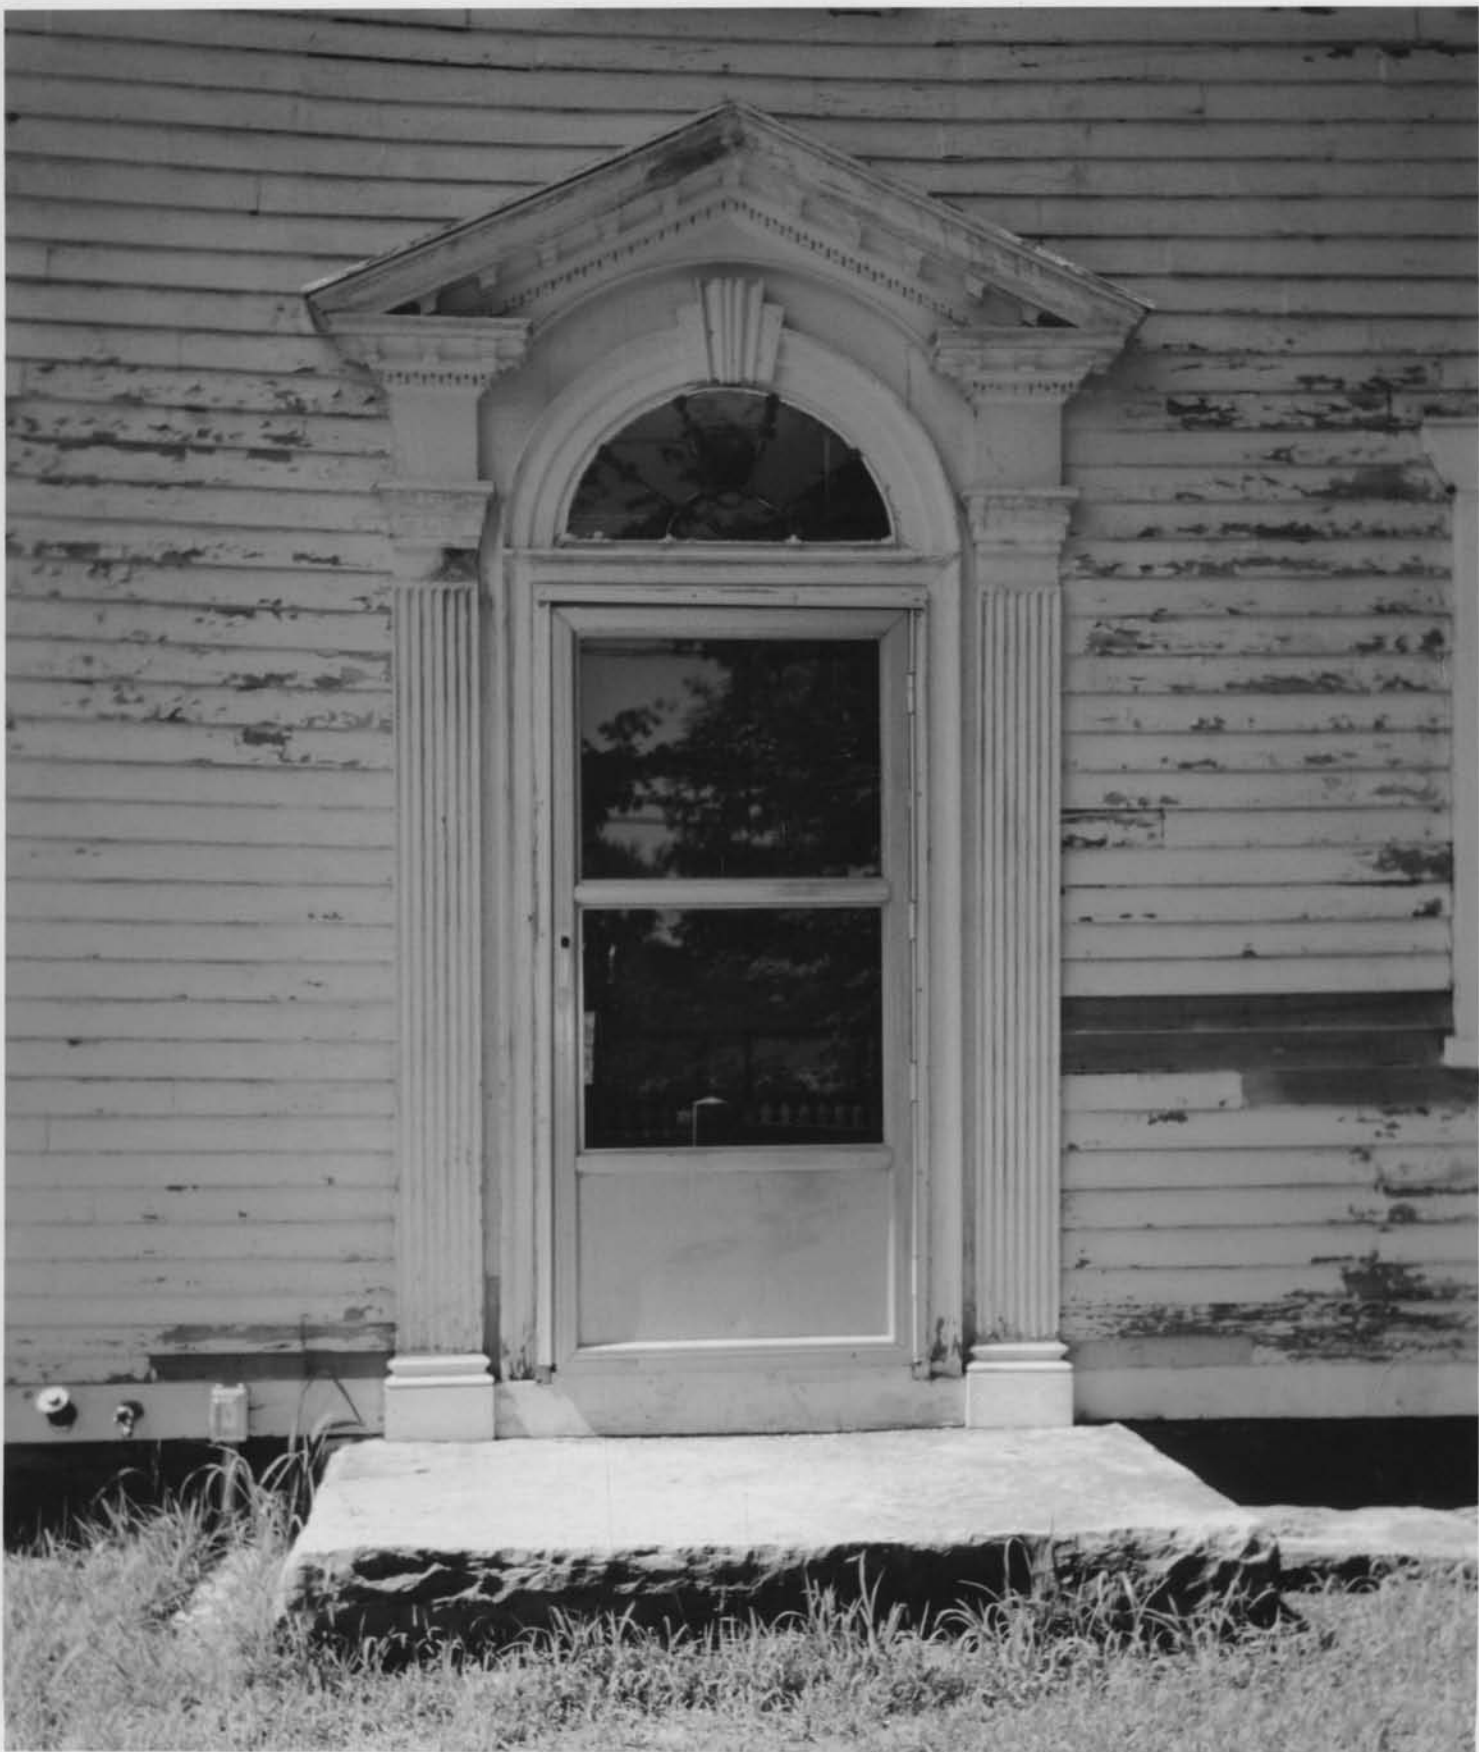
Angell-Balloy House
Providence County, Smithfield, RI
Photo #2 of 10

The pilastered doorway is the principal decorative feature of the house. The semicircular fanlight has five large lights separated by metal muntins with foliate ornament at the tips, radiating from a rosette and a smaller semicircle. The window is set in a wood frame with a keystone. The doorway still has the original eight-panel, raised-panel door and old hardware. It is surrounded by a series of moldings, including a beaded frame, beaded band molding, and an ovolo back band. The entablature is capped by a low-pitched gabled pediment with crown and modillion moldings.

Photo #2
View: Front entrance, east elevation, looking west.

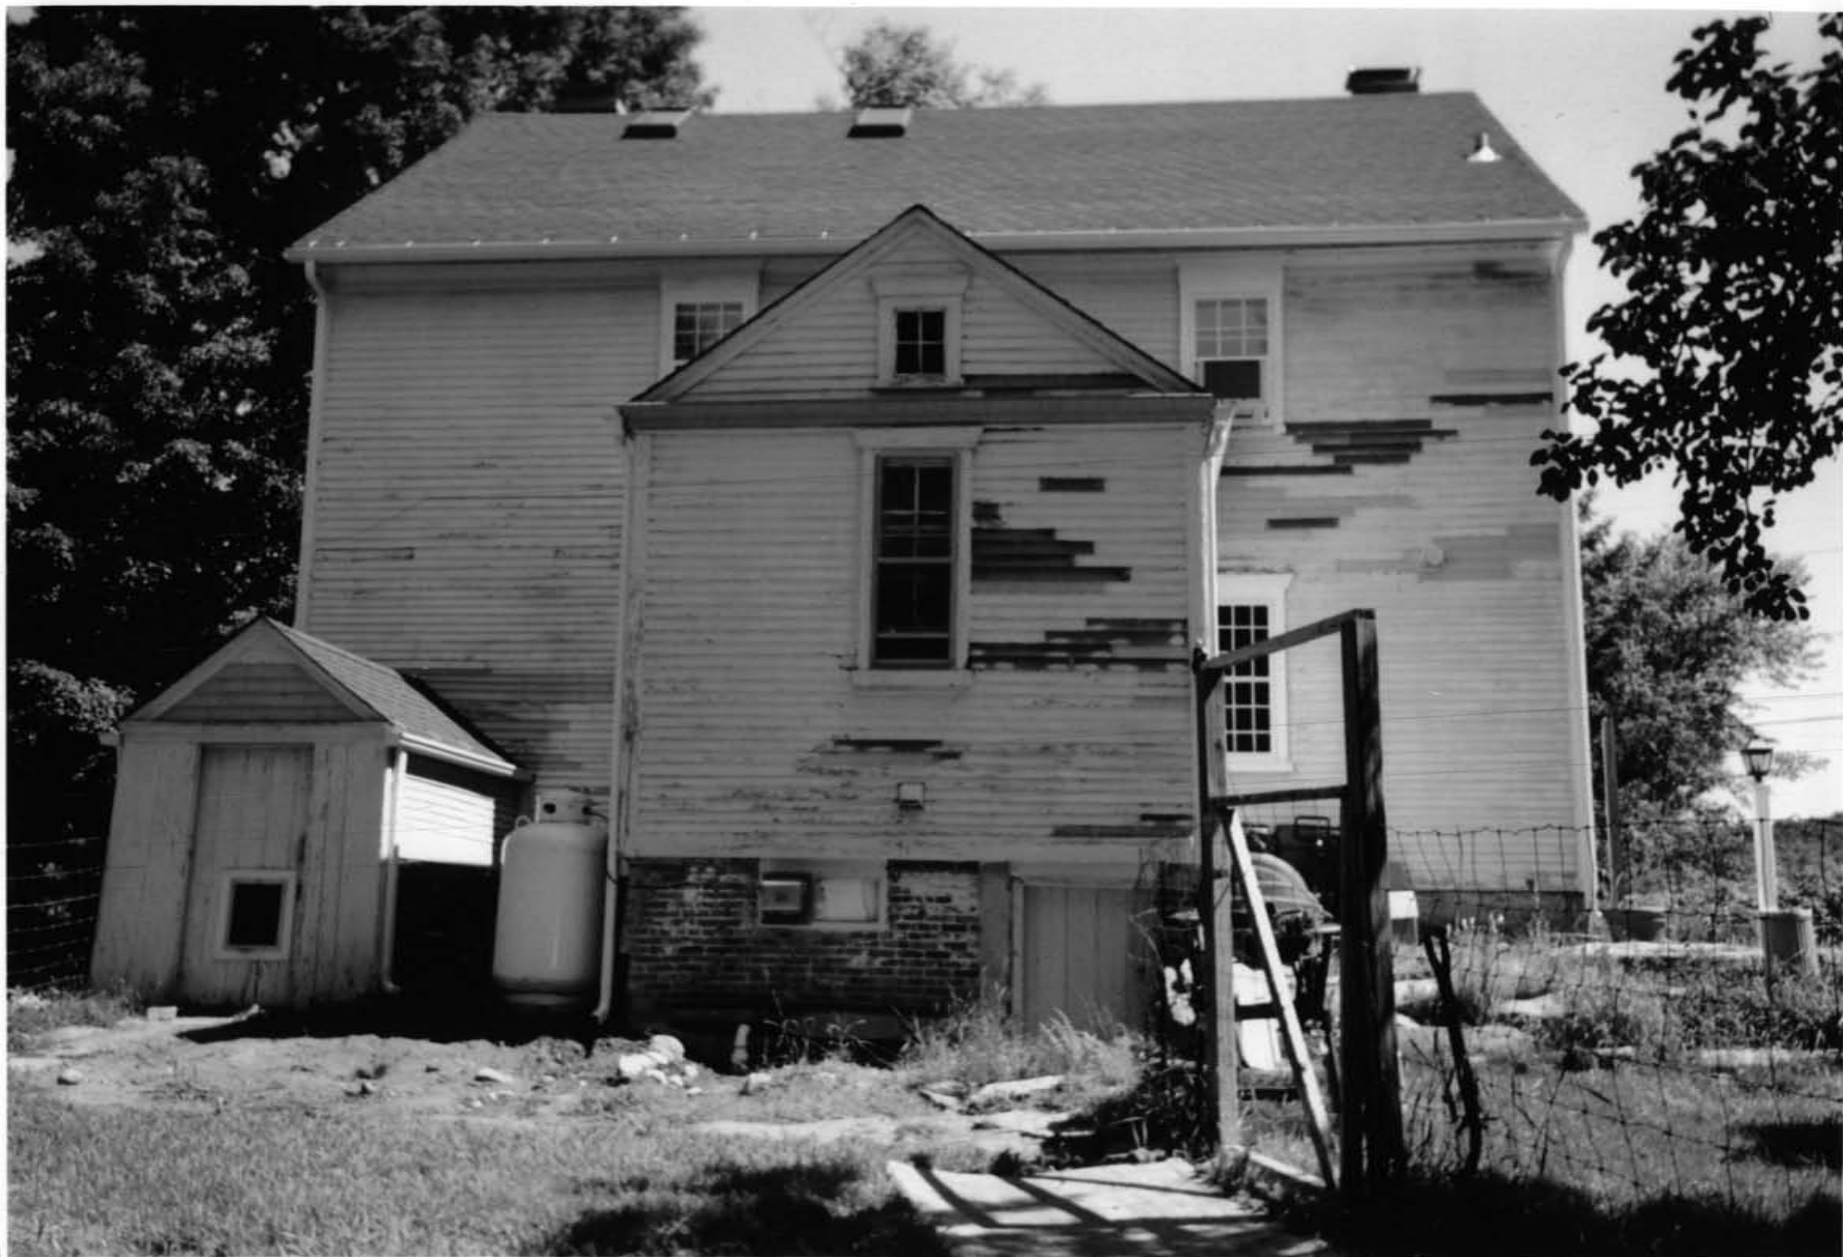
Angell Ballou House
Providence County, Smithfield, RI
Photo # 3 of 10

Photo #3
View: West elevation, looking east.

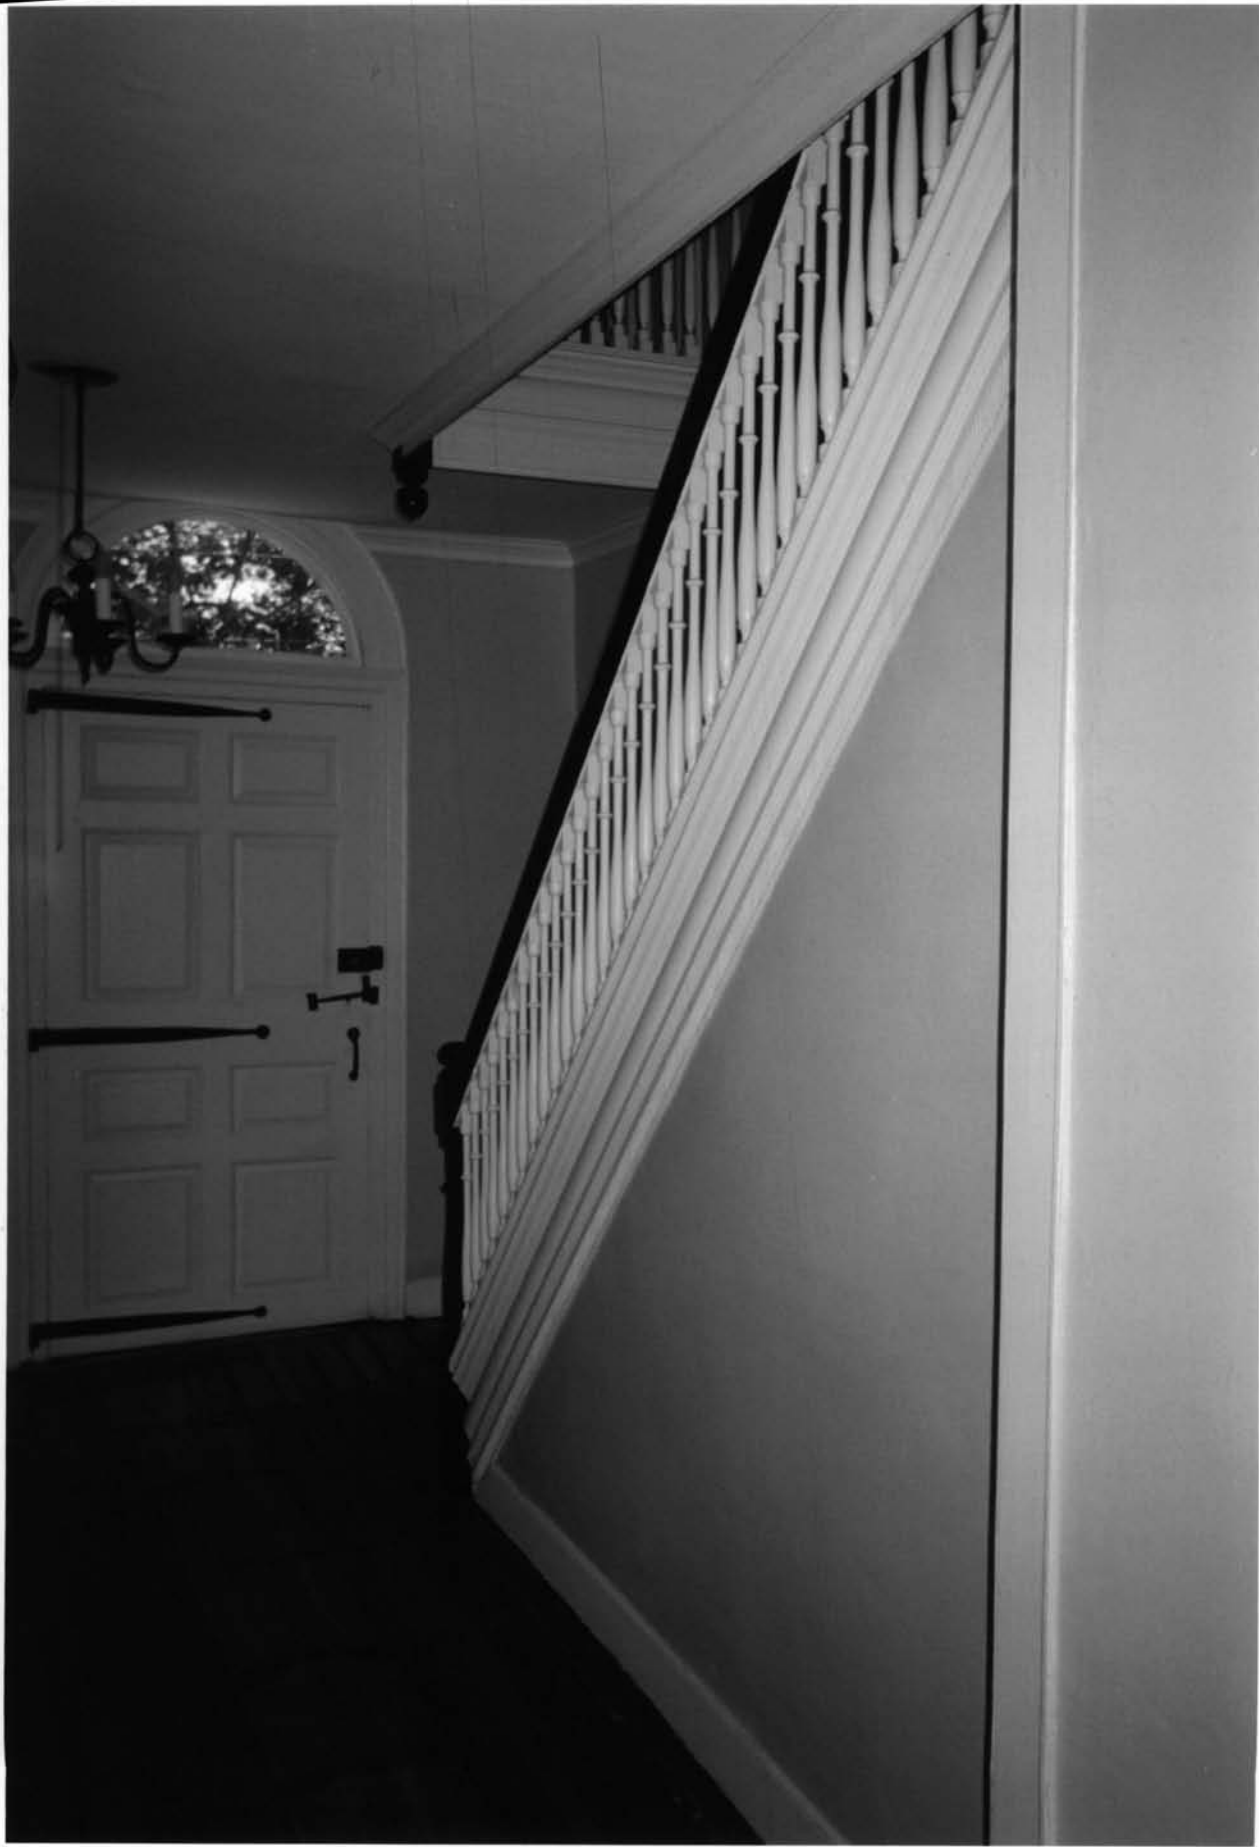
Angell-Balboa House
Pittsvidence County, Smithfield, VA
Photo # 4 of 10

In the front hall, the single-run stair has a closed stringer with a continuous cyma and torus molding, acorn drops, turned newel posts, a molded banister, and closely spaced turned balusters. Three doors lead

Photo #4
View: Center hall stair, looking east.

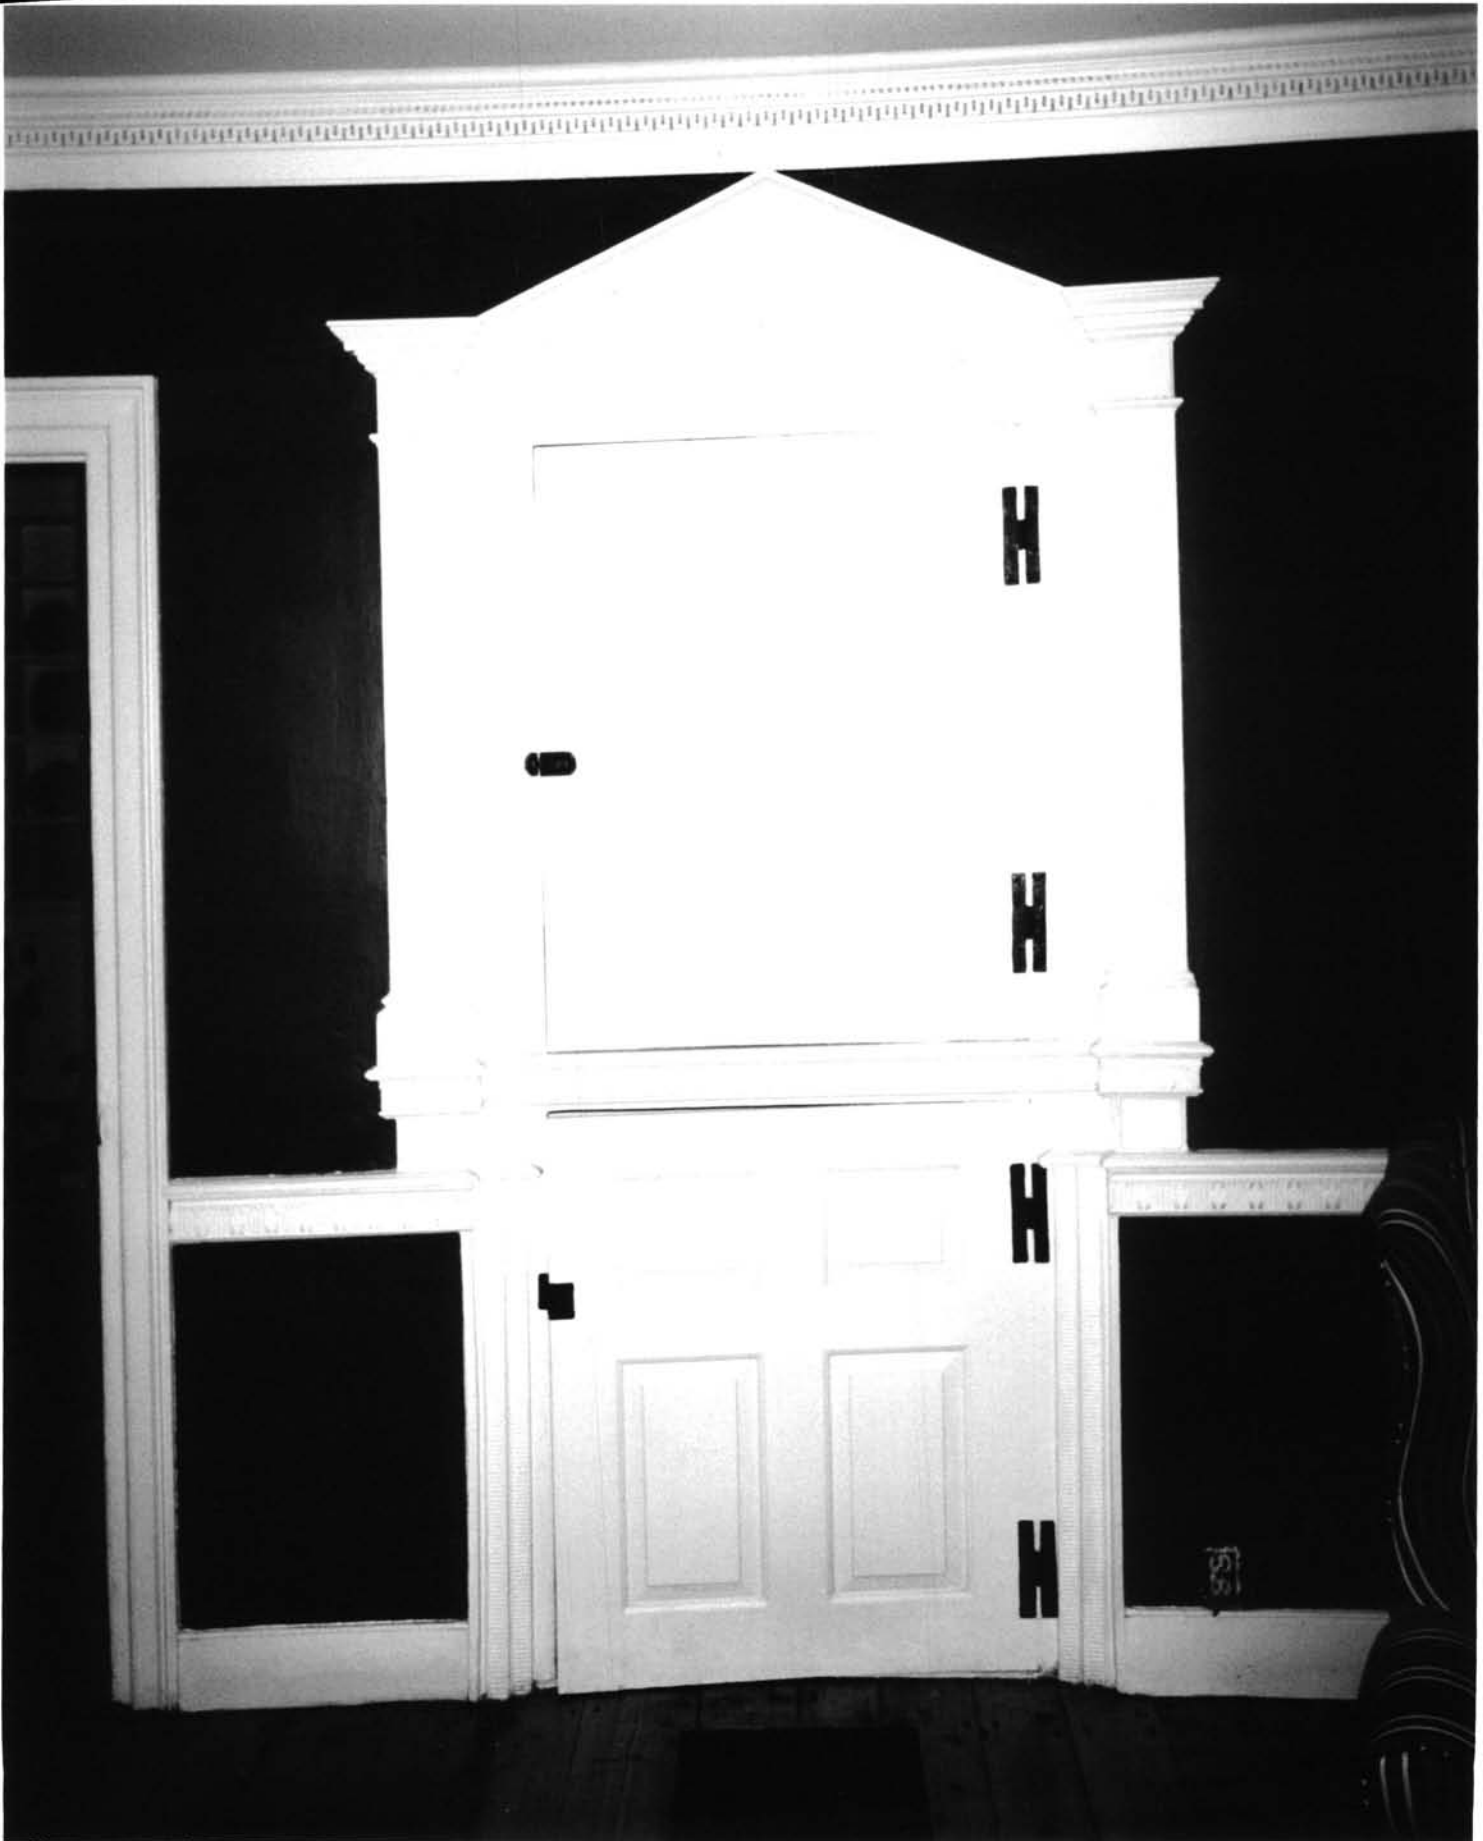
Angel - Ballou House, Providence County, Smithfield, RI Photo # 5 of 10

Photo #5
View: Wall Cupboard, northeast parlor, first floor, looking west.

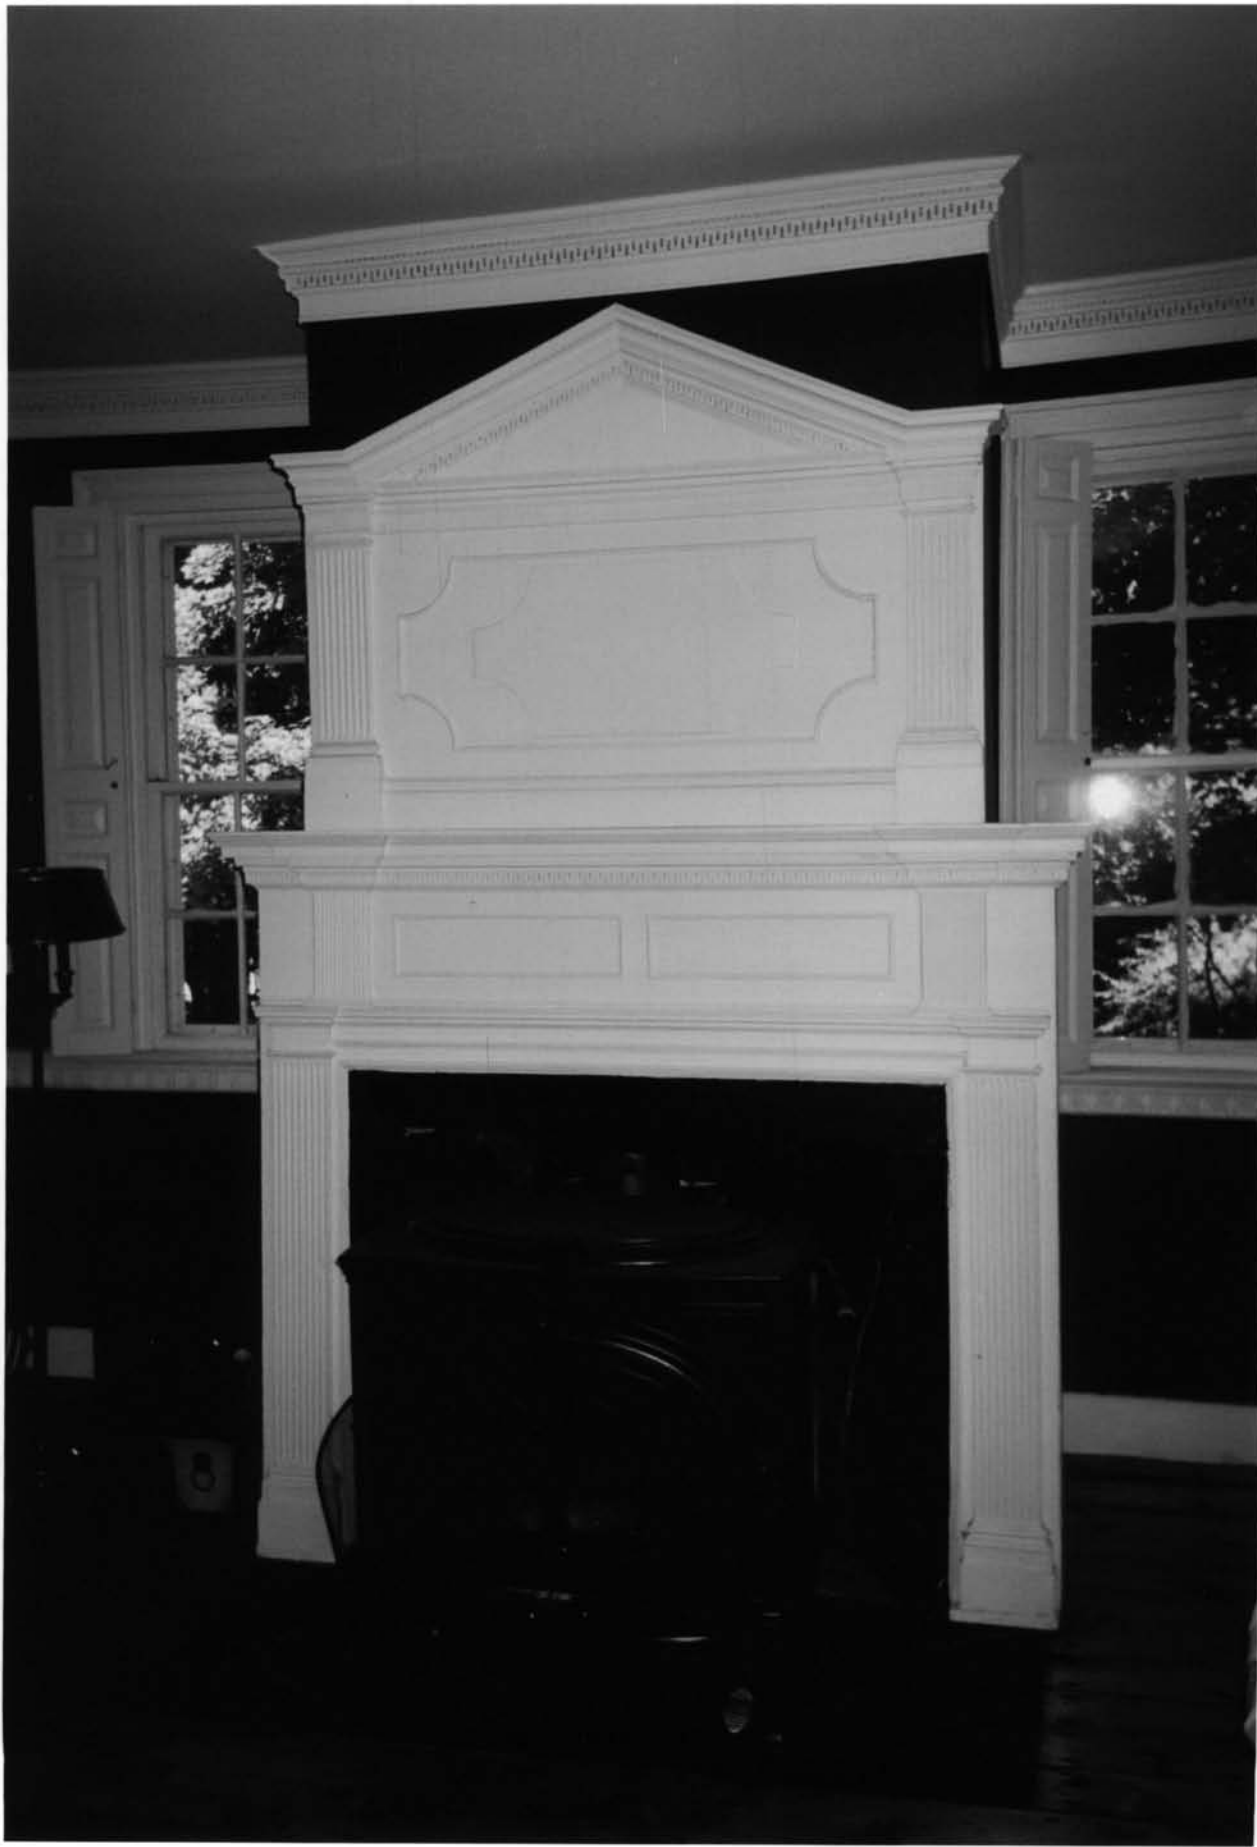
Angell, Balbu House
Providence County, Smithfield, RT
Photo # 6 of 10

Each of the front rooms has a fireplace with Federal mantel. The mantels extend beyond the chimney mass on both sides by a sort of false front; the mantel shelf itself also extends about 8 inches beyond the width of the chimney mass. The overmantels are made up of classical moldings, though they are arranged somewhat oddly (pilasters do not appear under the entablatures they should appear to support, or extend only half-way under their entablatures). The northeast front room has a built-in wall cupboard, with wide single-leaf doors, again oddly proportioned and arranged (perhaps the result of cutting a full-size door to make the cabinet doors). The front rooms have 3-panel interior window shutters with original hardware. Both rooms have beaded, cased corner posts, eight-panel doors (with HL hinges), and molded chair rails. The walls and ceilings are plastered. The floors are of narrow pine boards.

Photo #6
View: Mantel, northeast parlor, first floor, looking north.

The elements of the Federal style, however, are arranged here in an unusual mode. The chimneys are placed in an odd fashion, both in their inset from the end wall planes and their orientation of the wider side toward the façade. The result on the interior is fireplaces which project well into the side rooms. The façade itself is arranged rather mechanically, the window lintels unrelated to the entrance surround. On the interior, the decorative work displays the same unusual features: pilasters do not sit under the entablatures they purport to carry, or, in the case of the mantels, are off-set from each other. Pediments are cut short of the pilasters which would ordinarily appear to support them. The extension of the mantels and fireplace surrounds beyond the edges of the chimney breast is odd, as are the eccentric proportions of the wall cupboard. Many of the same classical elements found in the urbane Federal houses of the period are used here—but they are used by an idiosyncratic and untutored hand. In all, the effect is a charming provincial version of the Federal style.

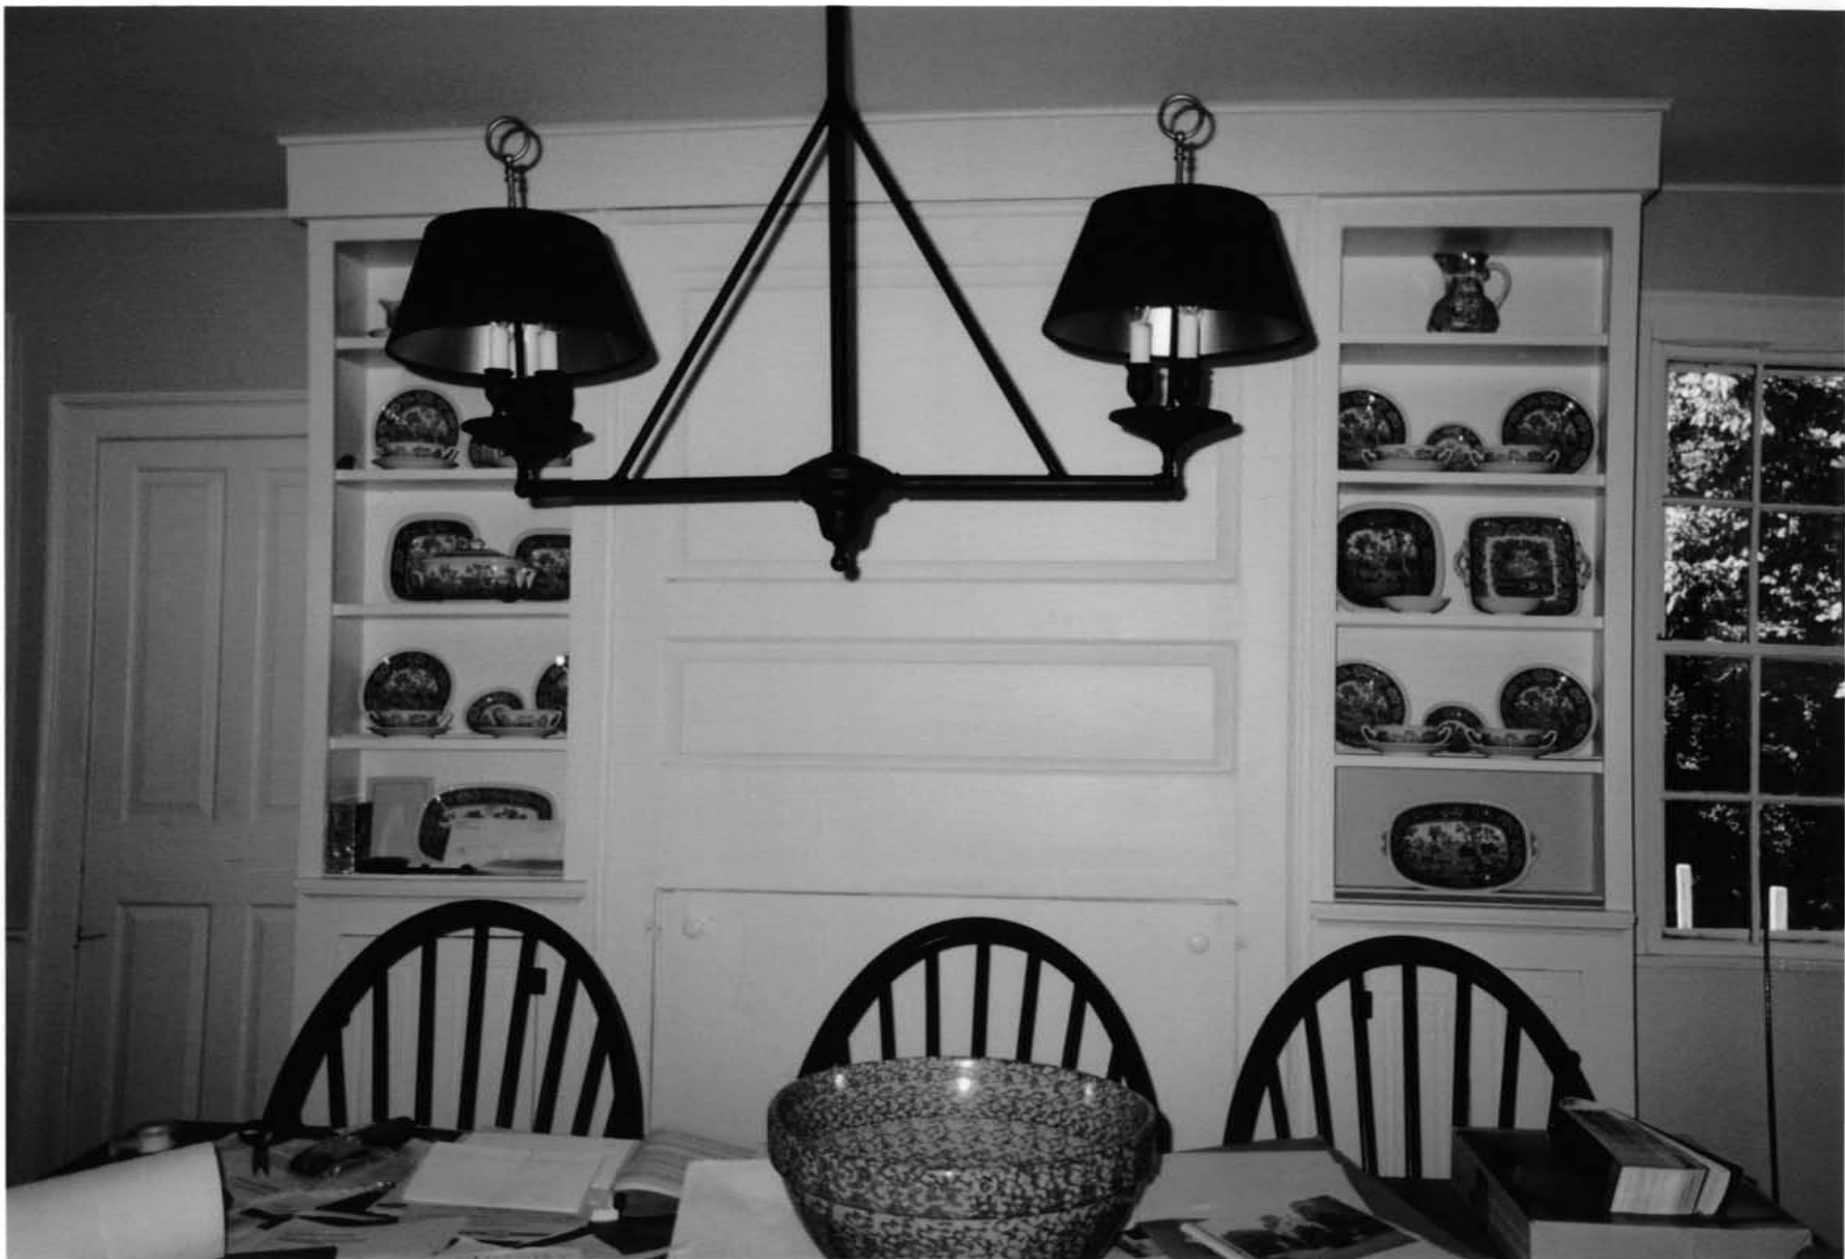
Angell-Bellou House
Providence County, Smithfield, N.H.
Photo #7 of 10

The cooking fireplace was originally on the back wall of the center room. The fireplace and portions of the original chimney have been removed and replaced with a late-18th-century-style chimney breast with cupboards and shelves on each side. Recent restoration work has opened up this chimney and revealed that at least portions of the original fireplace surround remain behind the later work. The kitchen ell is fitted with cabinets and pantry shelving dating from the 1930s.

Photo #7
View: Chimney breast/shelving, center room, first floor, looking west.

known. There is evidence of a cooking fireplace and chimney on the rear wall of the back center room, which has been removed. The kitchen ell may have been constructed when the chimney was removed, probably in the mid-19th century. For the most part, however, this is a well-preserved house. Much of the original finish material remains, including floors, plaster walls, doors, hardware, and woodwork (cornices, mantels, stairs, and paneling).

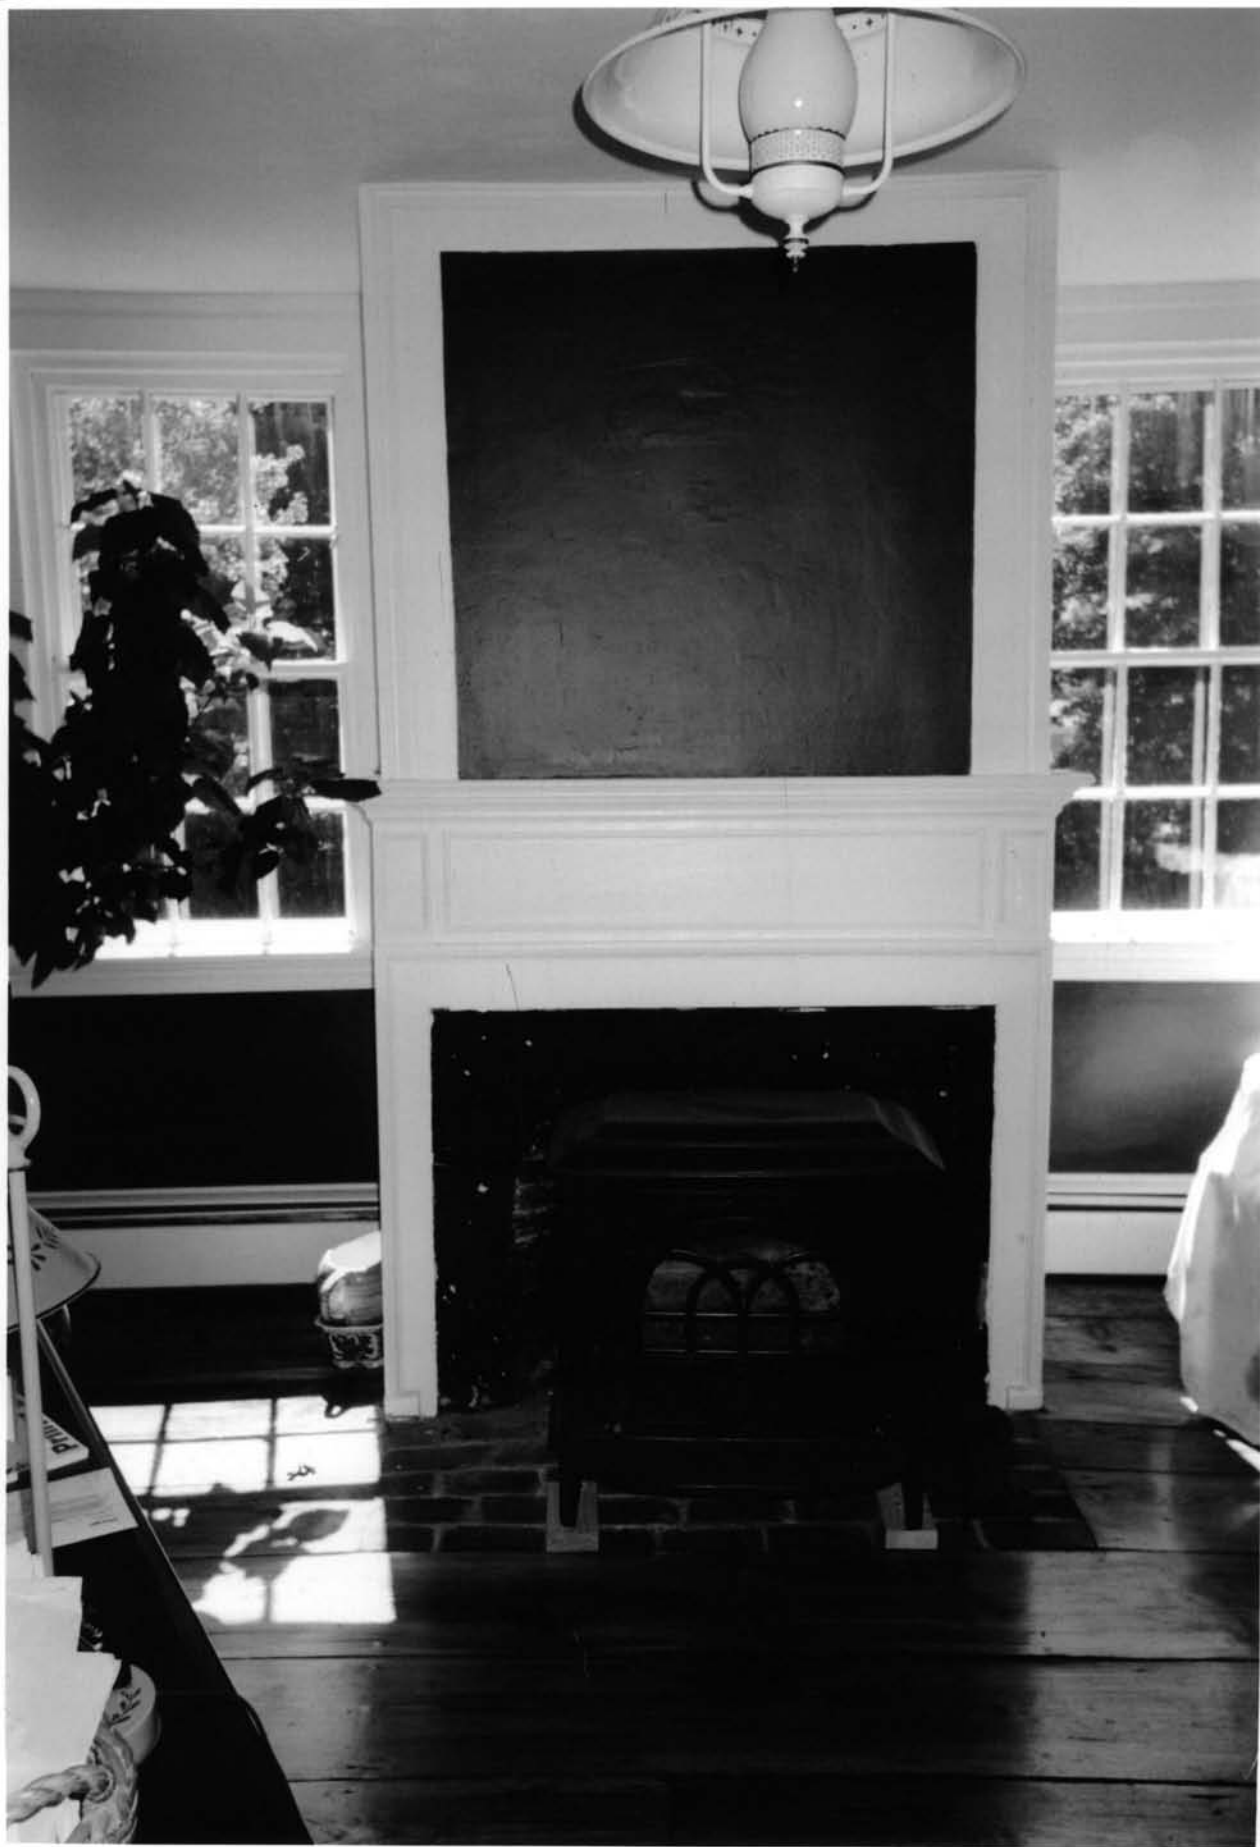
Angell-Balboa House
Providence County, Smithfield, RI
Photo # 9 of 10

Photo #8
View: Southeast chamber, first floor, mantel, looking south.
