**National Register of Historic Places
Registration Form**

historic name: Angell-Ballou House

street & number: 49 Ridge Road

The Angell-Ballou House (c. 1800) is a well-preserved 2½-story Federal farmhouse. It faces east and is located in a semi-rural setting on Ridge Road in Smithfield, Rhode Island. The house has a center hall plan; there is a rear kitchen ell. The house is located on a narrow road and is fronted by a wooden picket fence, granite walkways, and large maples. Dry-laid stone walls mark the boundaries of the 4-acre lot, which declines in grade at the rear of the house; a 2-car garage is located just north of the house.

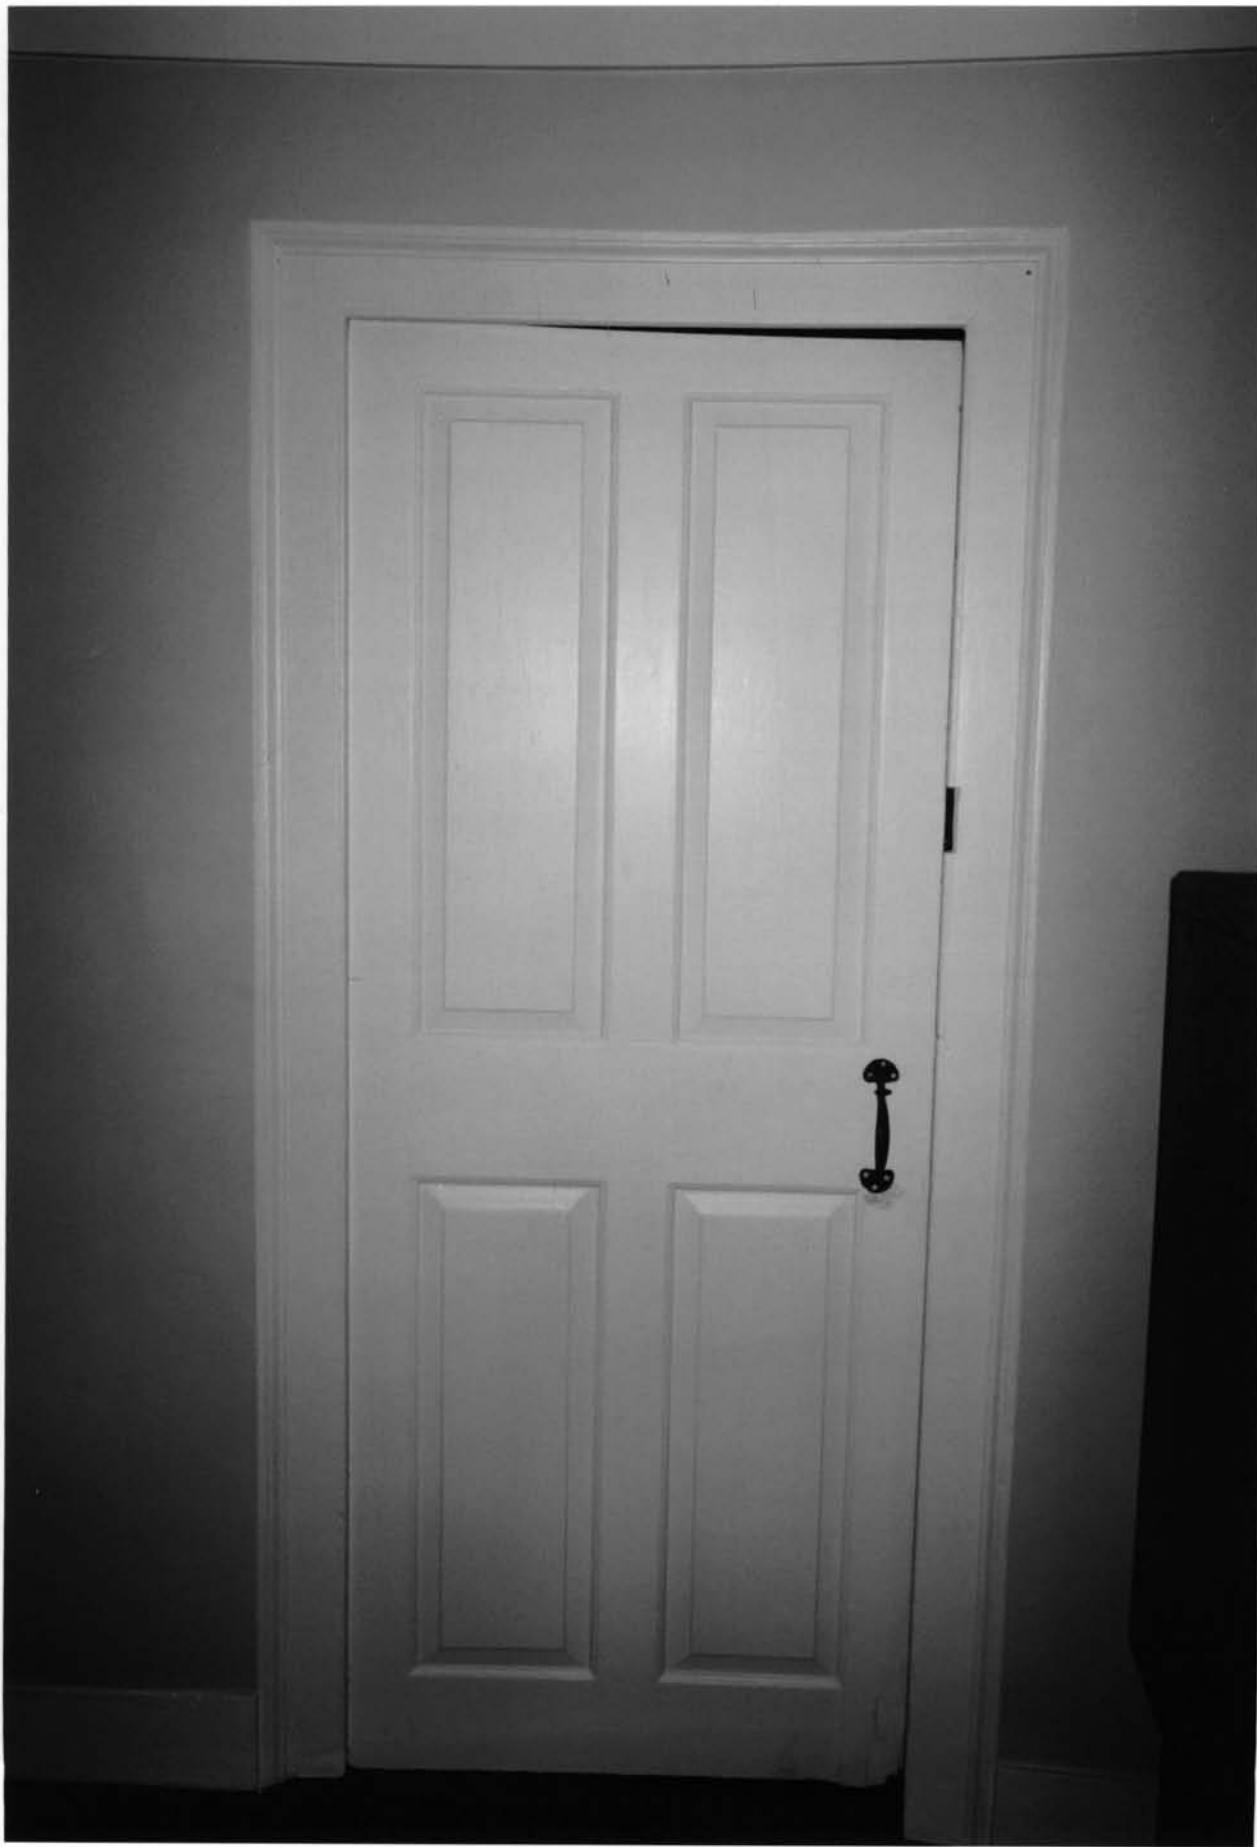
Angell-Ballog House
Providence County Smithfield, RI
Photo #9 of 10

Photo #9
View: Door, second floor, looking east.

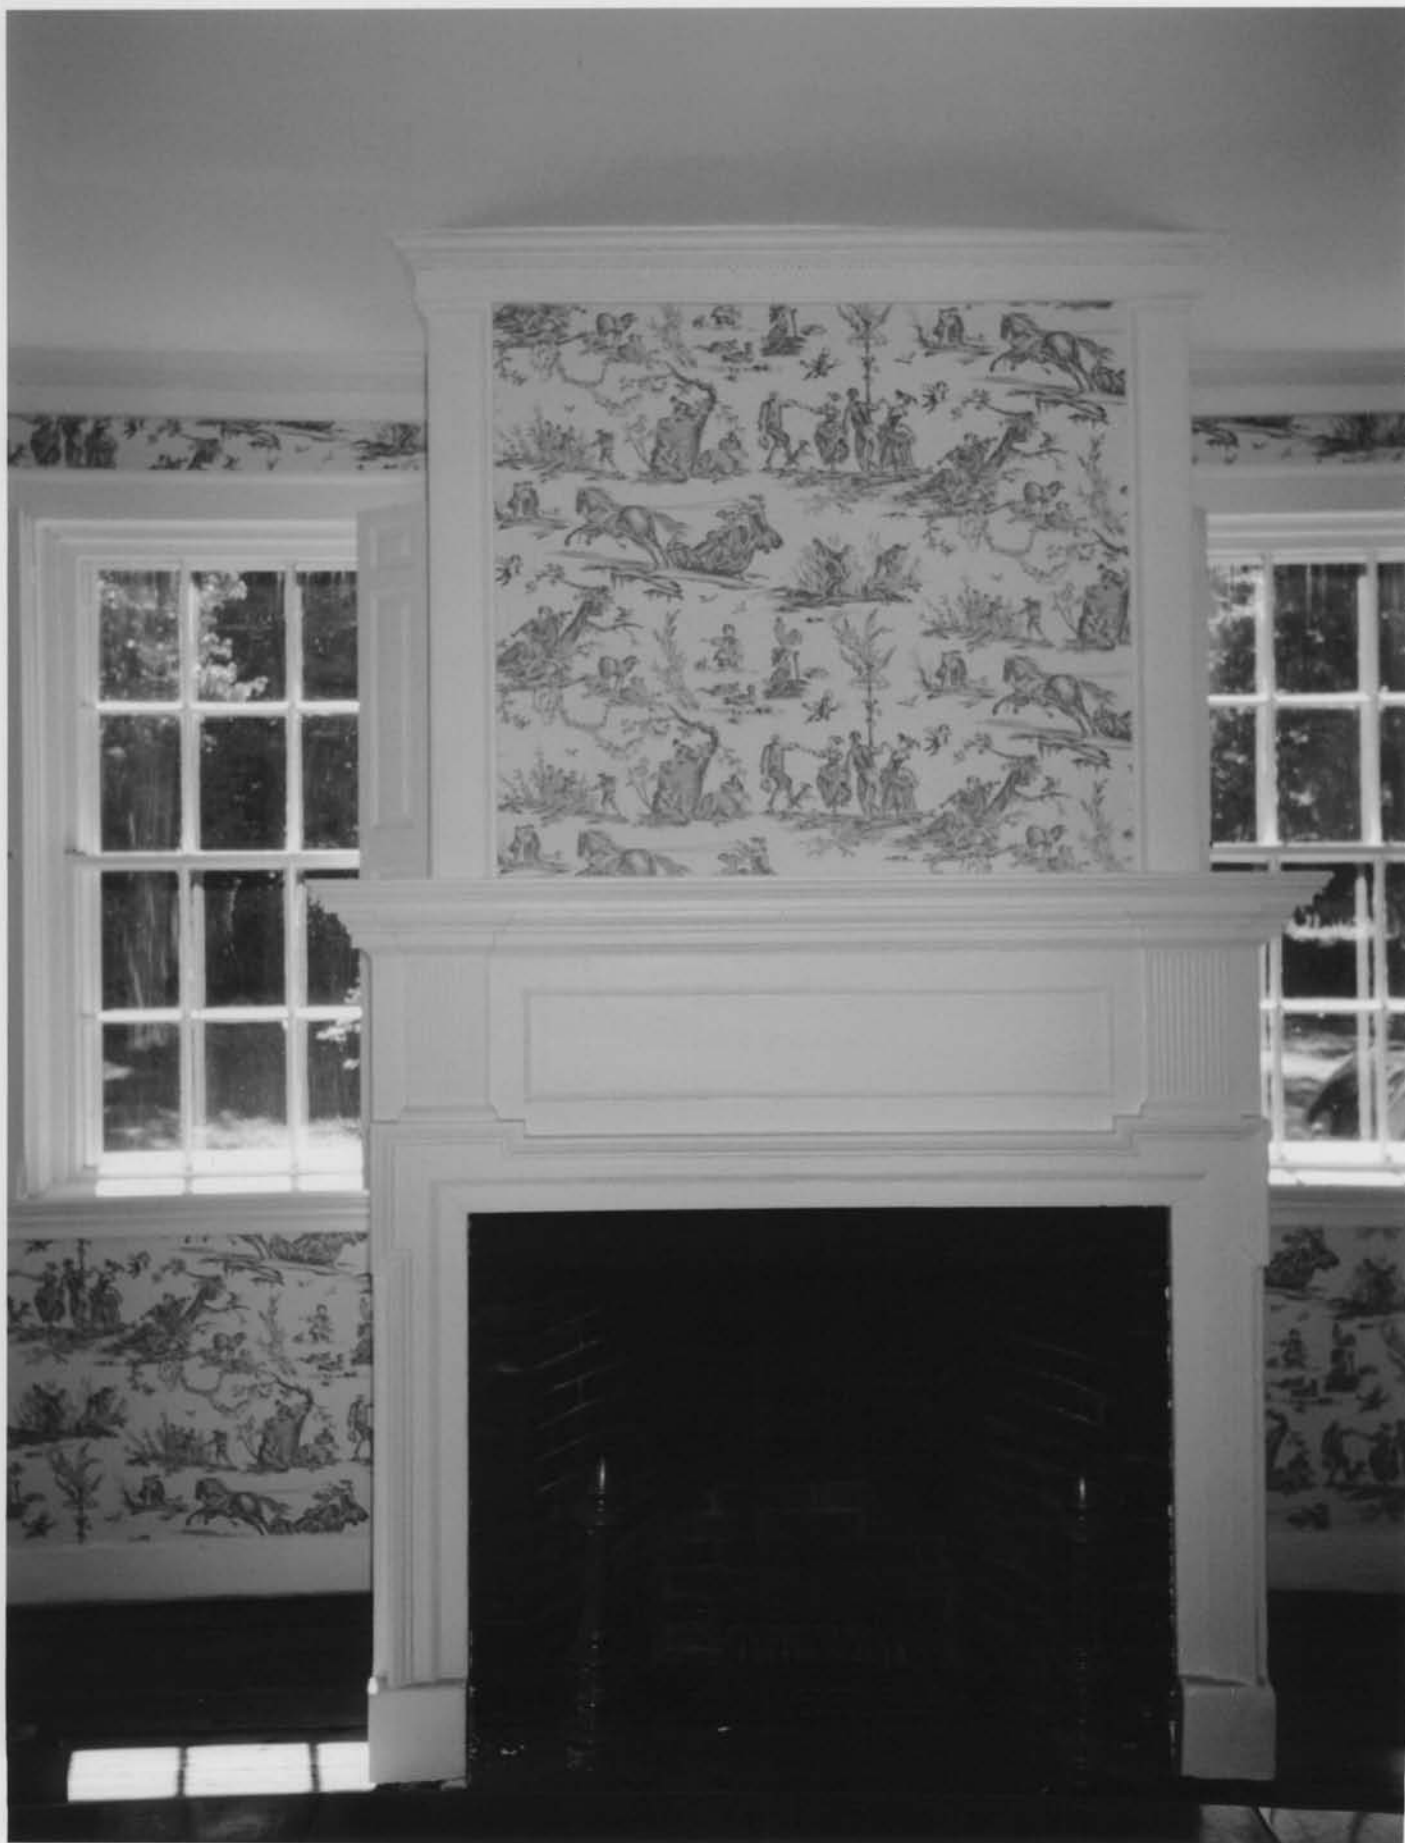
Angell - Ballou House
Providence County, Smithfield, R.I.
Photo # 10 of 10

Photo #10
View: Southeast parlor, second floor, looking south. m
