NATIONAL REGISTER OF HISTORIC PLACES
INVENTORY - NOMINATION FORM
(Type all entries - complete applicable sections)

COMMON:
Eliazer Arnold House

STREET AND NUMBER:
State Route 123 near junction with State Route 126

CITY OR TOWN:
Lincoln

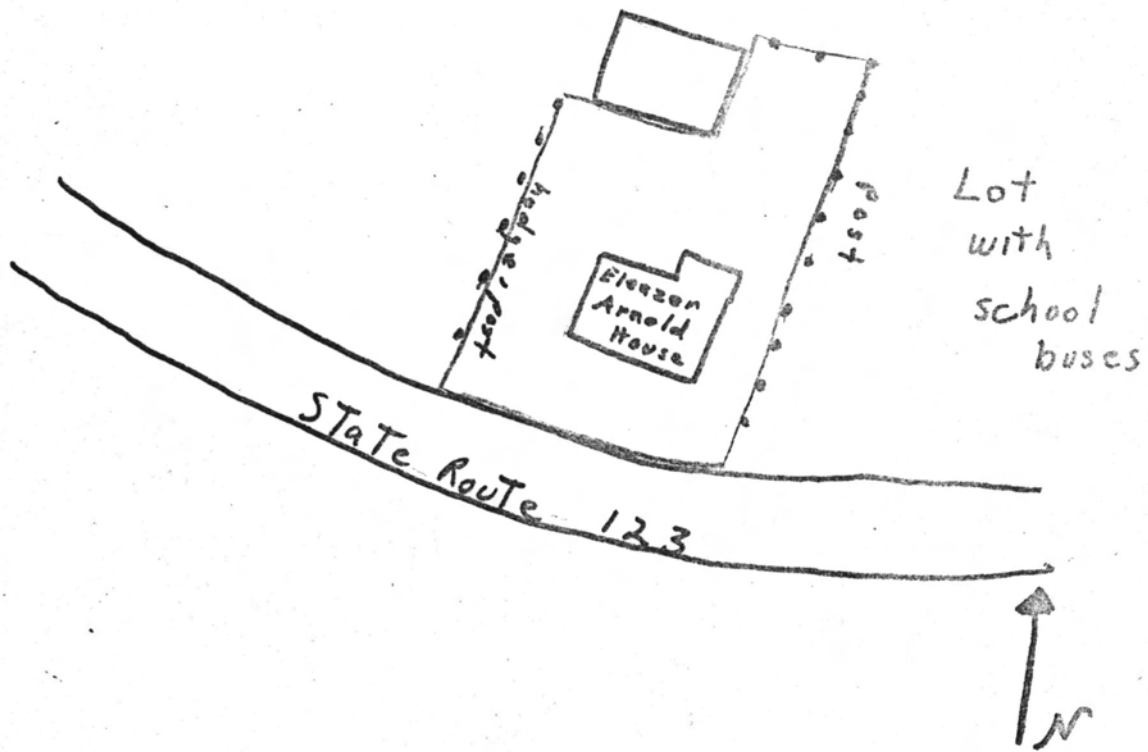
State Route 123

Elmer Arnold House

Hedge Post

Post

Lot with school buses

Located on a small plot of ground on State Route 123 near its junction with State Route 126, the boundary is drawn to include only the Eleazer Arnold House, beginning at the southeast corner where the posts between the lot on the east and the Arnold property meet Route 123, then west along Route 123 to the hedges and posts which mark the western boundary then north along these hedges to a point in line with the house to the northwest, then following along the wall of this house, first east and then north to the end of the wall, then continuing east along a row of posts until they intersect the posts of the eastern boundary at the northeast corner, then south along these posts to the point of beginning, as shown on the sketch map.
