# National Register of Historic Places Inventory—Nomination Form

Type all entries—complete applicable se	ections	·····	
1. Name			
historic Andrews-Luther Farm			· · · · · · · · · · · · · · · · · · ·
and or common Harley Luther Fa	arm

2. Location	····		
street & number Elmdale Road	•	N <u>. A</u>	not for publication
city, town Scituate	N <u>. A</u> vicinity of		
state Rhode Island code	.44 county	Providence	code 007

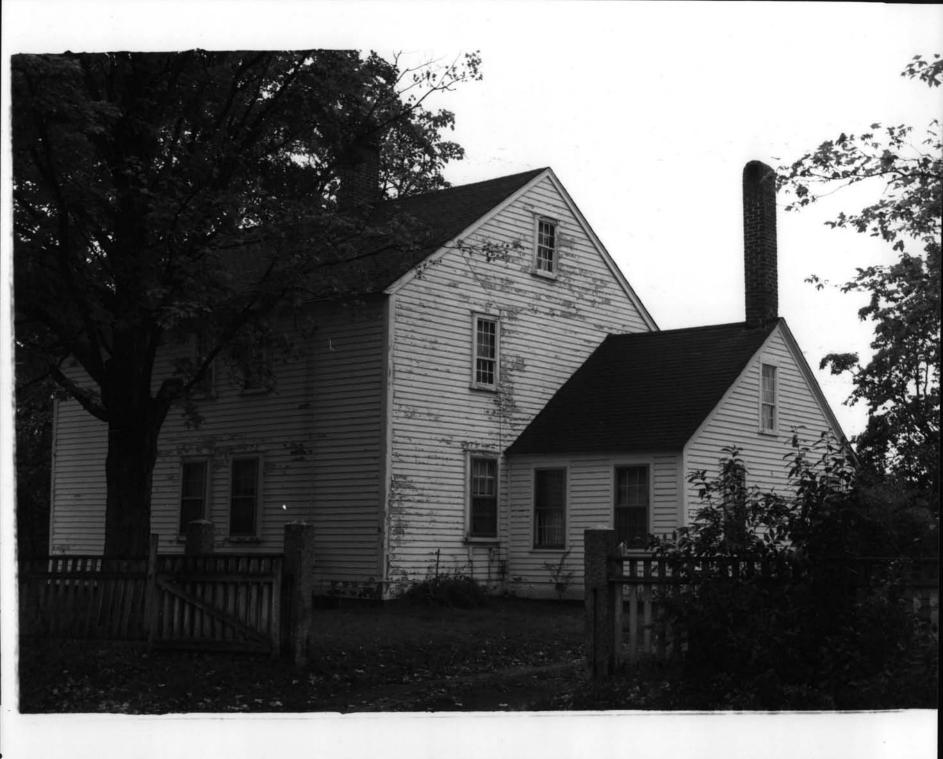
View: South facade.

The Andrews-Luther house is of post and beam construction set upon a low, mortared fieldstone foundation. The exterior is covered by wooden clapboards, and asphalt shingles cover the roof. The original house, which was built c. 1768, is five bays wide, and two bays deep, with a full cellar. The centrally located front entrance is situated on the south side of the dwelling. Subsequent construction modifications include the addition of a small late eighteenth/early nineteenth-century one-story woodshed to the east end of the house, the addition of a one-and-a-half story kitchen ell (c. 1850) to the west end of the house, the enlargement of the front hallway, the addition of a porch running between the kitchen ell and the front door, and the rebuilding of the exterior portion of the center chimney in the early twentieth-century.

Exterior ornamentation is restricted to the cornice molding and the front doorway. The latter was enlarged and rebuilt in a vernacular treatment of the Greek Revival style. Flanking the twentieth-century front door are two slender sidelights with rectangular panes. The lintel over the doorway is topped with a low, plain pediment. Six-over-six sash replace almost all of the windows on the first floor--probably at the same time that the doorway was enlarged. Smaller, framed, nine-over-six sash, which date to the initial house construction, are found in two first-floor windows and throughout the second story. Window frames are simple, pegged plank construction with straight, narrow lintels capping the first-floor windows. Simply molded caps of the second-story windows project from the cornice molding.

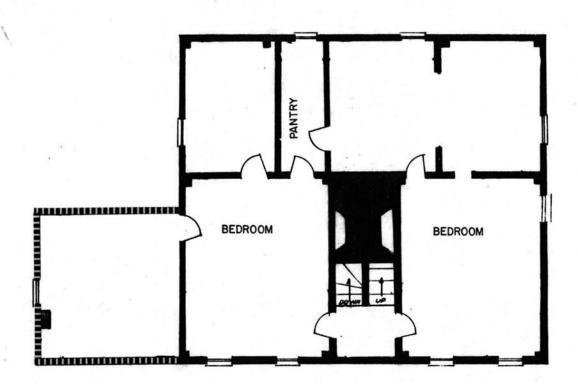
FIRST FLOOR HARLEY LUTHER FARM ELMDALE ROAD, SCITUATE 1985

SCALE I/8"=1'
LEGEND
ORIGINAL
INTERNALATER ADDITION

The house is constructed following the traditional eighteenth-century, center-chimney, five-room plan (see floor plans).
