NATIONAL REGISTER OF HISTORIC PLACES
INVENTORY - NOMINATION FORM

COMMON:
Old Congregational Church

CITY OR TOWN: North Scituate

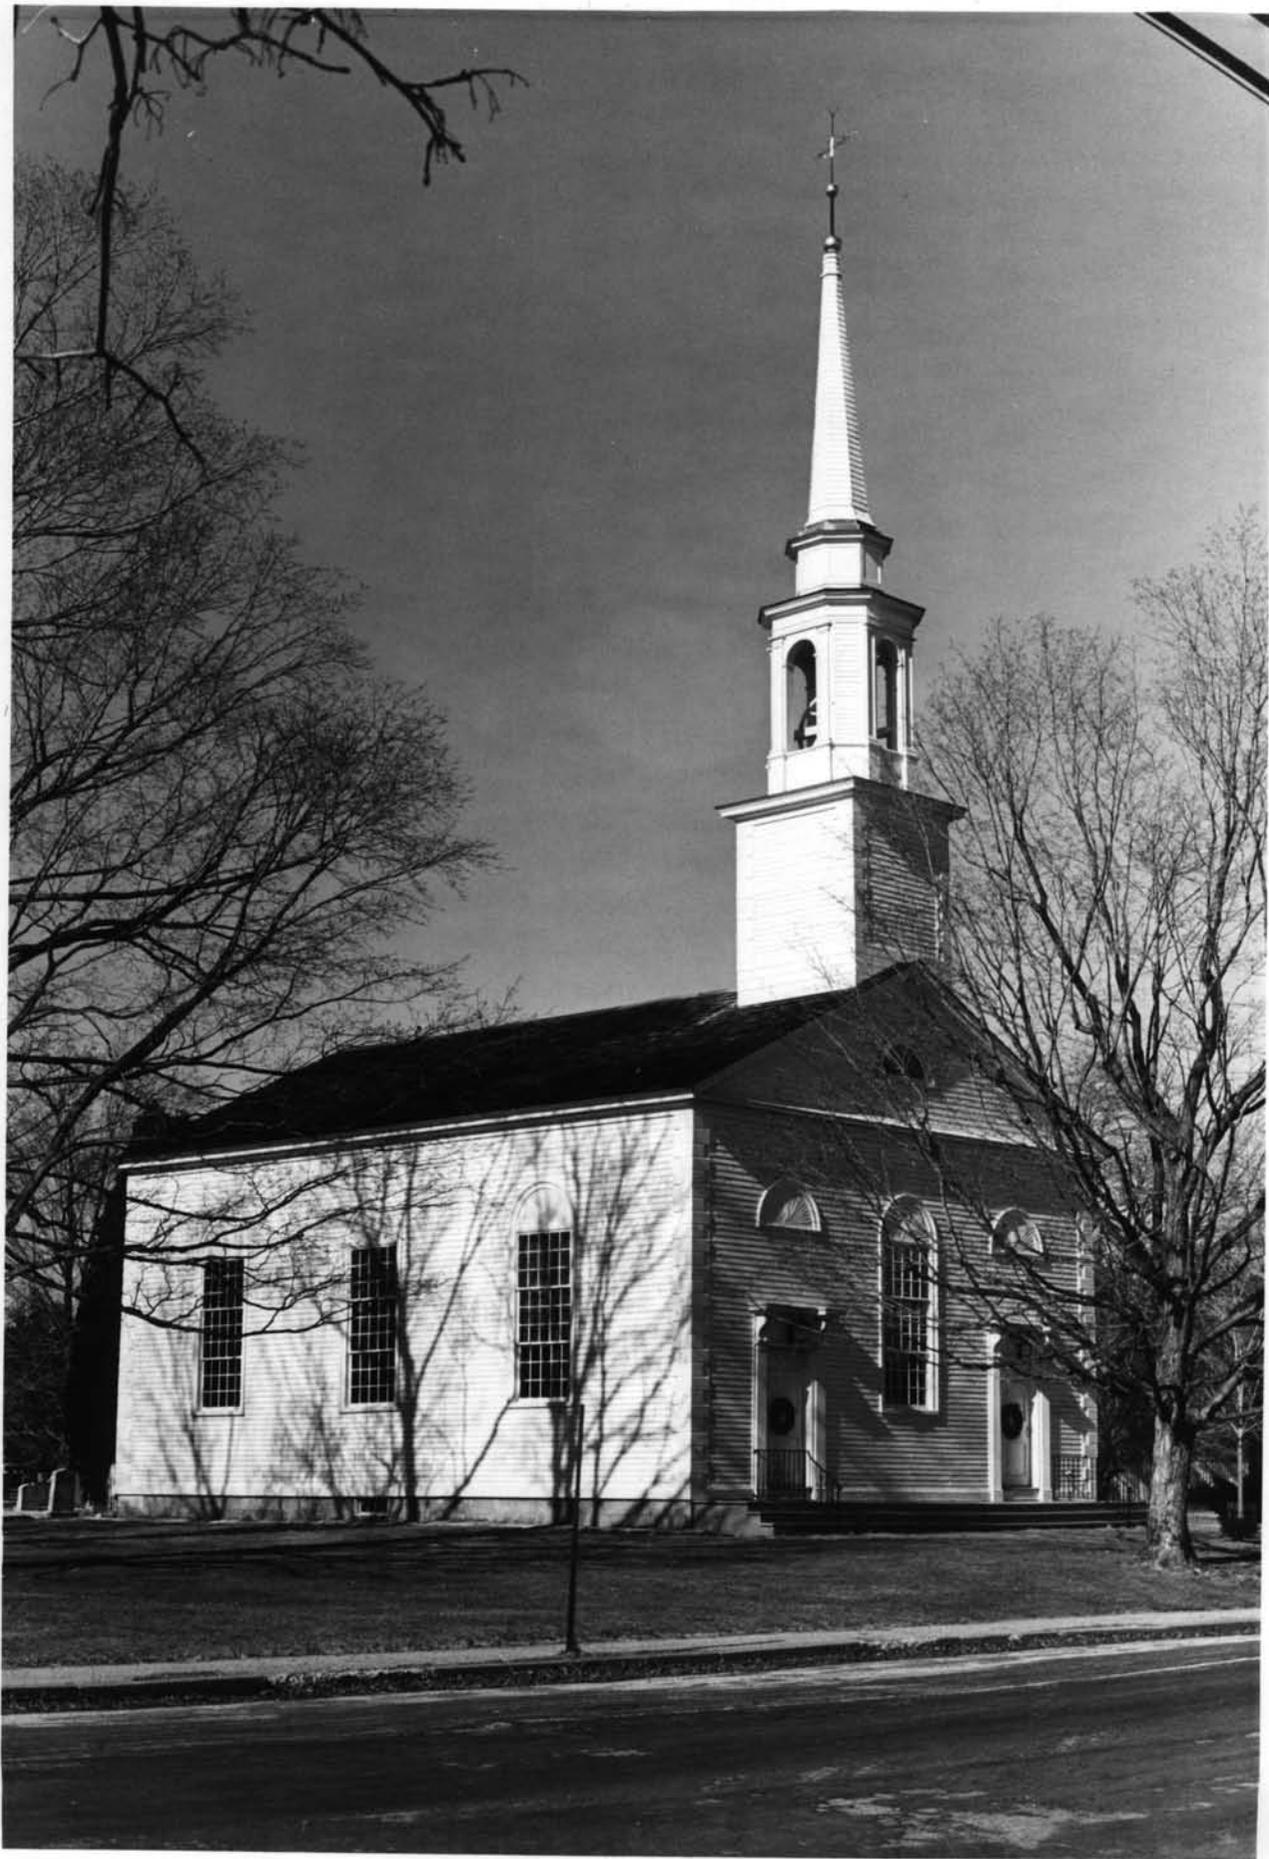
Exterior from the south-east.

The Old Congregational Church of North Scituate, completed in 1831 from designs by Clark Sayles, is on a slightly raised grassy site in the centre of town and has beside it the Greek Revival building of the former local academy and behind it a large cemetery bordered by a picket fence. It is a timber-framed rectangular structure of one high storey upon a low basement of dressed stone and measures about 38 feet by 52 feet. Its roof is a gabled one, end-to-the-street, and is covered by shingles; other exterior surfaces are covered by clapboarding with corner quoins, all painted off-white. At the east end a square tower rises above the gable, and set upon this is an octagonal belfry, smaller in latitudinal dimensions, with four round-headed openings between pilasters. A slightly smaller octagonal base on top of the belfry supports a tapering four-sided spire capped by a gilded finial with two balls and a weathervane. The front (east) elevation has a central window flanked by two doors; sides each have three window openings more widely spaced; the rear has one central window and a new fire-exit door at one corner. All window openings are tall ones, and round-headed in design: they contain triple-hung, 15-pane sash; however, the uppermost, rounded portions are blind and filled by louvred fans. Flanking the central frontal window are two flat-headed doorways whose heavy entablatures are broken-out over paired consoles supported by fluted Tuscan pilasters. At some distance over each doorway is a blind, louvred lunette, and a glazed lunette occurs in each gable.

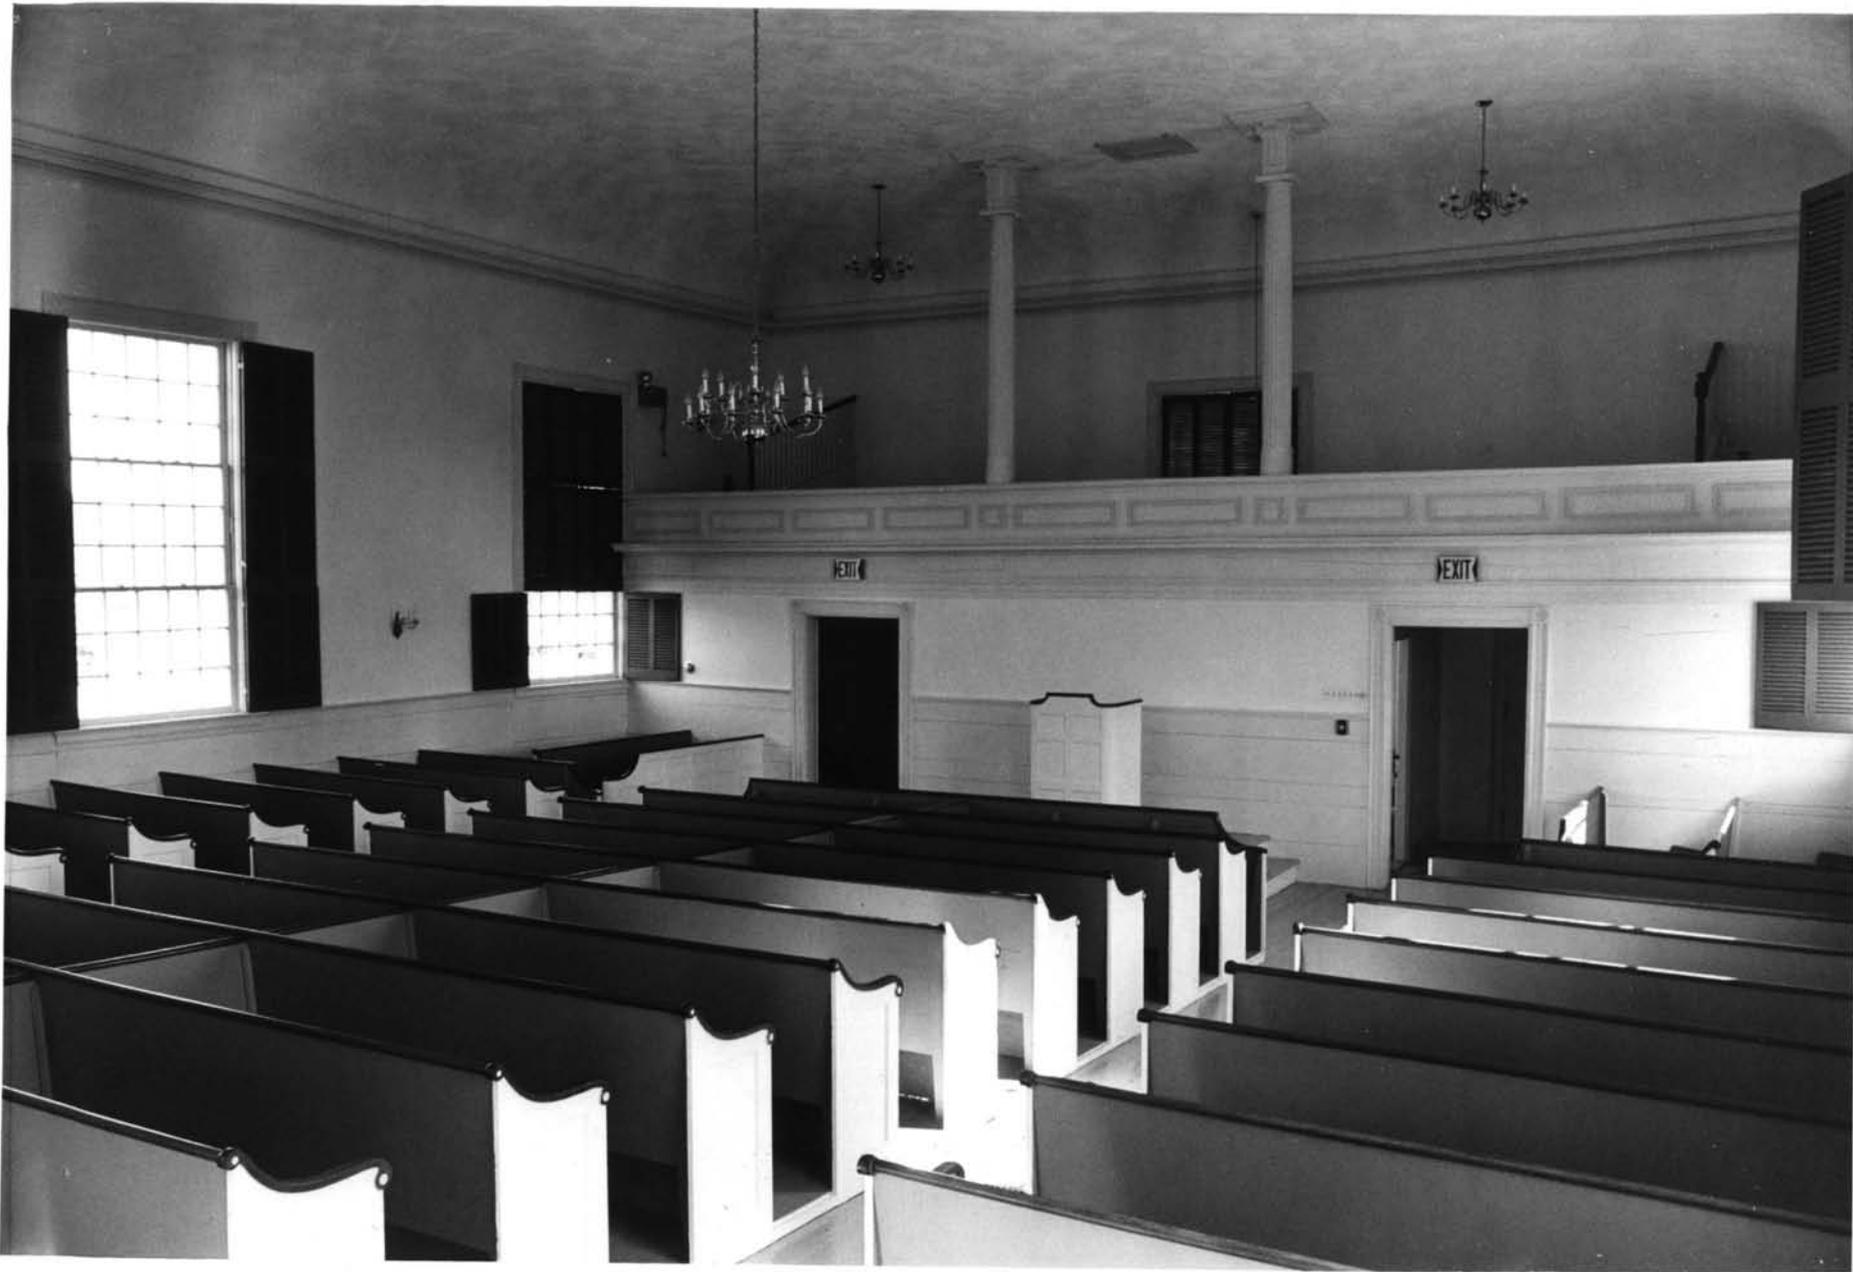
| DESCRIBE VIEW, DIRECTION, ETC. Church auditorium, looking north-east. | | |

Entrance to the church auditorium is gained through two corner vestibules within these doors, and each vestibule contains a stair leading to the choir gallery at the east end of the building. Between these vestibules are the former pastor's study and a storeroom. The three-aisled church proper, or preaching-hall, is a fully-open rectangular space with a high, coved plaster ceiling above a bold cornice of crisp wooden mouldings. Below this cornice, painted cream-colour like all the woodwork in the church, plaster walls are of oyster-grey above a wainscot of wide horizontal boarding. The tall windows are framed by sharp symmetrical mouldings with circle-in-square upper corner-blocks and are equipped with louvred folding shutters painted a deep sage-green. Excepting some corner seating just inside the vestibules, all pews face east towards the entrances and have ends with simple recessed panels, topped by S-curved, mahogany-stained armrests. The frontals of the first-row and corner pews are capped by a stained rail and are concavely scooped at their corners. The pews originally had doors, which are no longer present and will not be replaced; they are now furnished with cushions of a green not far from the colour of the interior shutters. In this room, acoustics are fortunately--if by chance--excellent, and provision for vision and attention to devotions was carefully arranged when building, as the basement framing gives the floor an intentional, gentle slope from west to east.

screen-wall runs the panelled frontal parapet of the choir gallery, which supports two symmetrically-placed Tuscan columns, each with its own square bit of full entablature. These rise to the ceiling but appear to exist only for decorative effect, and it is interesting to note that they are reeded rather than fluted--a treatment frequently favoured by Elias Carter, with whom Clark Sayles, the architect, had trained. From a carved rosette in the centre of the ceiling (replacing a disintegrated plaster rosette), hangs a brass chandelier, a reproduction substituting for the original and now-lost one, and there are brass wall sconces.

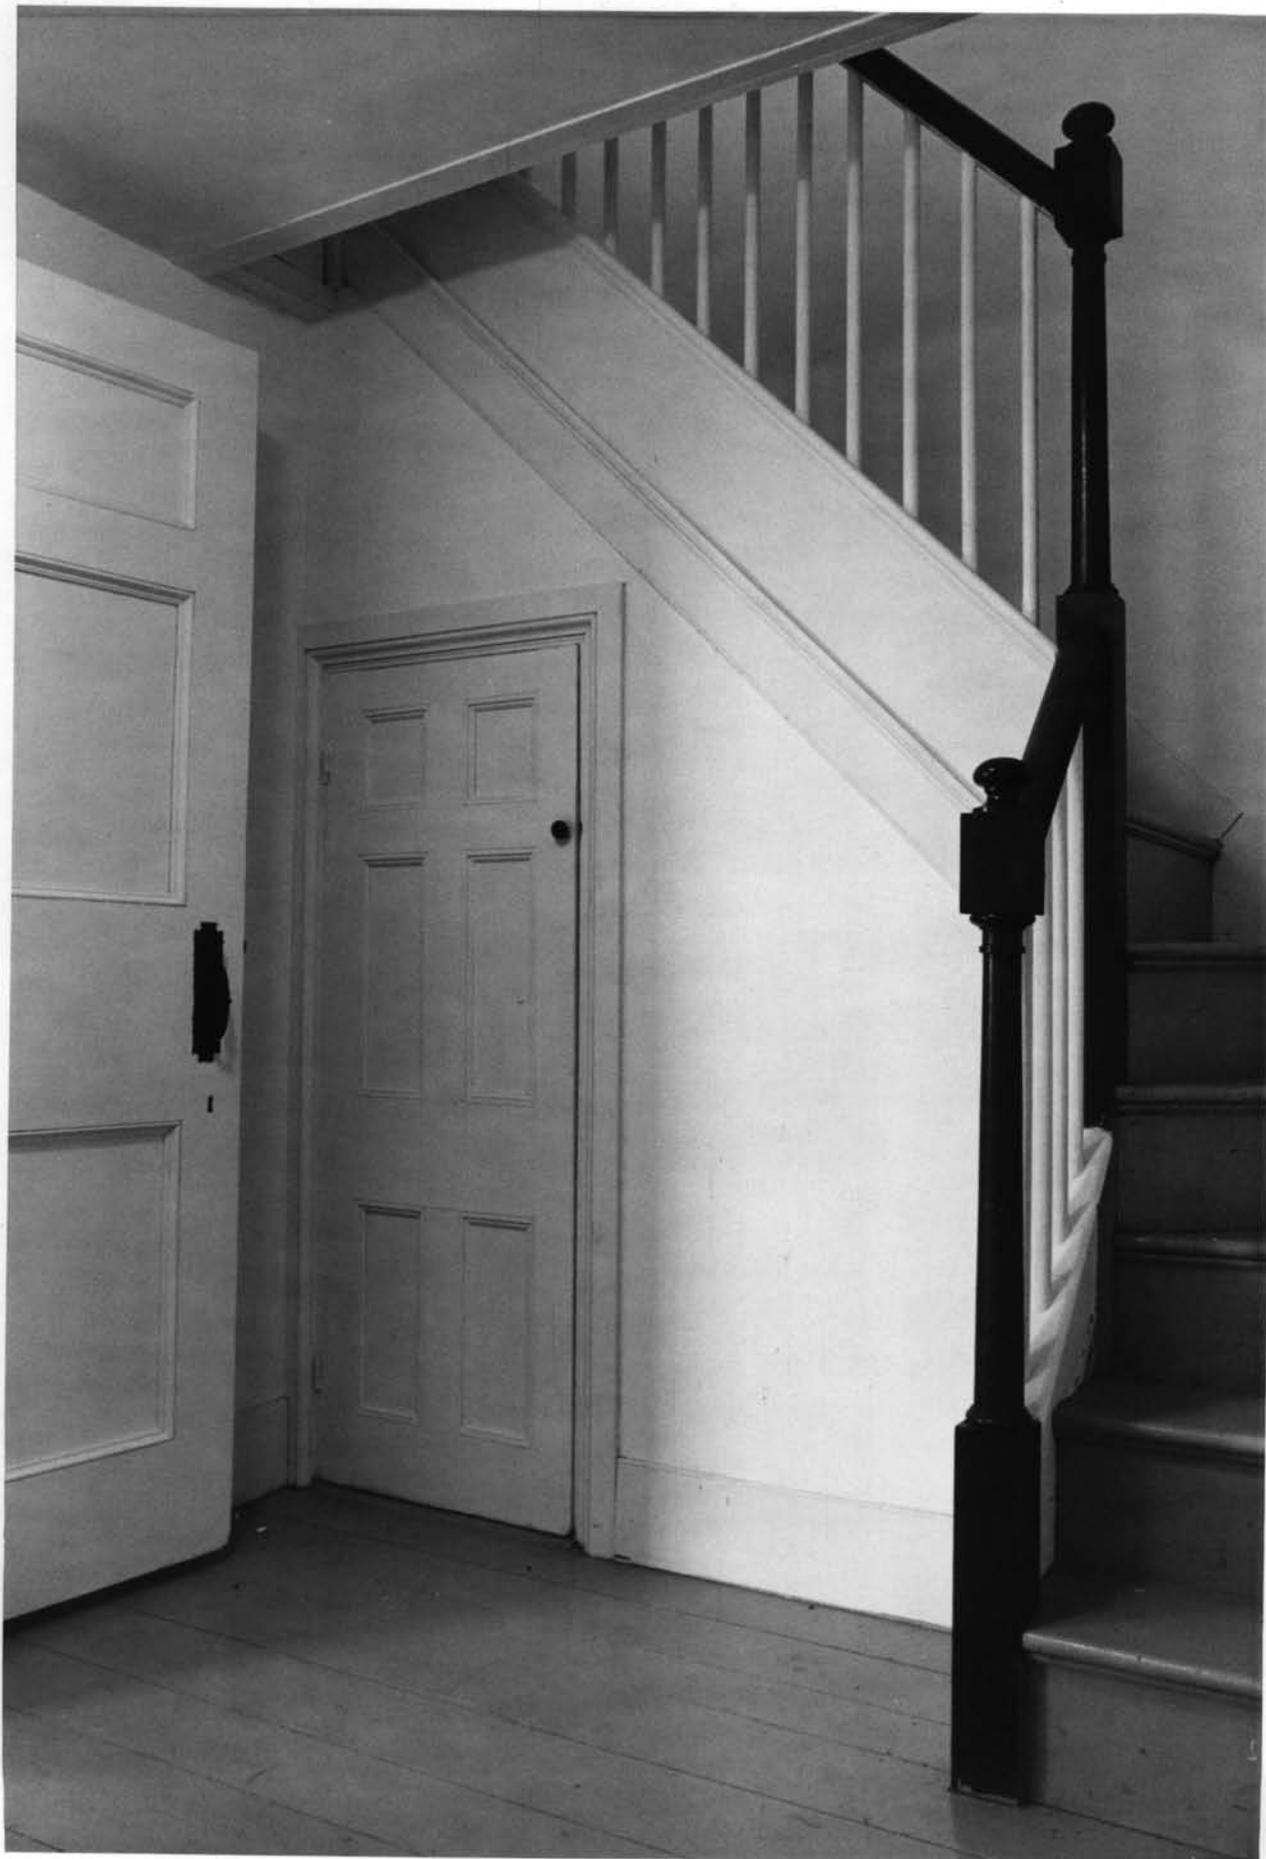
Detail of one of the two frontal vestibules and staircases.
