#### National Register of Historic Places Registration Form

1. Name of Property
historic name: <u>Rodman, General Isaac Peace, House</u>
other name/site number:
2. Location
street & number: <u>1789 Kingstown Road</u>
not for publication: <u>N/A</u>
city/town: South Kingstown vicinity: N/A
state: <u>RI</u> county: <u>Washington</u> code: <u>009</u> zip code: <u>02879</u>
3. Classification
Ownership of Property: <u>Private</u>
Category of Property: <u>Building(s)</u>
Number of Resources within Property:
Contributing Noncontributing
2     0     buildings       0     0     sites       2     0     structures       0     0     objects       4     0     Total
Number of contributing resources previously listed in the National Register:  Name of related multiple property listing:  N/A

#### Description

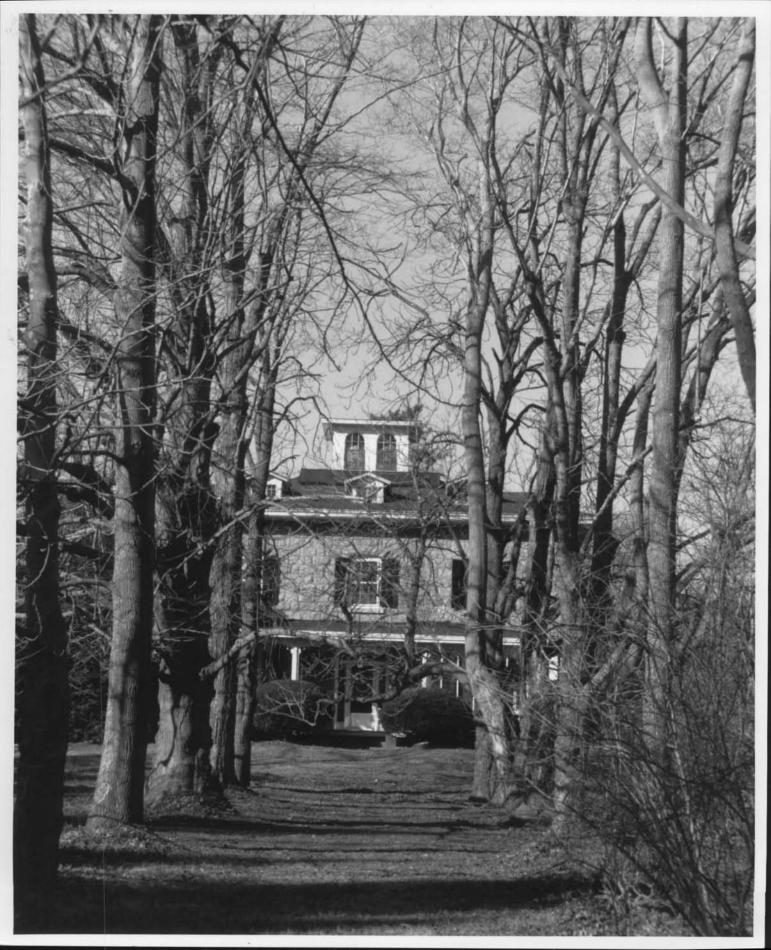
Isaac Peace Rodman House Peacedale, RI View of facade, looking north from tree alley

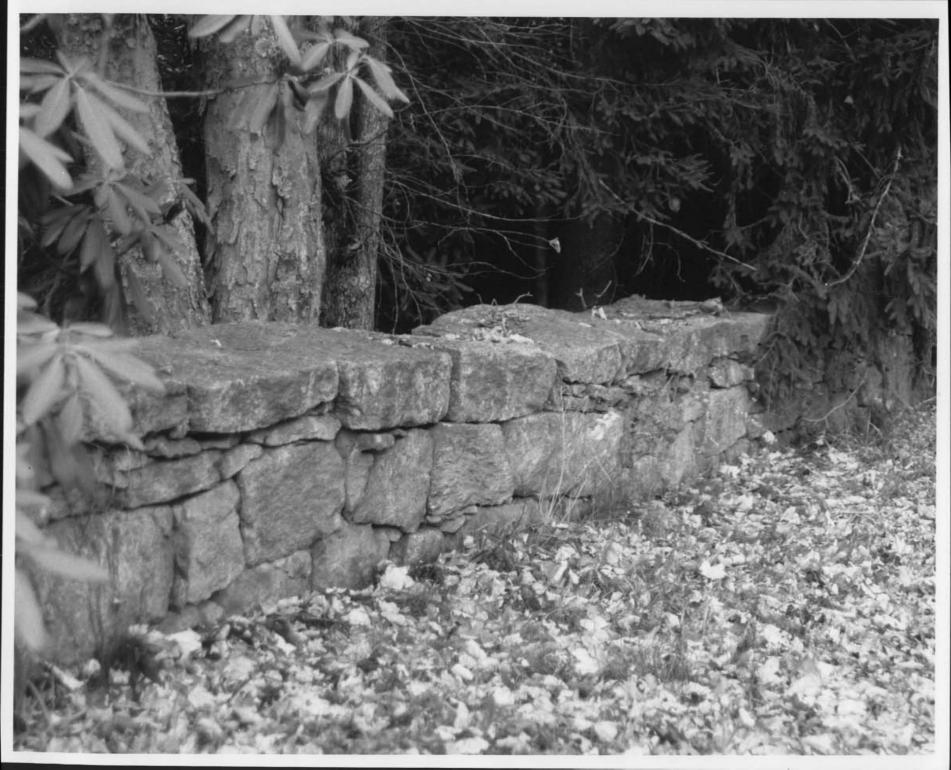
Isaac Peace Rodman's House Peace Dale, RI

Detail of stone wall surrounding the property

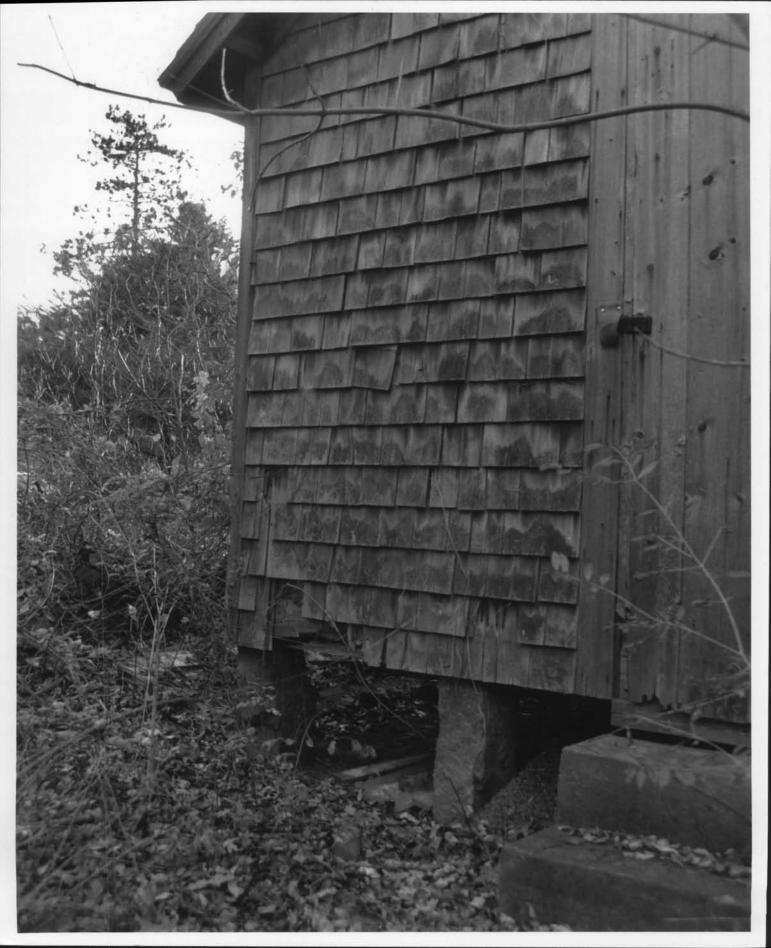
Isaac Peace Rodman's House Peace Dale, RI Detail of corn shed

The Shed/Corn Crib is set some distance north of the house at the edge of a dirt cart path leading eastward from the shed and bounded on both sides by a field stone wall. The northern wall terminates just east of the shed; the southern wall is continuous and has two granite gate posts at a break opposite the shed. The building itself is a 1-story, gable-roof, woodframe structure covered with shingles and raised on granite footings. Its construction suggests that it dates from the mid-nineteenth century and it may be the oubuilding indicated on an 1895 map (Everts & Richards 1985).

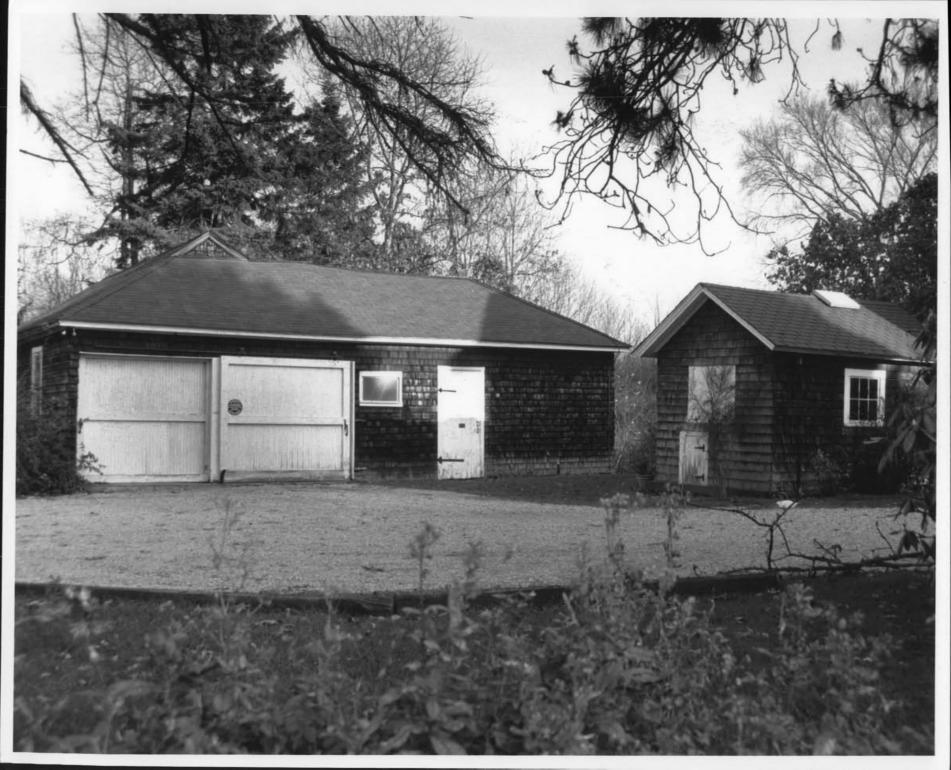
Isaac Peace Rodman's House Peace Dale, RI Outbuildings: garage, workshed and pumphouse (stable is in the back)

The Pumphouse is located approximately 10 feet from the northeast corner of the service ell. A small, gable-roof, shingled structure, it contains a pump and motor patented in 1903. The Pumphouse and pumping equipment were most likely put in place soon after 1906. It supplied water to the storage tanks in the basement for household use, along with the attic cistern, and also connected to a system of outside buried water lines servicing the garden areas.

The Garage/Stable/Workshed, located approximately twenty feet northeast of the Pumphouse, consists of three distinct structures either joined together, or added onto. All are of wood construction, sheathed in shingle, and date from the early twentieth century. The 1-story workshed area, with its hip roof, is the southernmost of the structures; the north exterior shingled wall is visible within the garage attached to the north. The 1-story garage is constructed of bolted Y-shoulder posts. The lower

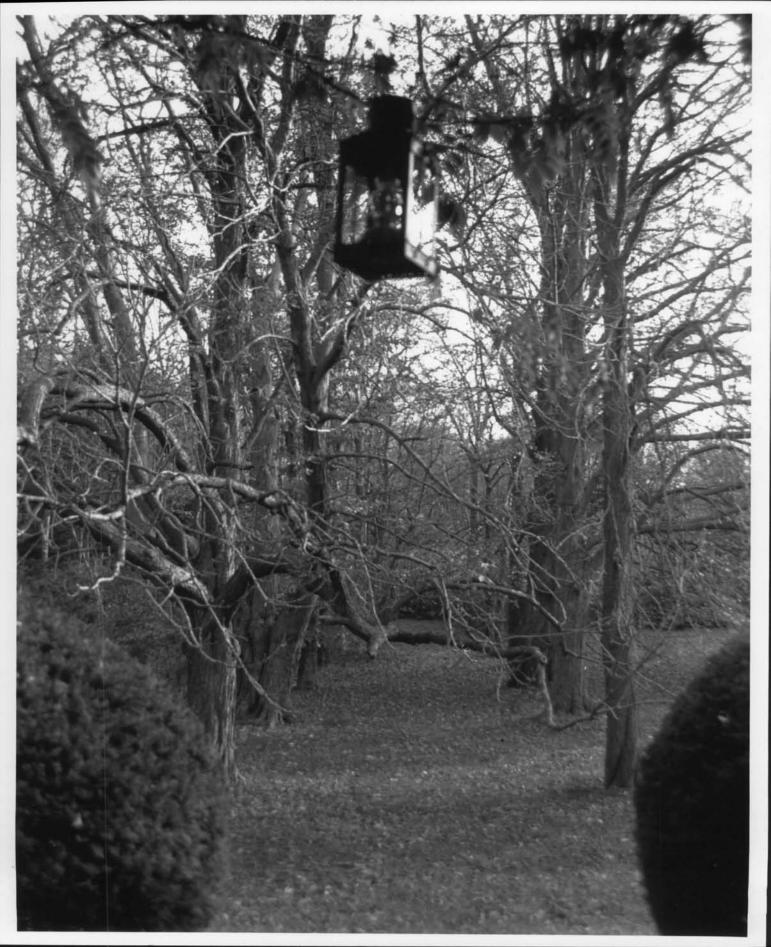
Isaac Peace Rodman's House Peace Dale, RI View of the tree allee, taken from the front porch (South)

Originally, the main approach to the house was no doubt from Saugatucket Road, through gate posts which remain today, and up the 250-foot-long gentle slope of the alley of trees. The trees consist of different species (chestnut, maple, linden, tulip, etc.) arranged in like pairs; several, including a massive chestnut near the house, may have been planted in the mid-nineteenth century. During the twentieth century, this drive was blocked off, and what may have been a secondary entrance opposite the house on Kingstown Road is now used as the main entrance. The present gravel drive leads to a gravel parking area adjacent to the rear service ell and two of the outbuildings.

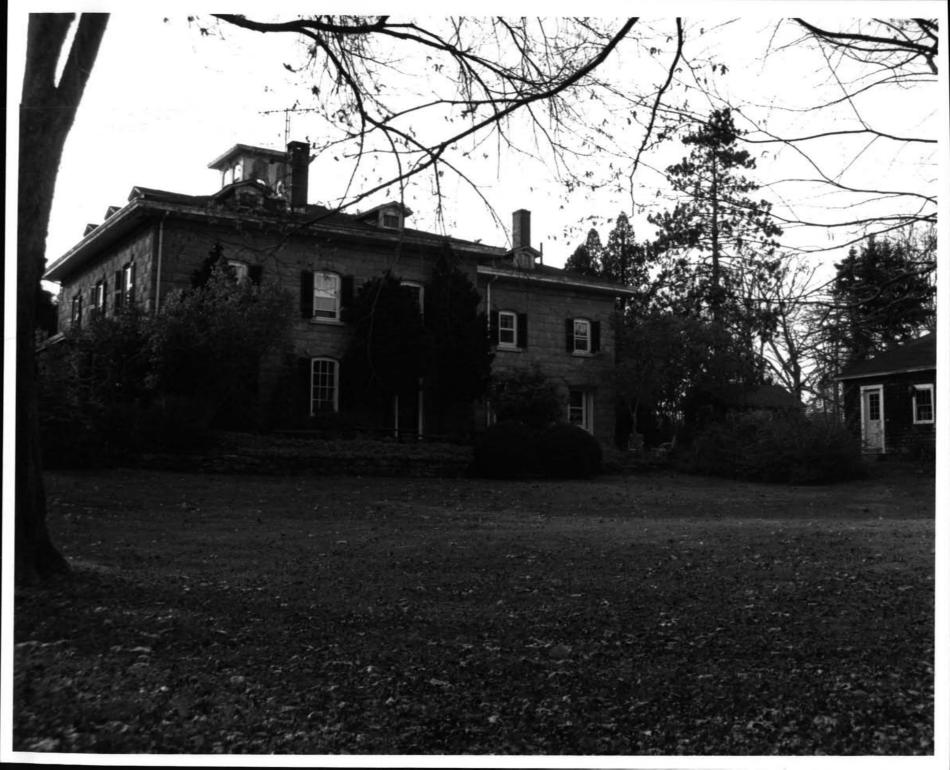
Isaac Peace Rodman's House Peace Dale, RI

East side of the house with  $pumphouse \ensuremath{\text{@}}$  and shed

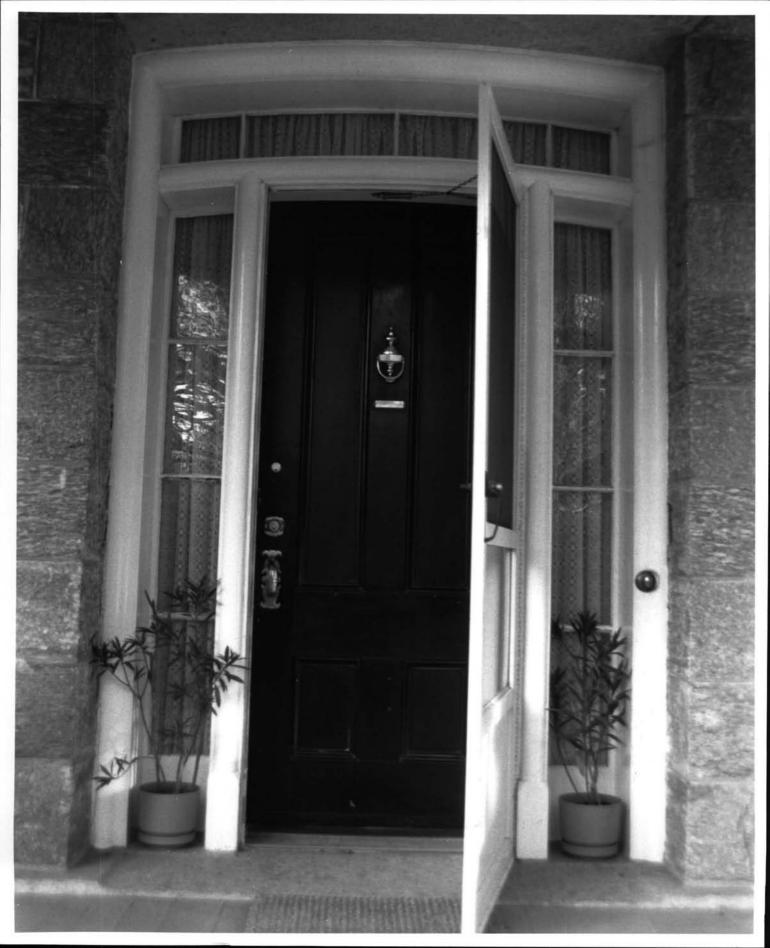
Isaac Peace Rodman's House Peace Dale, RI Front door

As originally constructed, the General Isaac Peace Rodman House possessed three exterior door openings: the main entrance and two in the service ell. The main entrance is enframed with sash sidelights like those at the windows described above and a segmentally arched four-light transom. The door itself contains four panels, with short panels in the lower third and longer panels in the upper two-thirds. Two secondary doors are located in

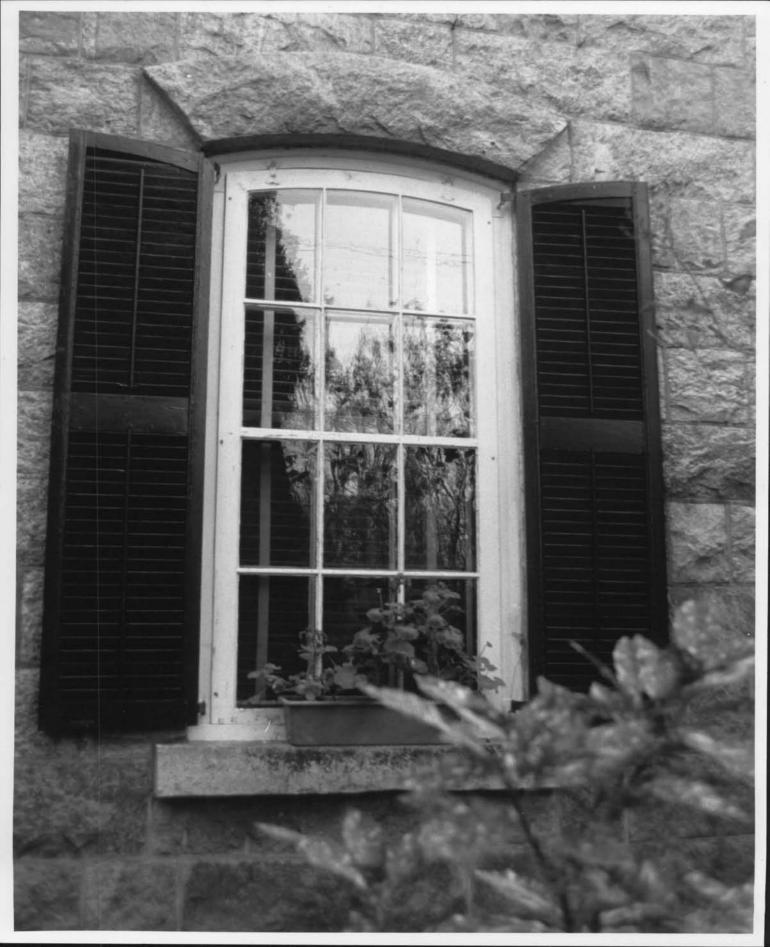
Isaac Peace Rodman's house Peace Dale, RI Window 1st floor

Door and window openings are all segmentally arched. The stone work of the arch spans is particularly fine, with projecting, hammered arched sections and flush, triangular end sections formed from a single block of stone.

Windows consist of wood six-over-six, double-hung-sash in the main block and second story of the ell; pairs of four-over-four, double-hung-sash in the first story of the ell; four-light double-casements in the attic dormers; and six-light basement windows. A fifth window type is found flanking the front door (south) and at the center of the rear (north) elevation. This more elaborate form extends to the floor and has full-height sidelights of double-hung sash, each containing two vertically set lights. The upper sash of all windows are segmentally arched and the windows are framed with arched wooden shutters.

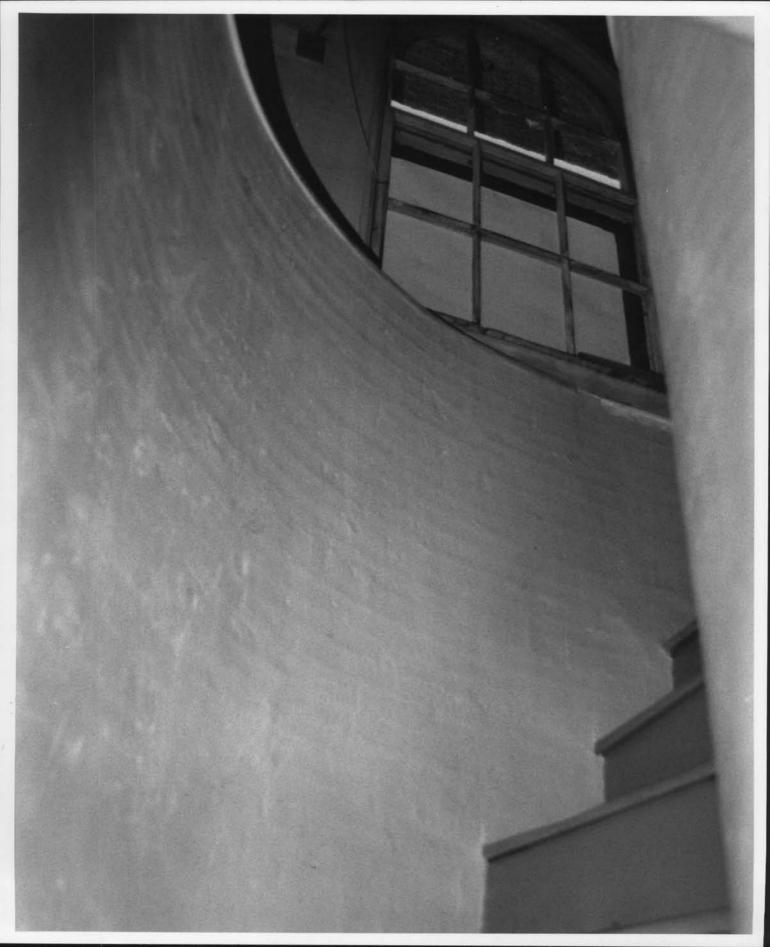
Isaac Peace Rodman House Peacedale, RI Interior view of lantern on top of house and winding stairway

The entrance and stairhall extends approximately half the depth of the house; three doors lead to rooms on either side and to the rear. The stair is a straight run with a curved quarter turn and winders at the top. One of the most elaborate features of the house, its treatment includes turned balusters and newels, and sawn stringer decoration. A round-arched niche is set into the curved wall near the top of the stairs.

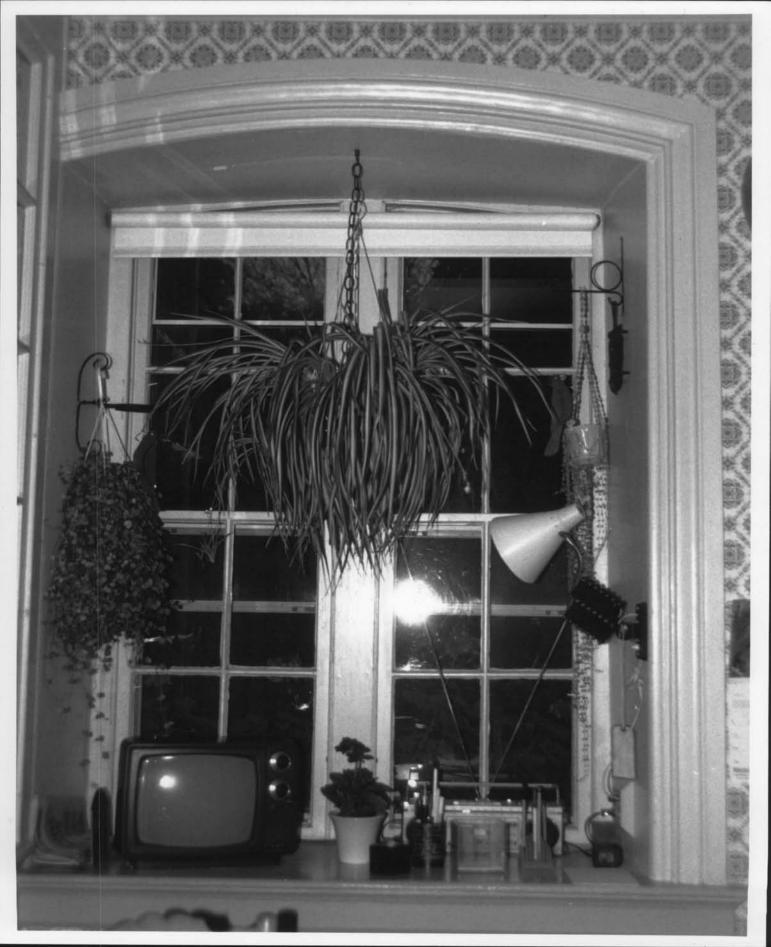
Isaac Peace Rodman's House Peace Dale, RI Kitchen window, west side

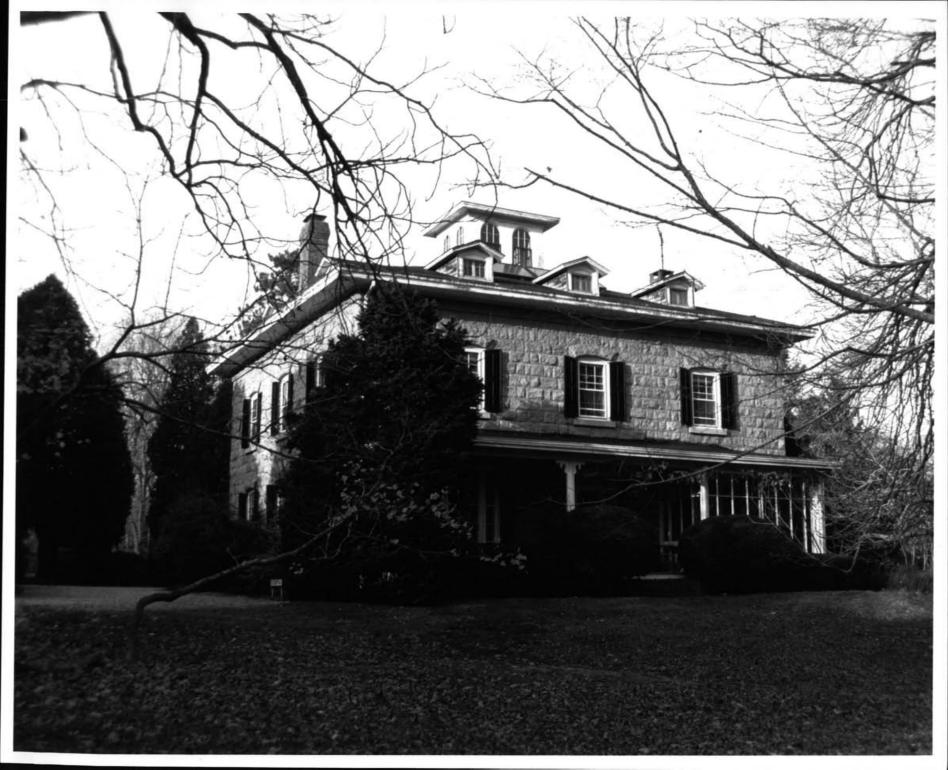
Isaac Peace Rodman's House Peace Dale, RI South and west sides of the house with porch and main entrance

The front porch is a fairly plain structure with square posts and simple sawn brackets. Before the last painting, in 1985, the vertical posts showed evidence of previous diagonally attached lattice work. The lattice work also appears in a early twentieth century postcard view of the house; it was removed in the 1940s. Pieces are extant and are stored in the stable on the property. The glass solarium enclosing the east end of the porch is also a mid-twentieth century addition. A wisteria vine runs much of the length of the porch, sprouting from a high base located in the southeast angle of the house and porch. It is thought to be an original planting.
