#### NATIONAL REGISTER OF HISTORIC PLACES REGISTRATION FORM

| nistoric name French Worsted Company Complex | | | | | | | | |
| street & number 153 Hamlet Avenue | for publication | | | | | | | |
| city or town Woonsocket | vicinity | | | | | | | |

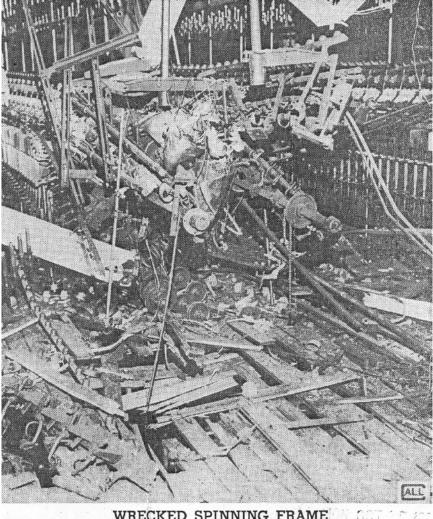
> **Figure 3** Halftone from *Woonsocket Call* after the October 16, 1966 bombing of Buildings 1 and 7

WRECKED SPINNING FRAME ... This machine, located in the rear section of the French Worsted plant, was one of several wrecked by explosion.

<sup>&</sup>lt;sup>1</sup> Many of these windows are filled with plywood. Fiberglass panel windows on the fourth floor were installed by French Worsted to replace those blown out in a powerful bombing in October 1966. Minutes later, another bomb exploded across the walkway on the fourth floor of Building 7. Fourth floor fiberglass windows in that building are of the same origin.
