National Register of Historic Places Registration Form

historic name: Saint Martin's Church

street & number: 50 Orchard Avenue

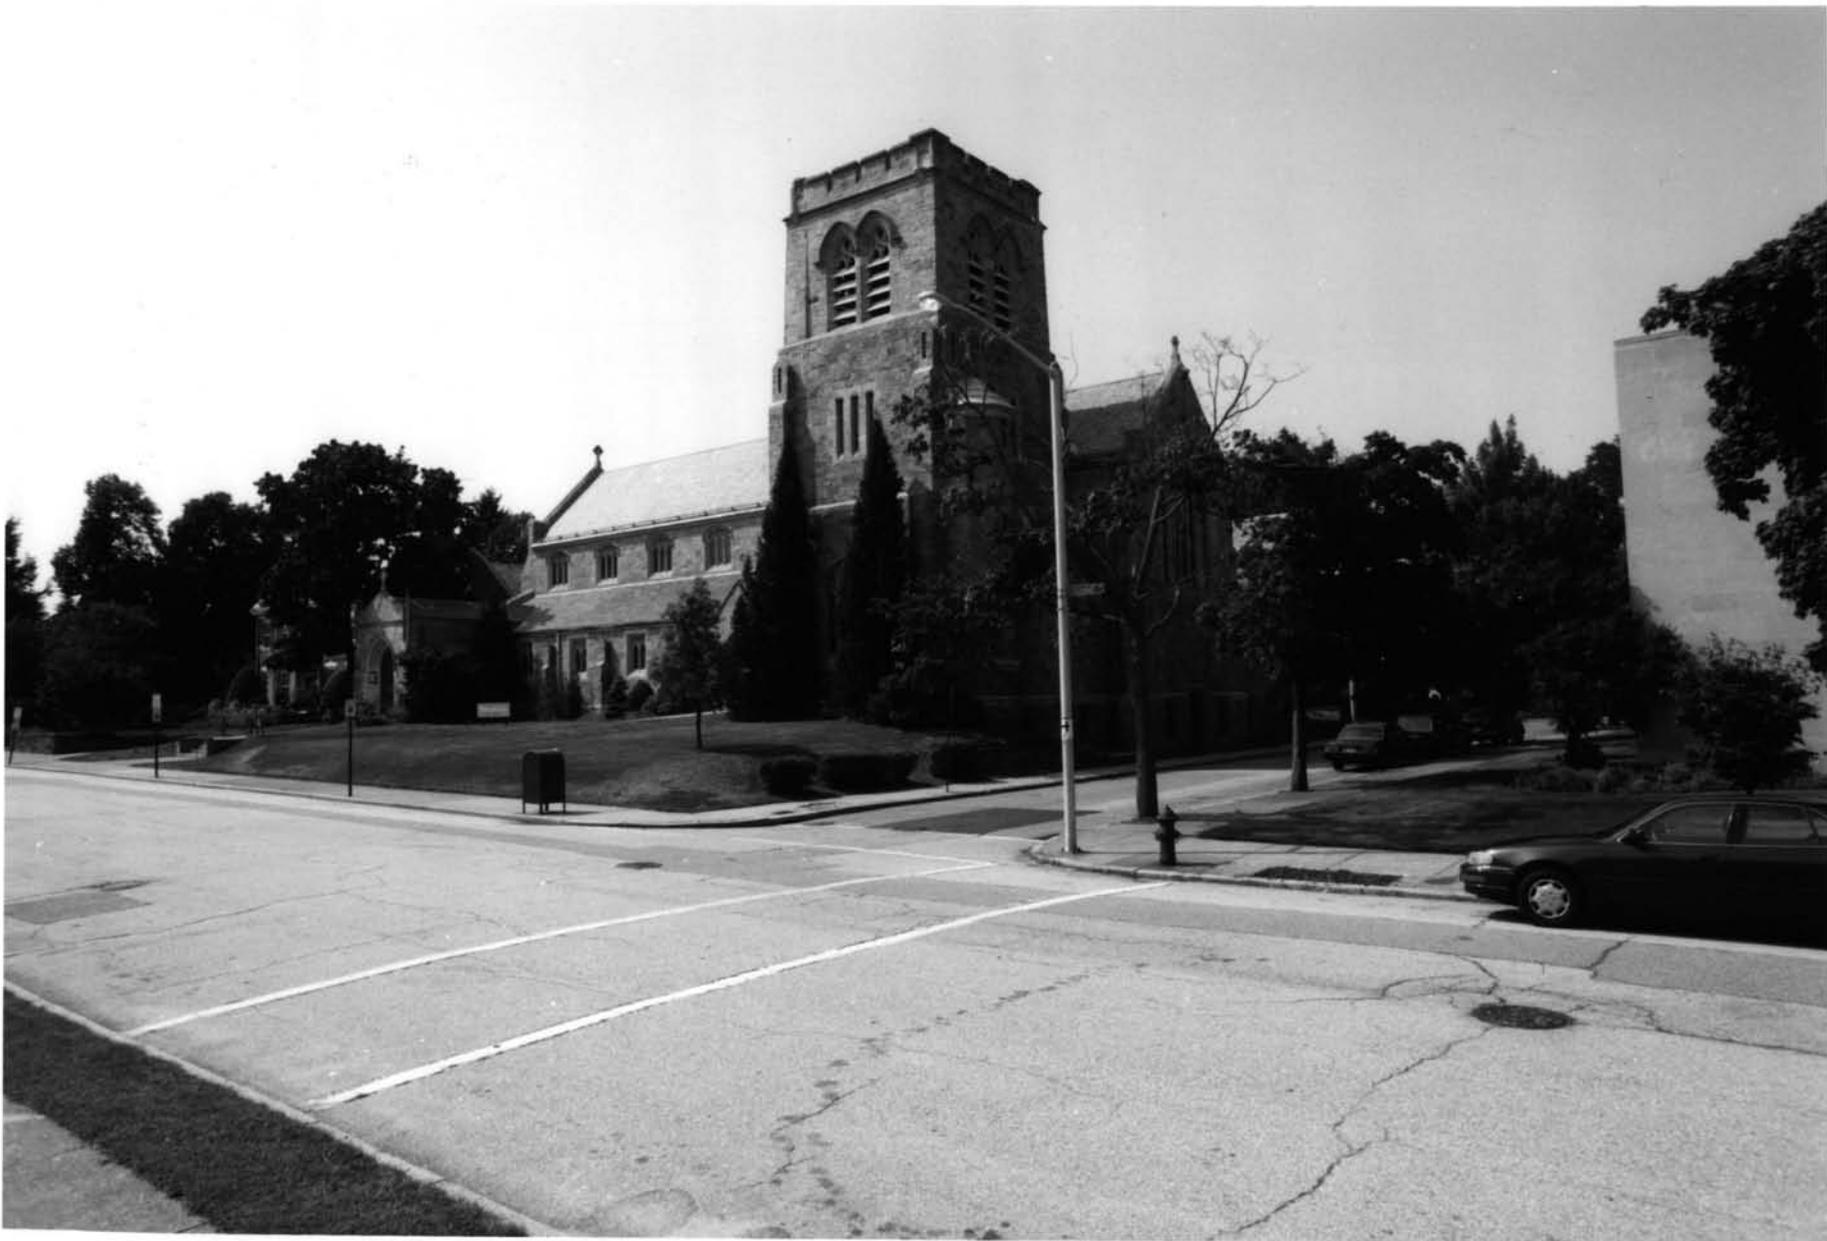
Photo # 1 of 8

6. View: South and east elevations, view to northwest
7. Photo #1

Exterior detail is restrained. Shallow battered buttresses frame each of the fenestration bays, and clasping buttresses frame the tower corners. Banked lancet-arch stained glass panels set within rectangular or Tudor-arch openings regularly punctuate the exterior walls. Large, complex stained-glass windows are located at the east end of the sanctuary, the west end of the nave, and the south side of the tower. Paneled wood doors are set within broad lancet-arch cusped frames. Exterior materials include random-course ashlar granite—in a variety of warm ochre tones—for the walls; cast-stone and limestone¹ trim for the windows, doors, and belfry louvers; and slate for the roof. The peak of the narthex's gable roof is crowned with a cross, and crocketed finials cap its eaves.

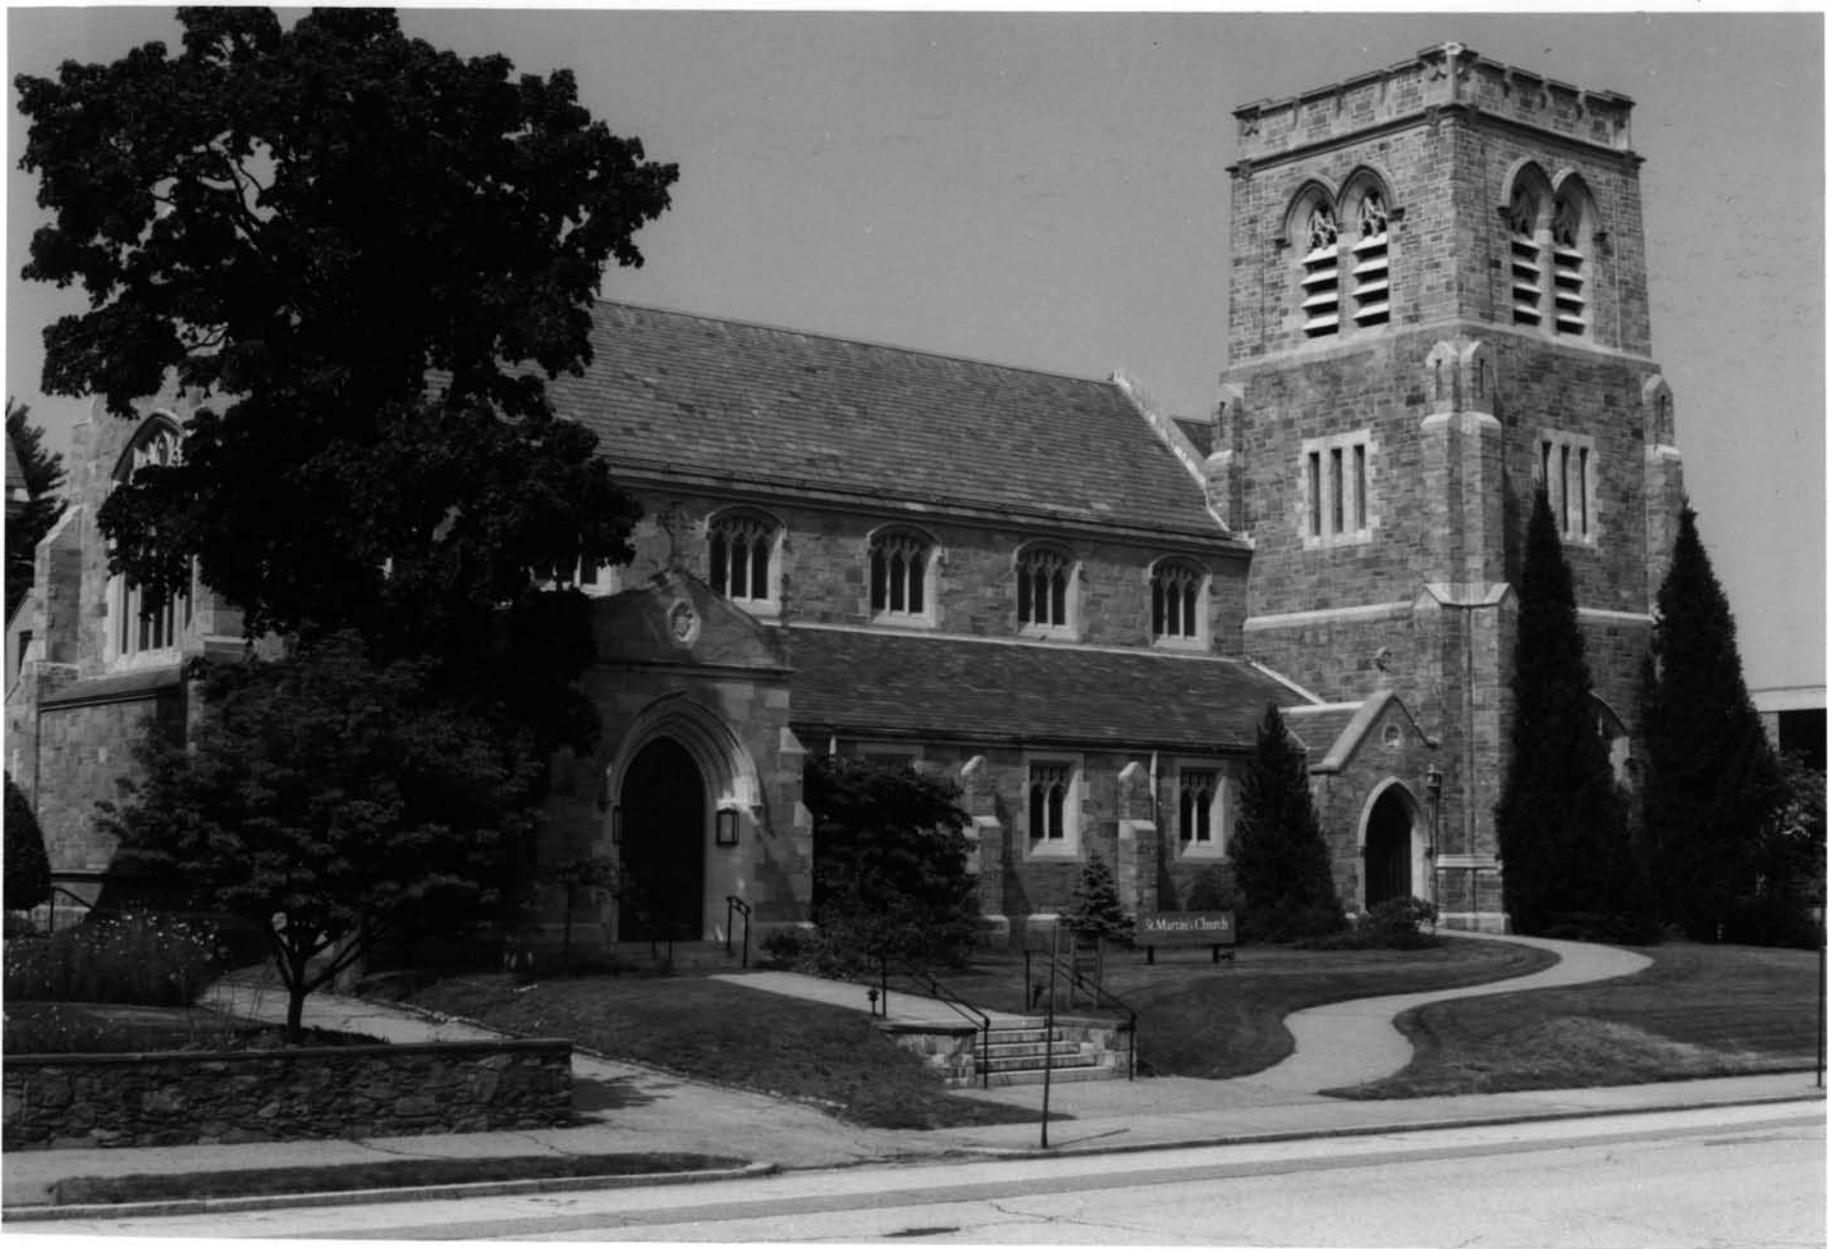
St. Martin's Church
Providence County, Providence, R.I.
Photo #2 of 8

6. Facade, view to northeast
7. Photo #2

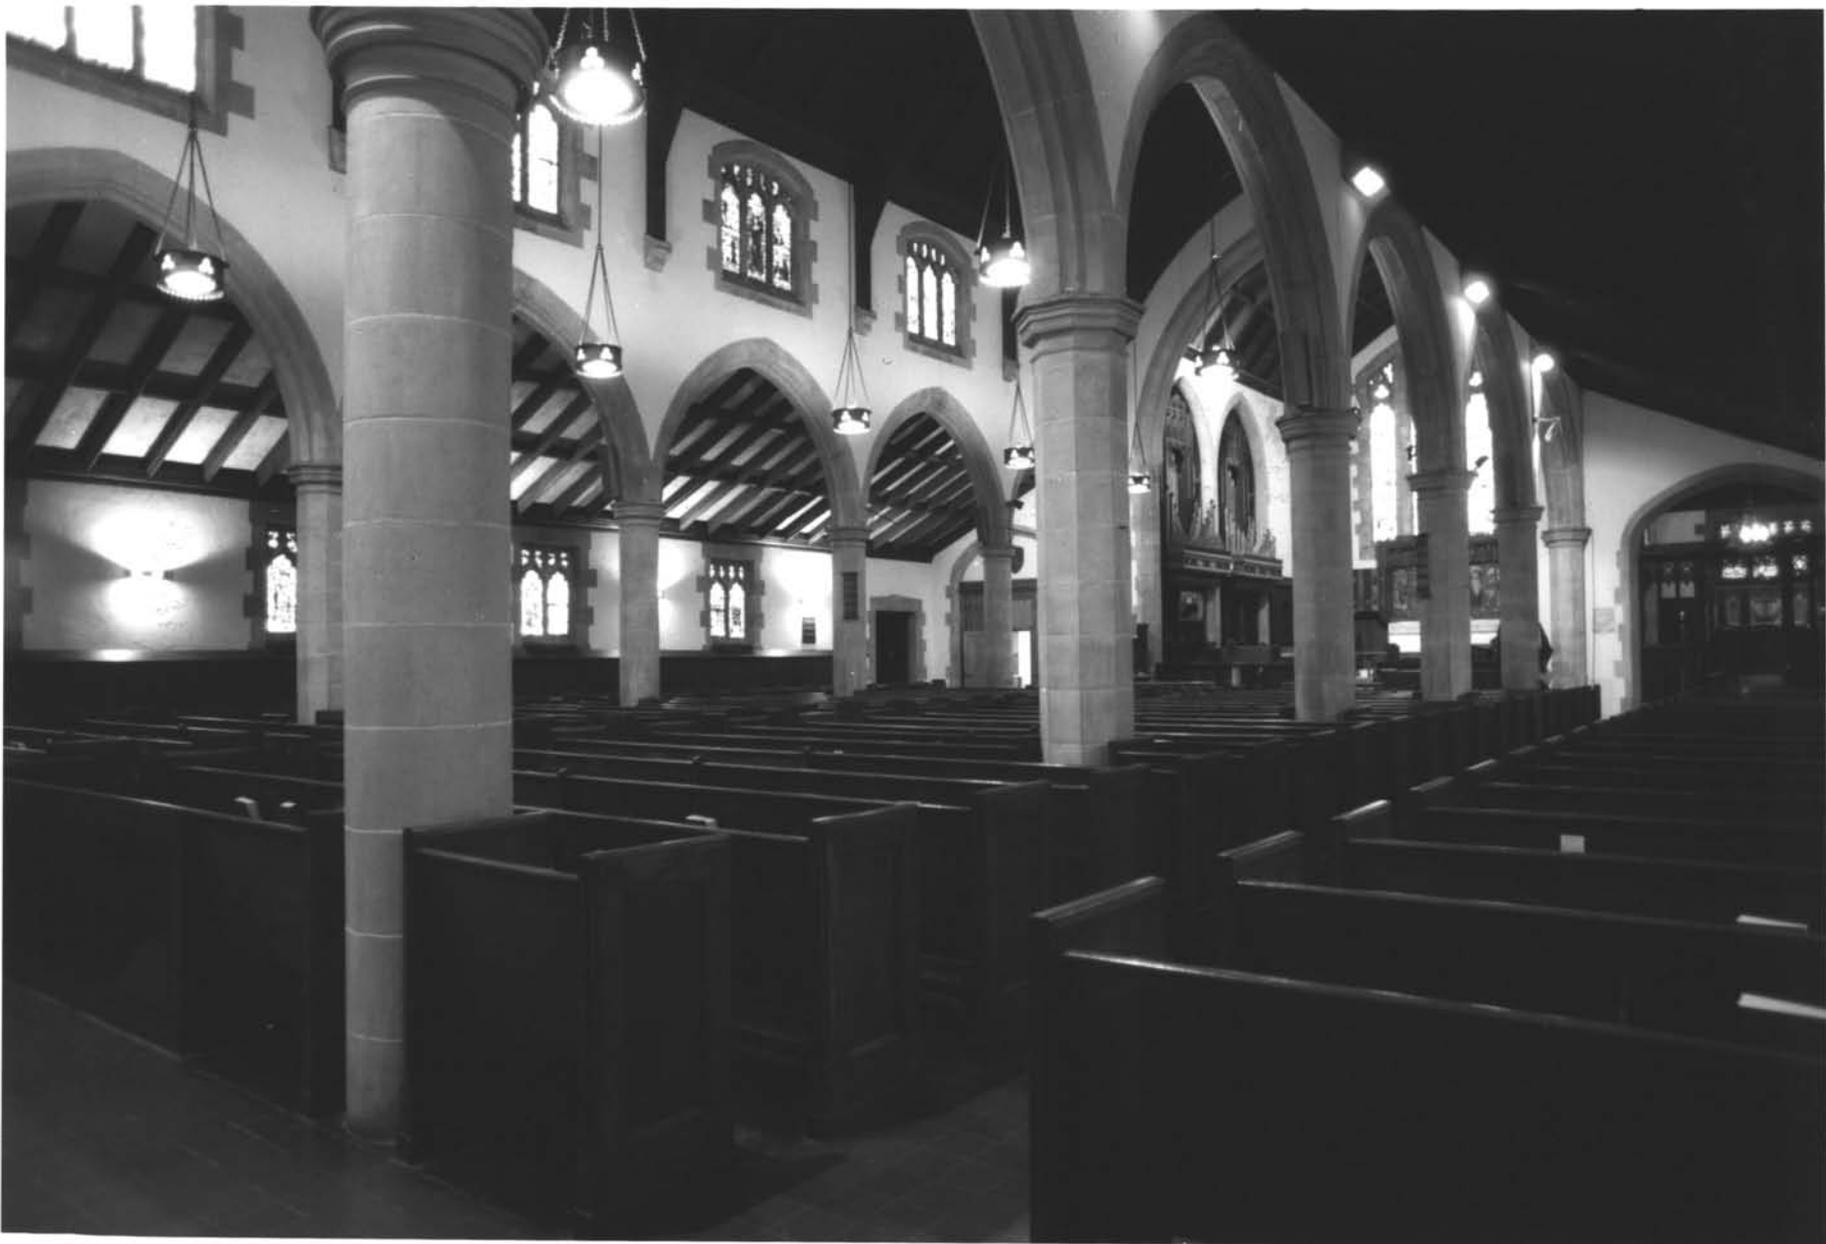
St. Martin's Church
Providence County, Providence, R.I.
Photo #3 of 8

6. View: Nave, view from southwest corner to northeast
7. Photo #3

alternating molded ecclesiastical symbols in the chancel and sanctuary; within the pew areas the floors are tongue-and-groove oak strips. Ceilings have exposed oak rafters above the side aisles and oak trusswork—hammer-beams, collarbeams, and king posts—above the nave. The ceiling of the nave is beaded tongue-and-groove oak; the ceilings of the aisles have acoustical tile over the oak paneling.

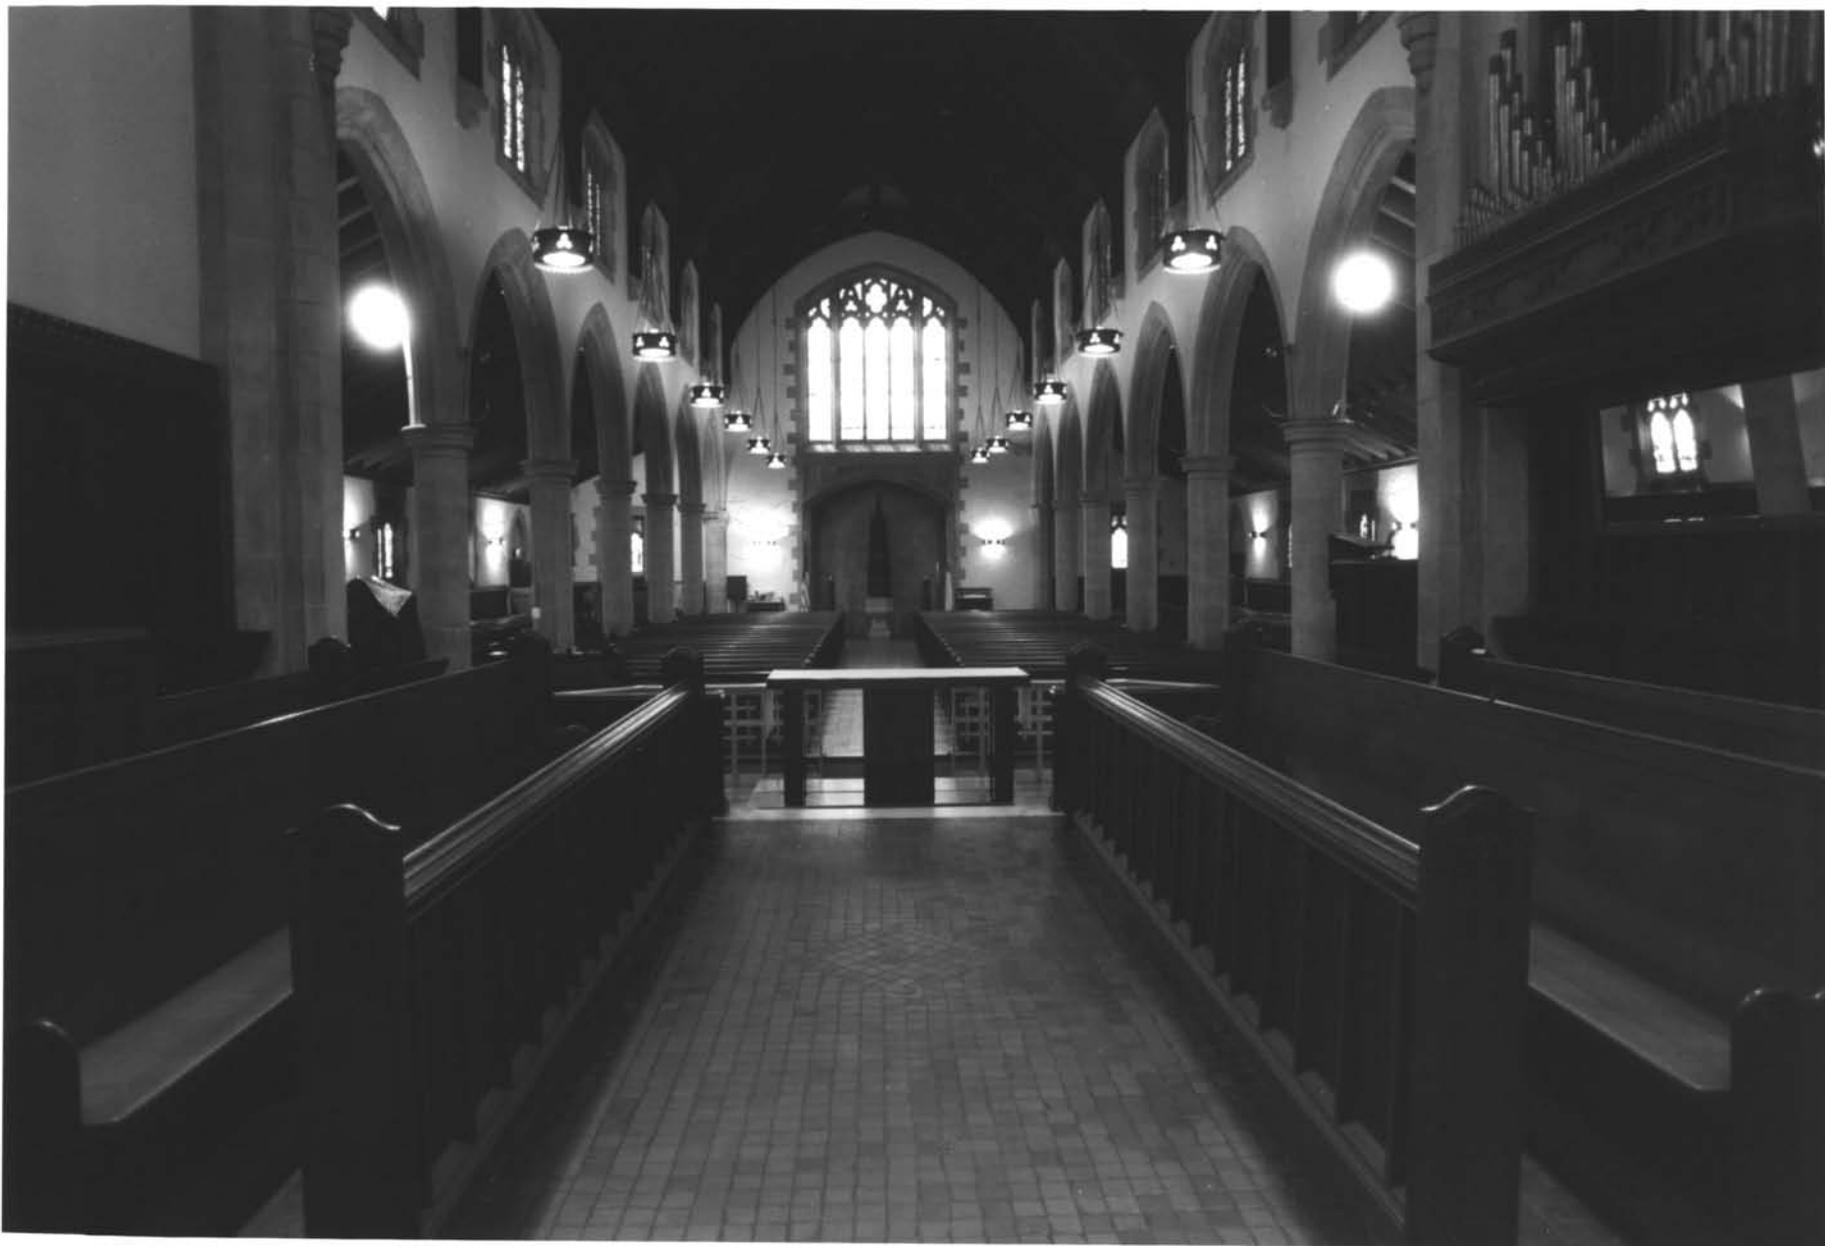
St. Martin's Church
Providence County, Providence, R.I.
Photo #4 of 8

6. View: View from chancel to west
7. Photo #4

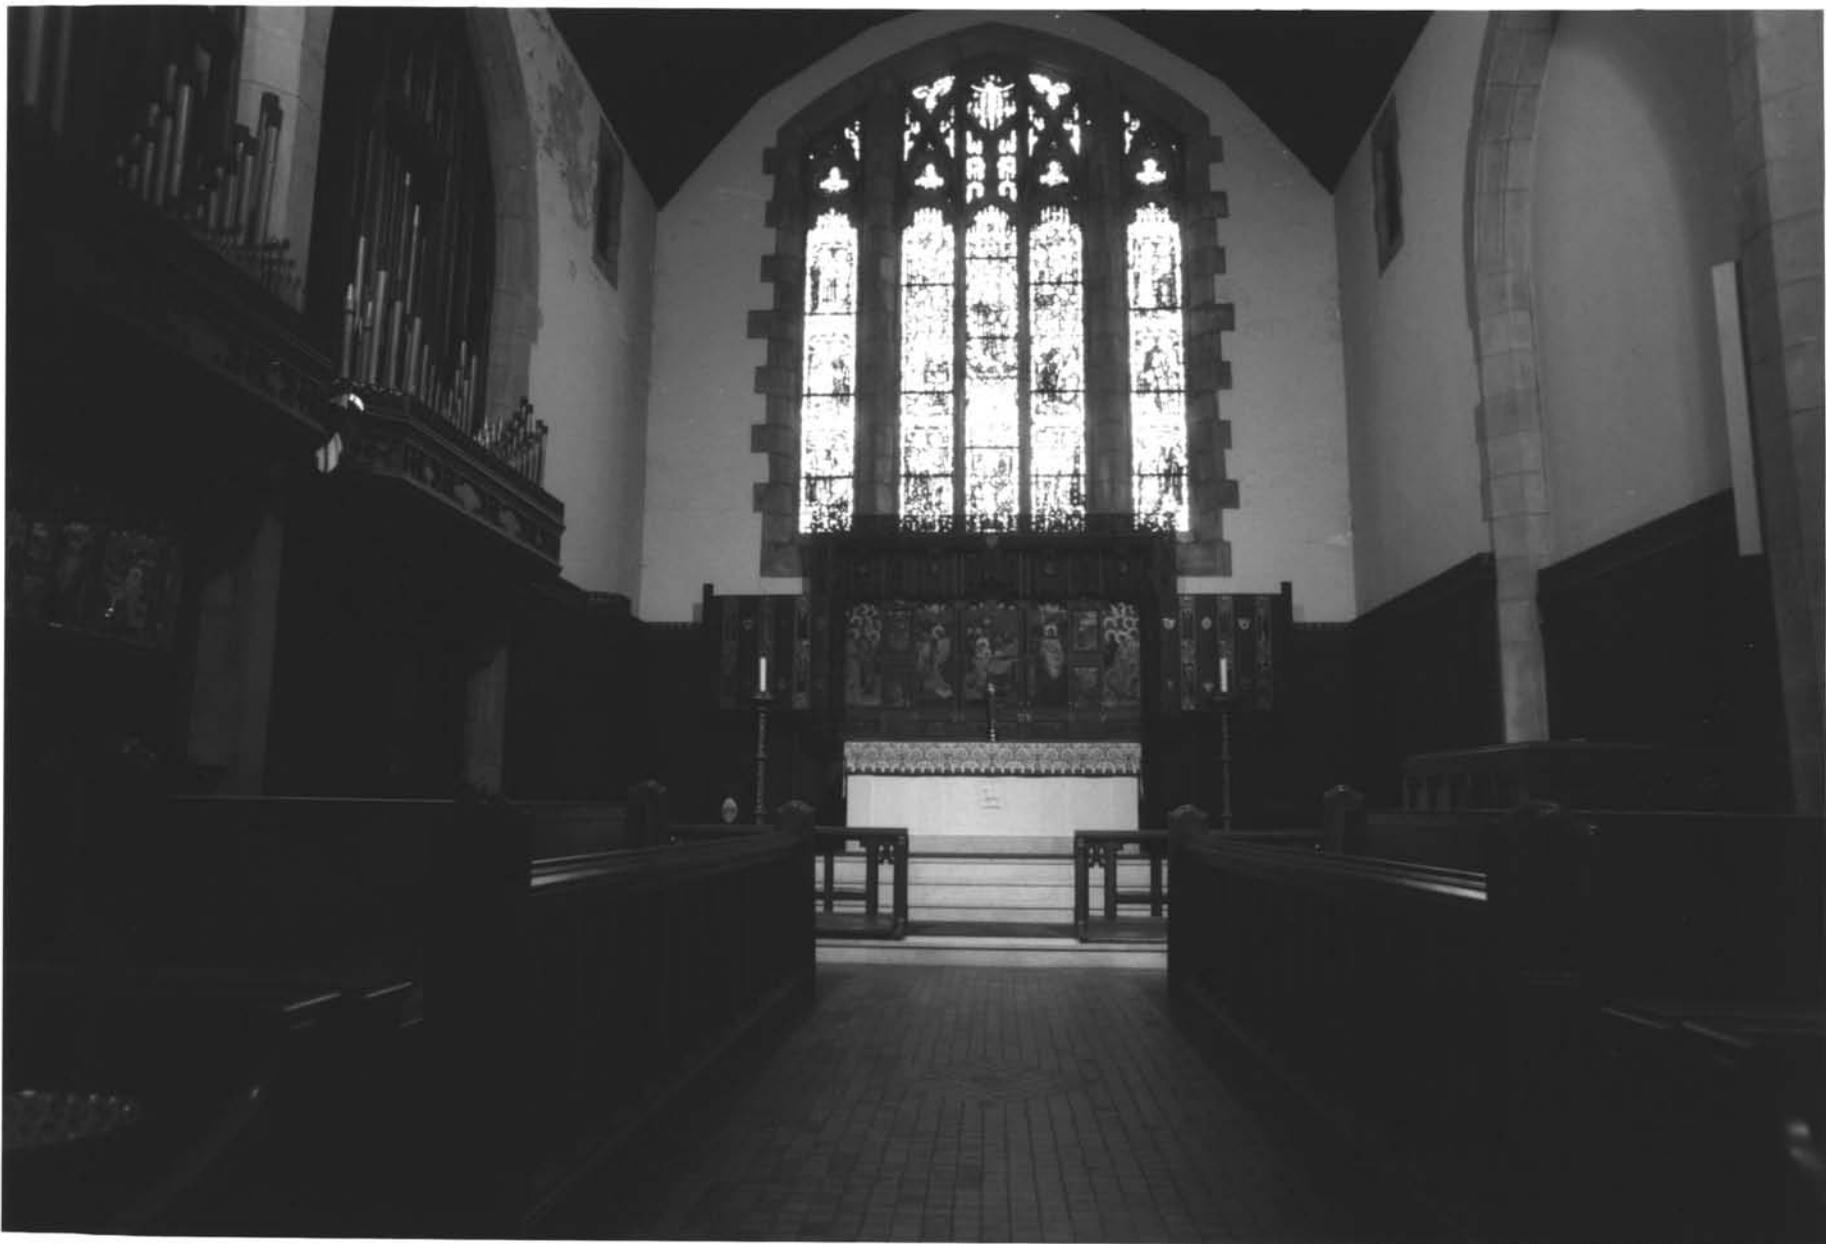
St. Martin's Church
Providence County, Providence, R.I.
Photo # 5 of 8

6. Chancel and sanctuary, view to east of altar
7. Photo #5

The most significant interior features of the church are the carved oak paneling and the stained glass. The high altar reredos (1923), designed by Bertram Grosvenor Goodhue (1869-1924), depicts scenes from the lives of Christ and St Martin of Tours, the church's patron saint. The paneling in the chancel, sanctuary, chapel, and nave is the work of Irving & Casson. Of particular note are the chapel altar (1944) of Christ the King by Ernest Pellegrini, a member of Irving & Casson; the tracery lectern with statuettes of St Anselm, St Columba, and Thomas Cranmer; the tracery pulpit, with statuette-capped newel posts in the image of St Martin of Tours and St Augustine of Canterbury; and the octagonal baptismal font (1947) with limestone base and carved wood superstructure. The stained glass is chiefly by Harry Eldridge Goodhue, Wilbur Herbert Burnham, and Reynolds, Francis & Rohnstock. As originally installed, it was largely grisaille, reminiscent of fifteenth-century English examples as secularized by the Arts & Crafts movement. When the church was enlarged in 1945 (see below), new, more highly colored glass, reminiscent of thirteenth-century French examples, was installed at the west end, and existing glass was reworked in more brilliant colors.

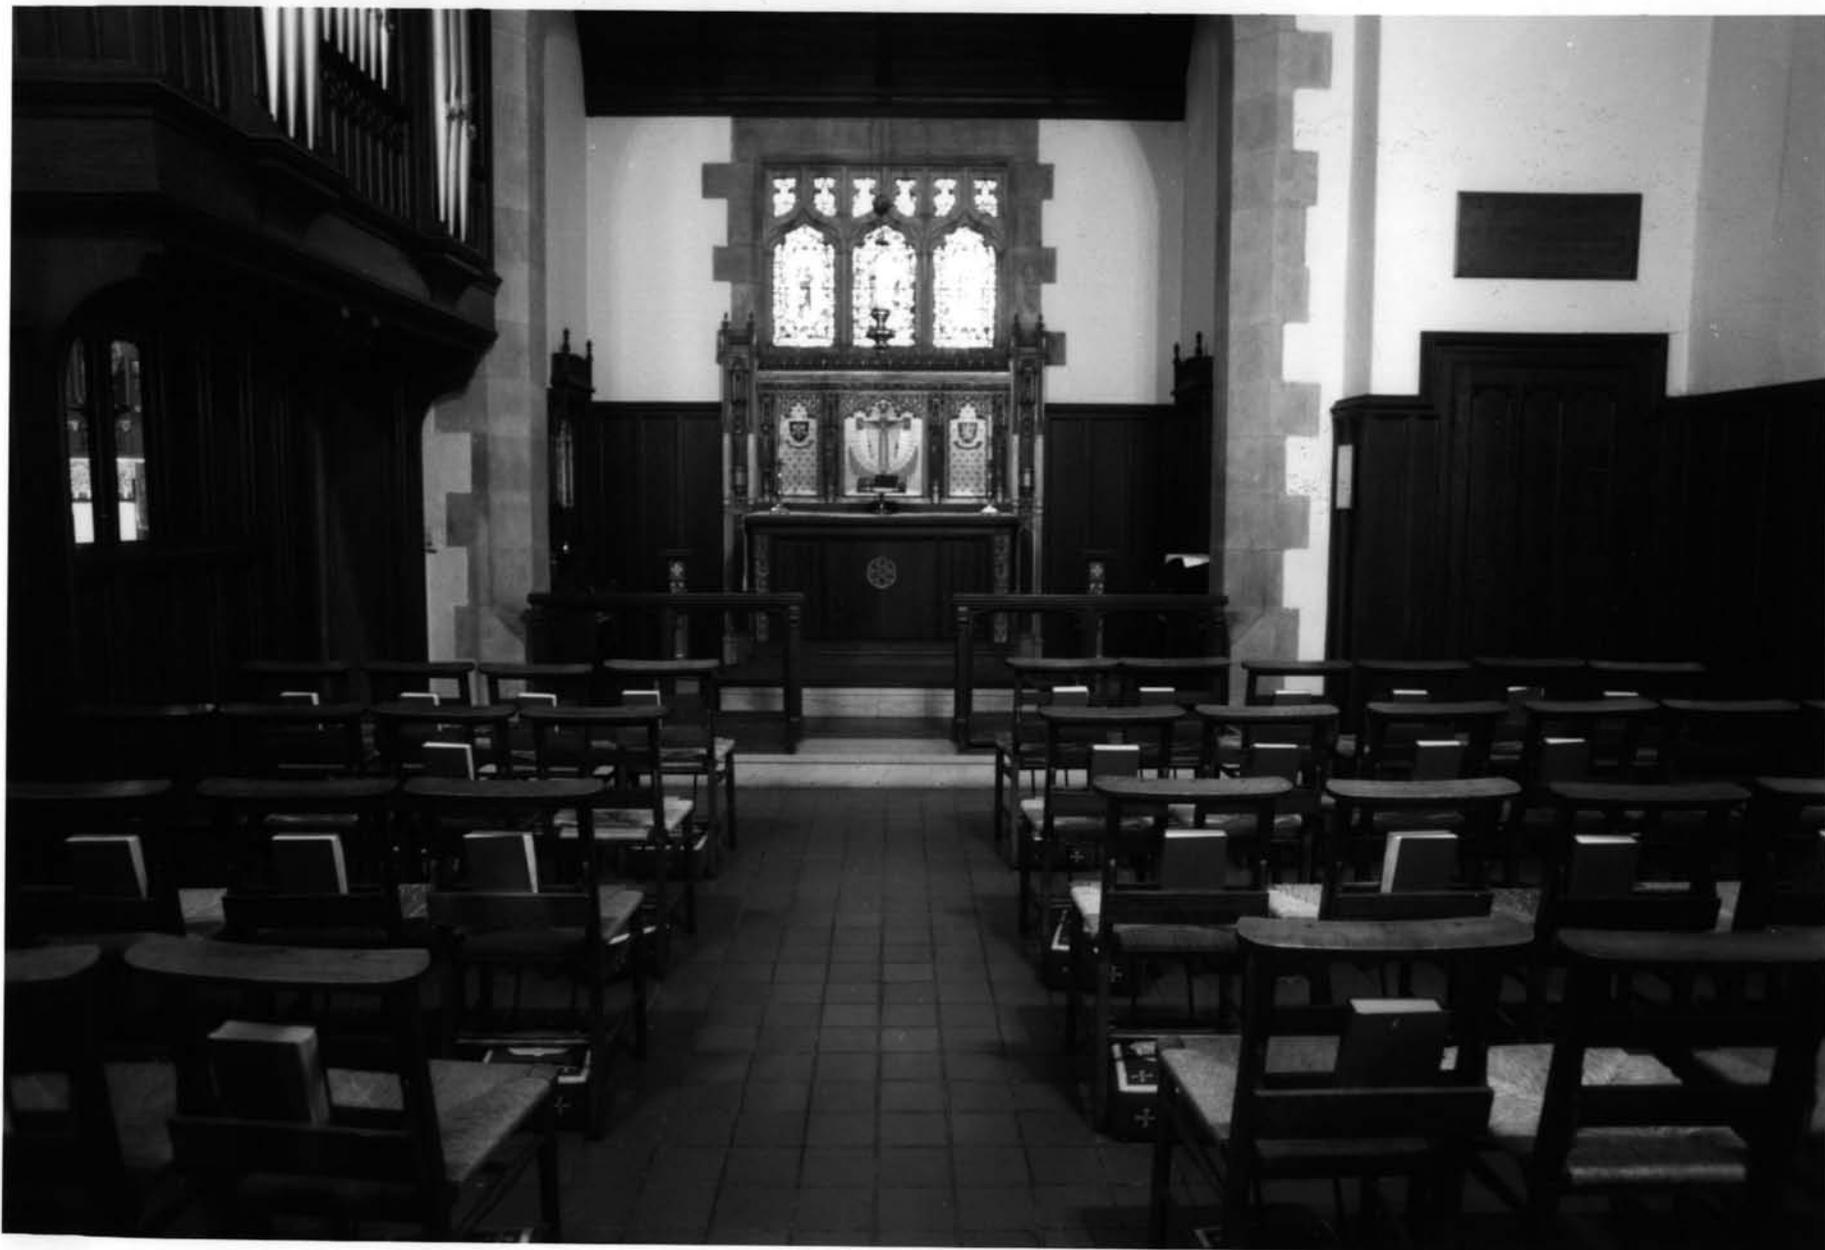
St. Martin's Church
Providence County, Providence, R.I.
Photo #6 of 8

6. View: Chapel, view east to altar
7. Photo #6

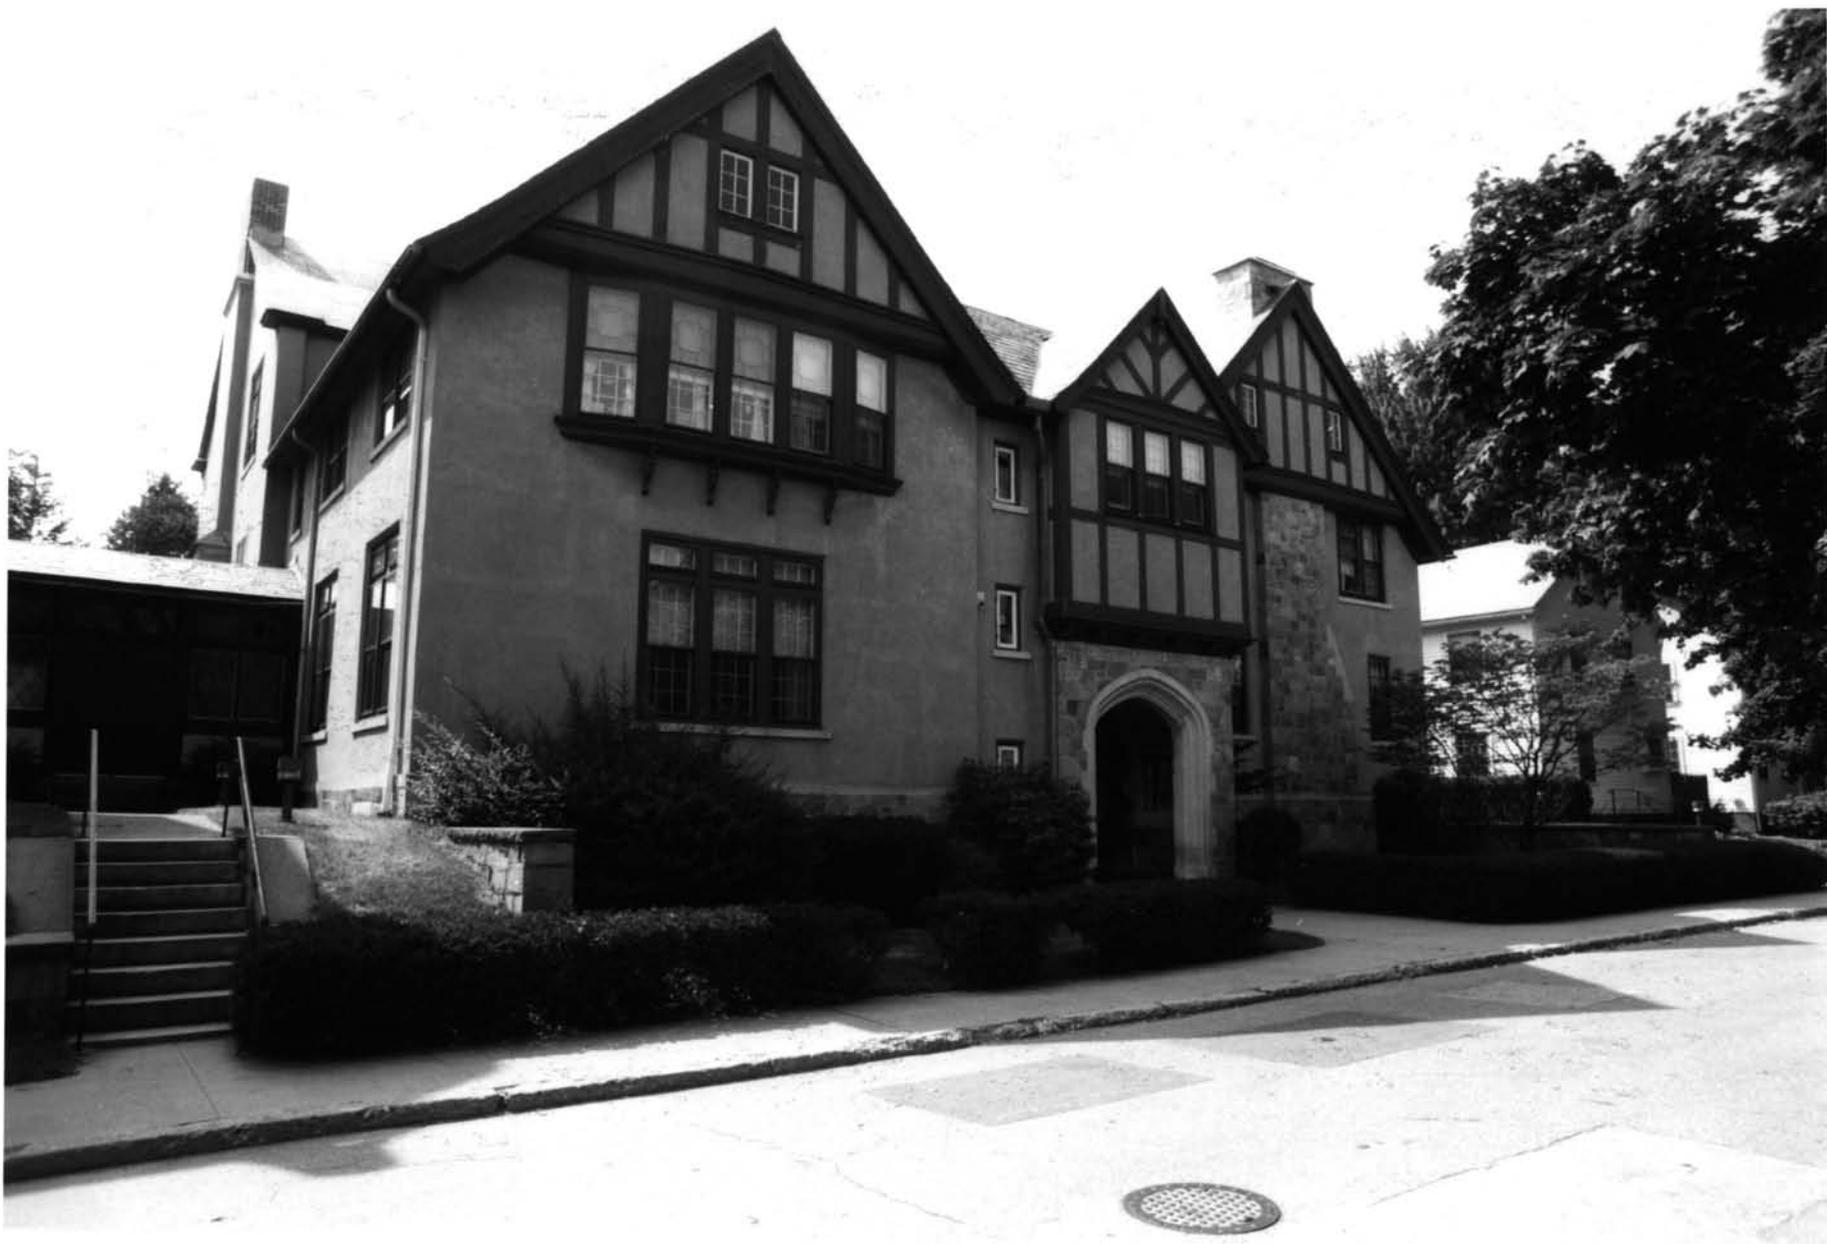
Photo # 7 of 8

6. View: Parish House, facade, view to west-northwest
7. Photo #7

To the northeast of the church is the parish house. Its façade is half timber, and the remaining walls are grey stucco. The slate roof is capped with an elaborate octagonal copper wind vane, capped with a whimsical child's silhouette. The interior contains seven levels arranged on a split-level scheme, with only the main level occupying the full depth of the building and the other six levels occupying alternatively the east and west halves of the building. The alternating-level scheme, not uncommon in early twentieth-century parish houses, allows for a large gymnasium in the lower cellar; stage dressing rooms at cellar level; entrance vestibule at ground level; parish hall, meeting rooms, kitchen, and scullery at the main level; parish offices at next half level, and classrooms and small meeting rooms in the top two levels.

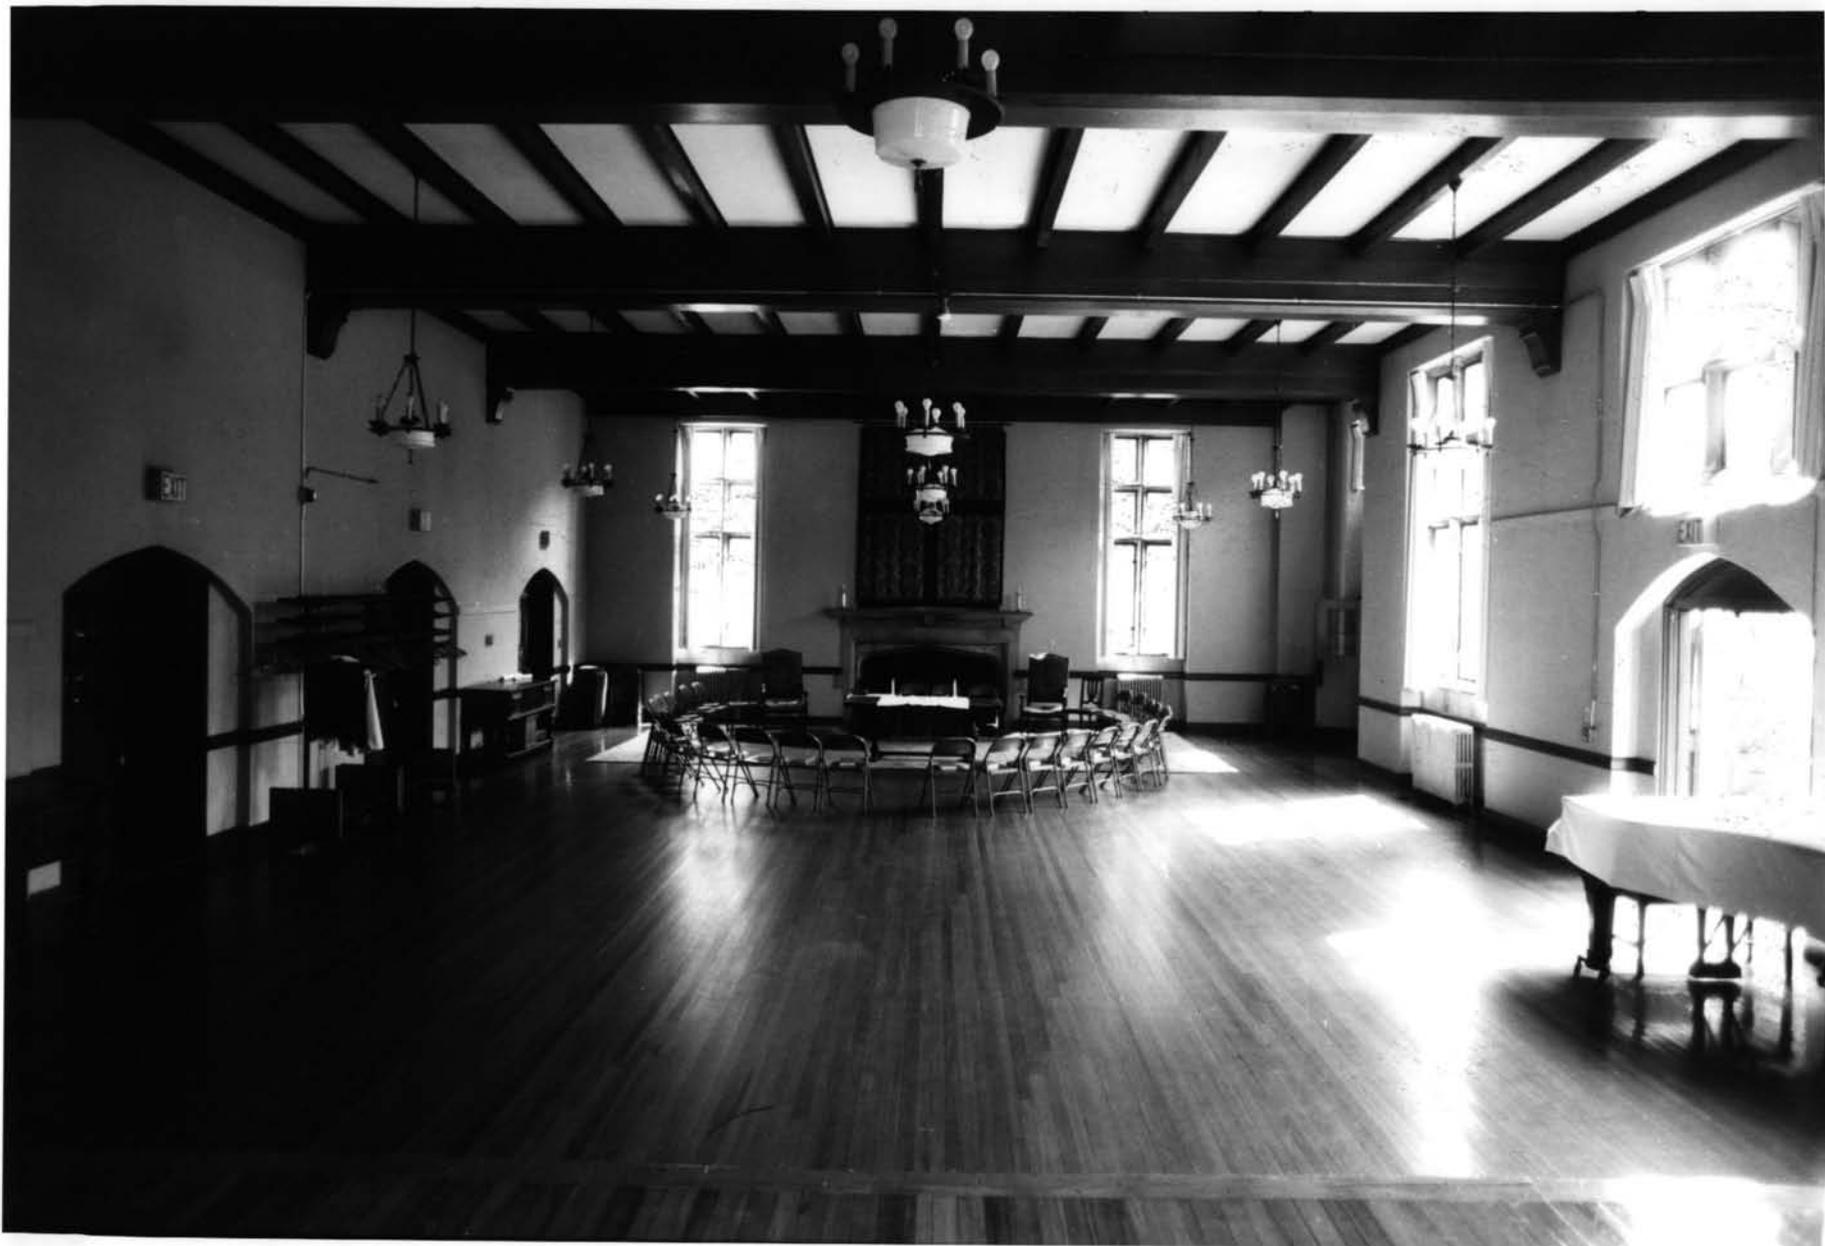
St. Martin's Church
Providence County, Providence, R.I.
Photo #9 of 8

6. View: Great Hall, view south from stage
7. Photo #8

The Great Hall is the most impressive space in the parish house. Occupying the space of two levels on the west side of the building, it features a stage at the north end and a large fireplace with Tudor-arch mantel at the south end. Tall casement windows illuminate the room on the

south and west. The floor is oak, and massive carved oak fictive beams and joists span the plaster ceiling.
