UCTIONS IN HOW T PE ALL ENTRIES		·	•	2/6/9/
1 NAME			<i>,</i> .		
· · · · · · · · · · · · · · · · · · ·	h Hicks House	2			
AND/OR COMMON				•	
2 LOCATION	· · · · · · · · · · · · · · · · · · ·				·
STREET & NUMBER 494	Main Road		NOT FOR P	UBLICATION"	
city.town Tivert	on _	vicinity of Dist.	1 Hon. Fe	sional district rnand J.	St.Germai
state Rhode Isl	and .	CODE 44	COUNTY	Newport	CODE 005
3 CLASSIFICATI	ON				
DISTRICTPU X_BUILDING(S)	VATE "	STATUS X.OCCUPIED —UNOCCUPIED —WORK IN PROGRESS ACCESSIBLE —YES: RESTRICTED —YES: UNRESTRICTED X.NO	COM EDU ENT GOV	MERCIAL _ CATIONAL X ERTAINMENT _ VERNMENT _ USTRIAL _	IT USE _MUSEUM _PARK _PRIVATE RESIDENCE _RELIGIOUS _SCIENTIFICIRANSPORTATIONOTHER
OWNER OF PRO					
NAME Mrs. Sylv	via sarie				
STREET & NUMBER 494	Main Road				
city.town Tivert	on	VICINITY OF	Rh	state ode Isla	nd 02878
5 LOCATION OF	LEGAL DESCR	RIPTION			· · · · · · · · · · · · · · · · · · ·
COURTHOUSE, REGISTRY OF DEEDS, ETC.	Tiverton Tow	n Hall

Joseph Hicks House 494 Main Road Tiverton, Rhode Island

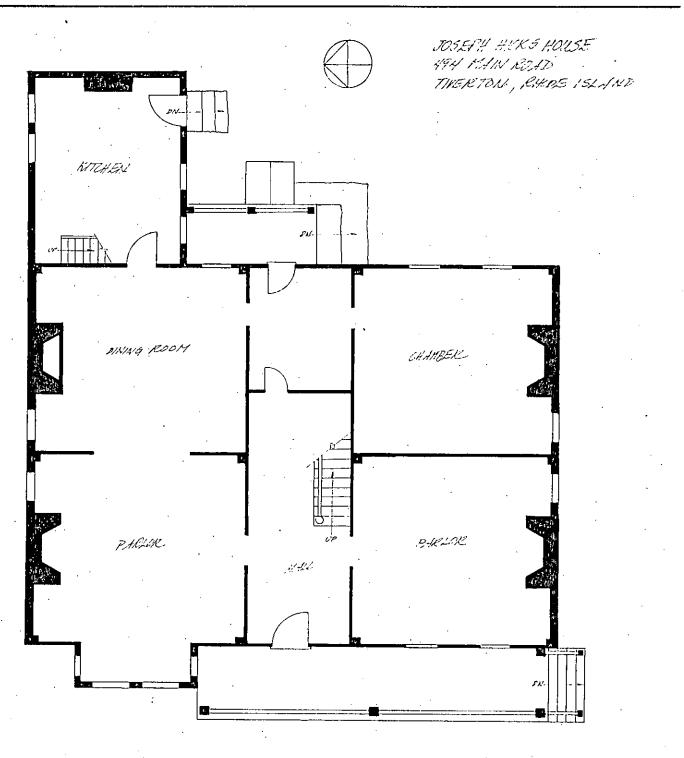
CONTINUATION SHEET 3 ITEM NUMBER 7 PAGE 4

Inside is the formal and elegant eighteenth-century plan of a front-to-back stair-hall flanked by two squarish rooms on each side on both principal floors (see floor plan). On the first floor this hall is divided into two parts by a transverse partition with doors about two-thirds of the way to the rear, thus forming a small oblong entry inside the east, or back, entrance. In its western or front end, in the portion not taken up by the stairwell, the hall is given the rather unusual feature of a shallow coved ceiling.

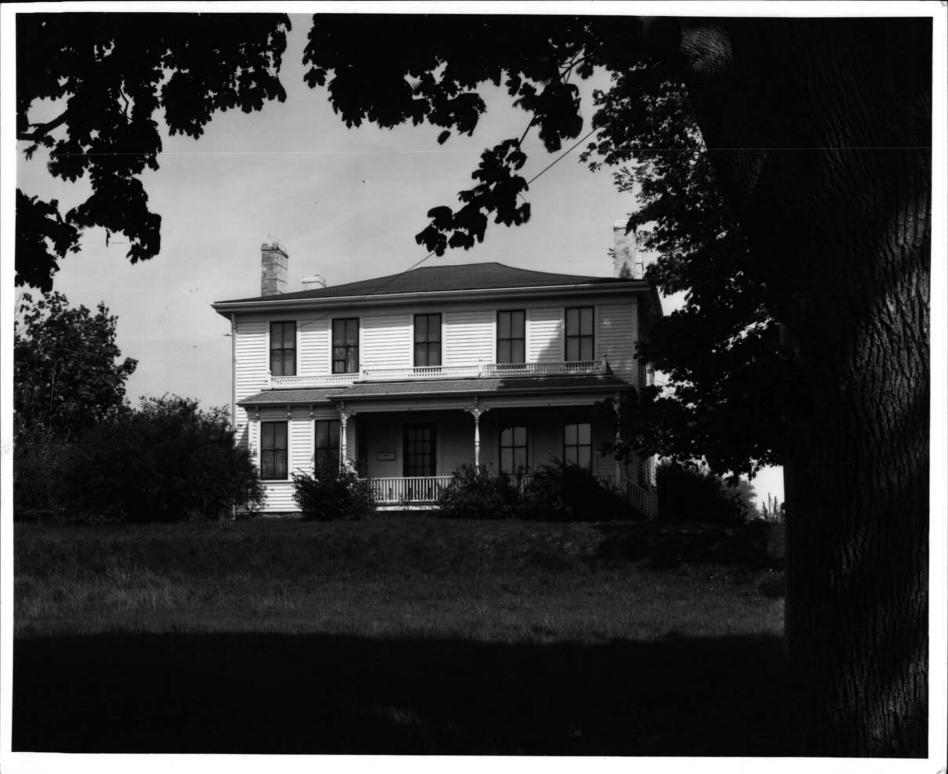
photo #1

West Elevation

In 1893 a kitchen pantry extension with chamber above was added at the northeast corner of the rear; at the same time, a rectangular onestory bay window was added at the north end of the entrance (west) front, and a one-story railed porch was constructed across the remainder of this elevation (photo 1). The two end walls of brick were covered by clapboarding, and the chimneys were given coatings of stucco. Two-over-two-paned window sash were likewise introduced. Otherwise, the house remains much as it was when originally built. Exterior adornment originally was kept to a noticeable minimum: windows have very plain flat board enframements with no mouldings or cappings and the only modest embellishment to be seen is the plain fascia-board and moulded cornice treatment under the eaves. Otherwise, the outward beauty of this house depends only upon its fine proportions, well-spaced fenestration, and the four vertical accents of the chimneys.

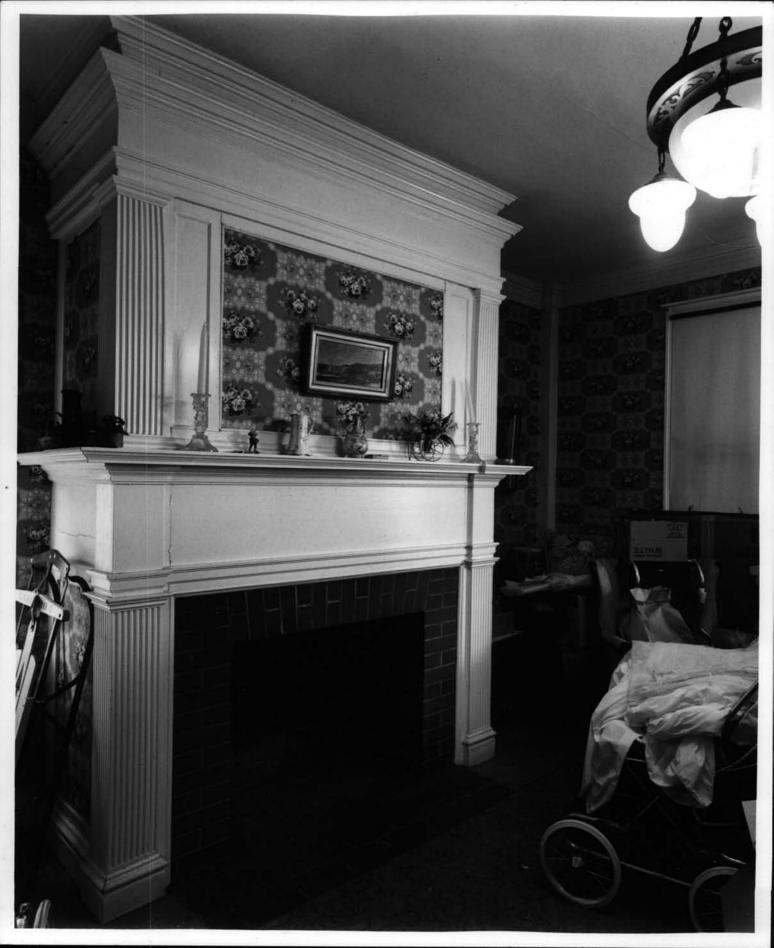
photo #3

Mantel in south parlor

On each floor only the two front (western) rooms have notable trim. On both floors, doors at the front of the house have six raised panels; those in the rear portion have only four shallow flat panels. The only rooms to have ceiling cornices (and these are rather conspicuous ones. of moulded and carved wood) are the two western rooms on the first floor, and it is these latter rooms which contain the most elaborate mantel treatments in the house. The northwest room has a two-story mantel composed of an entablature (brought forward, and its frieze panelled, at each end) supported by half-round Tuscan columns above which rises a heavily-moulded blind arch also supported by half-round Tuscan columns (see photo 2). The arch has a keystone, and its innermost moulding is ornamented with spaced drilled circles. The southwest room has a two-story mantel exhibiting a lower entablature which breaks out over its supporting fluted Tuscan pilasters; above, a similar pair of pilasters uphold a second entablature with a heavy cornice (see photo 3). The overmantel area here is filled by two narrow and one wide raised panels. In the south-east room at the rear of the house there is a much simpler Federal-style mantel with no upper adornment, while in the northeast room the fireplace has been closed and no mantel remains. From this northeast room there is access to the kitchen and pantry in the rear ell.

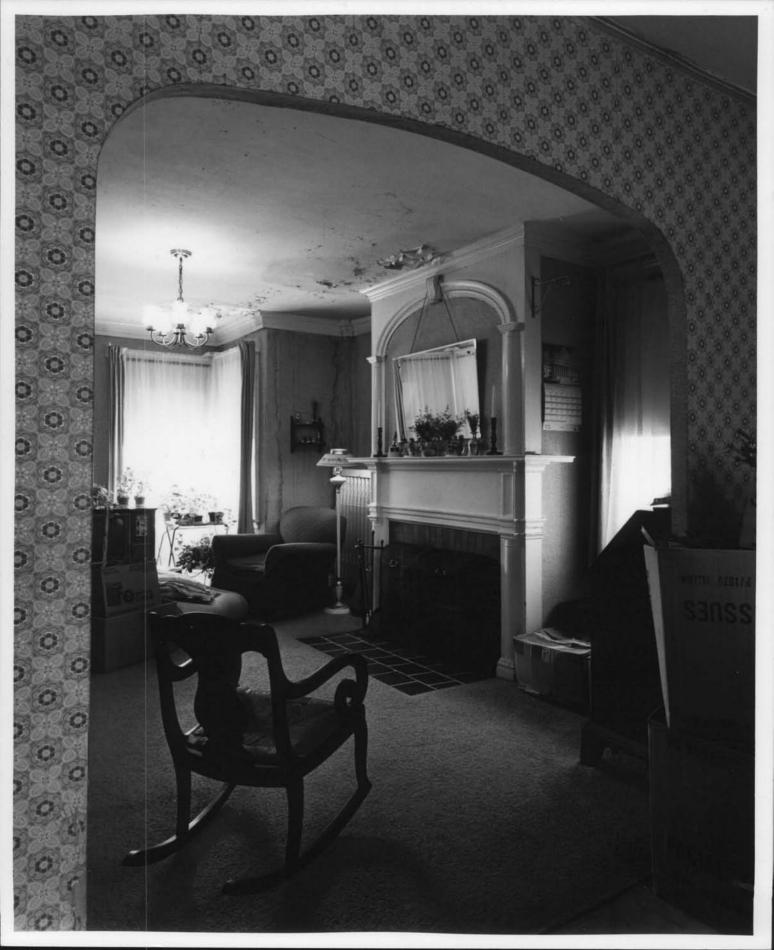
photo #2

North Parlor
